# ROAD SAFETY AUDIT

Newport Avenue at Beale Street

City of Quincy

February 28, 2019

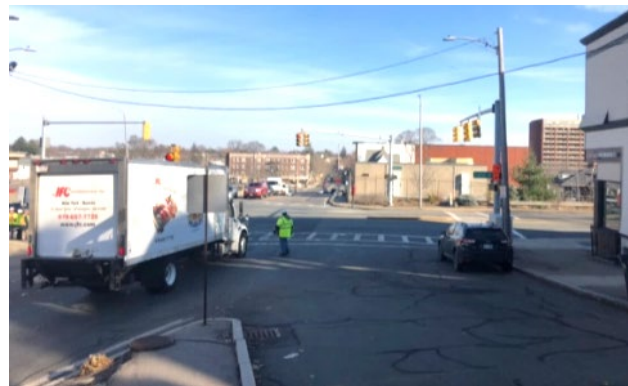
The Beale Street eastbound approach is intersected by the one-way out Grandview Avenue. This creates an approach approximately 42 feet wide, which is wide enough for three to four vehicles with no lane markings provided (**Figure 3**). Vehicles coming from Grandview Avenue and wanting to continue through or make a left turn onto Newport Avenue must force their way to the

**Figure 3 - Beale Street EB with Grandview Avenue merge.**

left side of the approach in a span of approximately 40 feet before they enter the intersection. If they are unable to merge in this short distance, two vehicles are likely to continue through the intersection side-by-side, even though there is only one eastbound receiving lane. There are no stop or yield signs present for the Grandview Avenue approach. Further, while the receiving lane for eastbound through vehicles is intended for one lane of traffic, it is un-marked and approximately 22 feet wide, which is sufficient to fit two through vehicles and is facilitating this driver behavior. The audit team observed that this results in confusing and inconsistent travel patterns for eastbound traffic and makes it difficult for westbound left-turning vehicles to judge if the opposing eastbound traffic is going through, turning left, or turning right. This is a key factor contributing to the four instances of a westbound left-turning vehicle being struck as it turned in front of an eastbound through or right-turning vehicle.

The audit team noted that it is unclear where vehicles should queue when making an eastbound through or right-turn movement due to the offset geometry created by Grandview Avenue, and exacerbated by the lack of lane markings on the eastbound approach. This can result in two vehicles attempting a right turn side-by-side, as supported by crash records indicating a side-swipe crash between two vehicles making eastbound right turns simultaneously. According to audit members, local traffic on Grandview Avenue has increased due to GPS's re-routing vehicles through neighborhoods to avoid congestion on Newport Avenue.

2. Consider options for closing or reconfiguring Grandview Avenue egress at Beale Street to provide a formalized eastbound approach and eliminate the merge condition at the intersection that creates confusion on this approach. In conjunction with reconfiguration or closure of Grandview Avenue, consider expanding sidewalks on the southwest corner to shorten the length of the western crosswalk. If Grandview Avenue is to remain open, evaluate stop or yield signs to designate which road has the right of way.

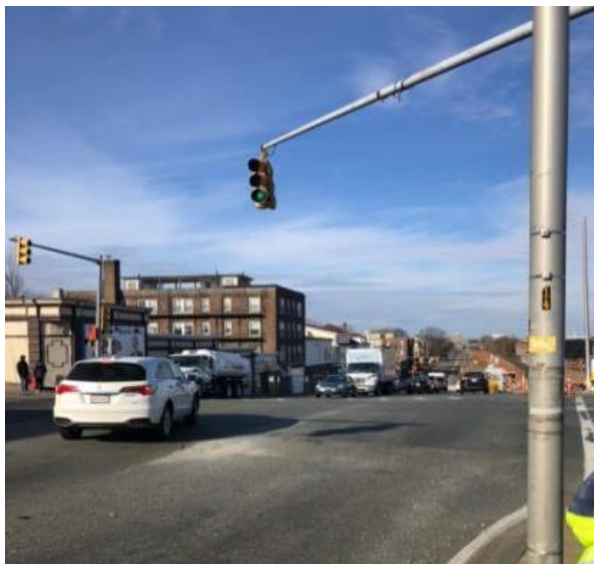
The Newport Avenue northbound left turn to Beale Street westbound was observed to have low volume relative to other turning movements, with 2018 count data indicating 15 vehicles per hour and 38 vehicles per hour in the AM and PM peak hours, respectively. The movement is given a green ball and must yield to the oncoming southbound traffic. The southbound through traffic is a higher volume and northbound vehicles turning left will queue while waiting for a gap, which blocks a northbound through lane (**Figure 4**). The permissive only northbound left turn condition is a key factor contributing to the five collisions reported between northbound left turns and southbound through

**Figure 4 - Northbound vehicles making left turn to Beale Street**

vehicles. The intermittent blockage of the northbound through lane by left-turning vehicles may also be a contributing factor for the six rear-end collisions and one side-swipe collision on the Newport Avenue northbound approach.

4. Evaluate potential to add left turn bay for Newport Avenue northbound left turn through combination of roadway widening or removal of the median island to reduce northbound through lane blockages caused by left turns. In conjunction, evaluate potential for a protected left-turn phase.

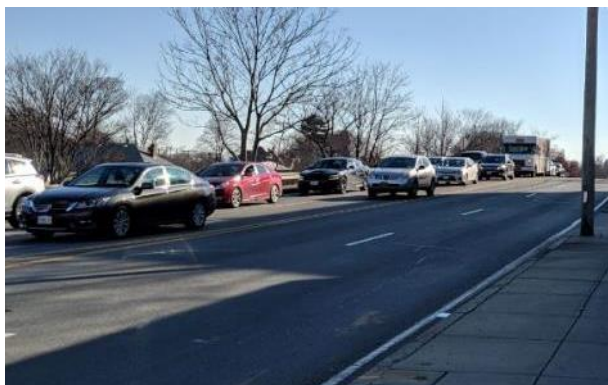
The audit team observed that there is a slight hill crest approaching the signal on Newport Avenue northbound. The signal is difficult to see at distance and queues can extend beyond the crest of the hill, which was noted by the audit team as a safety concern given the high rates of speed, downward sloping roadway, the fact that there are no signs warning of a signal ahead, and the northbound queueing (Figure 5). Speed is a potentially a factor for the six rear-ends collisions on the Newport Avenue northbound approach. The audit team observed that the signal clearance times for red and yellow may be too short at the intersection due to the steep grades on some approaches and higher vehicle speeds. Queue lengths for northbound traffic on Newport Avenue at Brook Street would occasionally back up to Beale Street (Figure 6).

**Figure 5 – Newport Avenue Northbound queueing reaching hill crest south of intersection.**

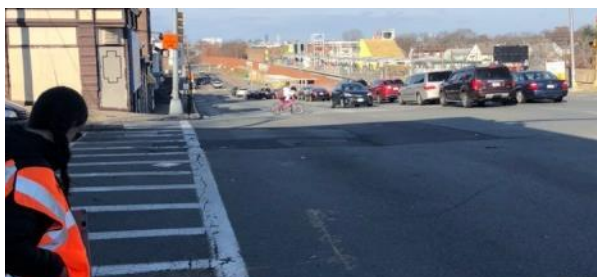
**Figure 6 – Northbound traffic queuing back from Brook Street**

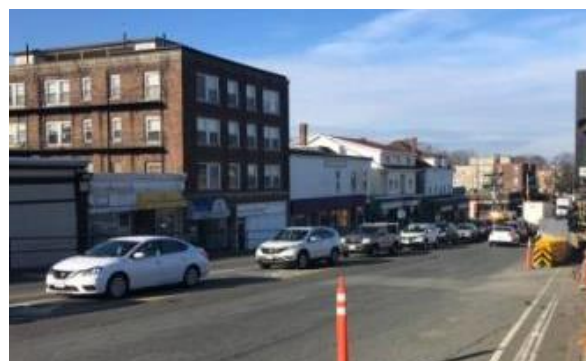
The audit team observed that Newport Avenue southbound left-turning traffic can queue further back than the left-turn storage lane, which is approximately 150 feet in length (Figure 7). As a result one of the through lanes is blocked in the vicinity of Brook Street. A blocked through lane due to queueing spillover can contribute to sideswipe collisions, as drivers change lanes to try to drive around the blockage. Additionally, rear-end collisions can be attributed to this condition as well, as southbound through traffic may need to stop suddenly to accommodate downstream lane changes,

**Figure 7 – SB left turn queue exceeding storage capacity**

or if a driver is caught off-guard by the unexpected lane blockage. This queueing condition is also indicative of congested conditions, which can lead to driver frustration and aggressive driving. Finally, the steep grade of this approach may contribute to drivers having to accelerate more quickly making it difficult to stop suddenly, if needed. As previously mentioned, the signal clearance times for red and yellow may be too short at the intersection. These are all potential factors in the nine collisions involving rear-end and/or sideswipes along the southbound approach.

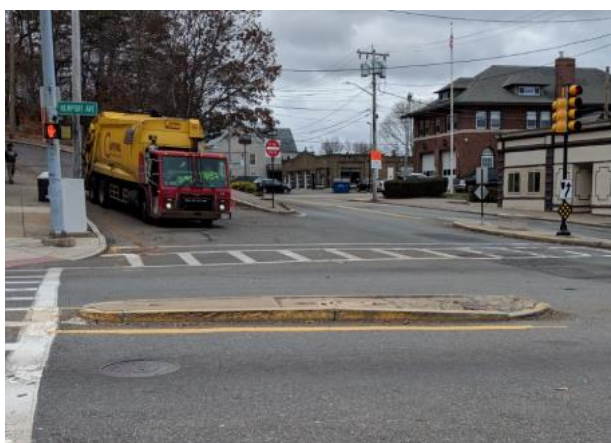
A median island that had been formally located on the northern leg of Newport Avenue had been removed and paved over at the time of the audit. The southern leg of the intersection is separated by a median island. The audit team observed a passenger vehicle driving over the median while trying to make the left turn and the median appeared to be heavily cracked, indicating that it has been struck many times in the past, as shown in **Figure 8**. The audit team observed that larger vehicles turning left had a difficult time consistently navigating around the median island, which is extended approximately 18 feet into the intersection from the southern crosswalk. This is creating a sharper turn for the westbound left-turning vehicles and may not be sufficient for larger vehicles.

**Figure 8 - Damaged median island on southern leg of Newport Avenue**

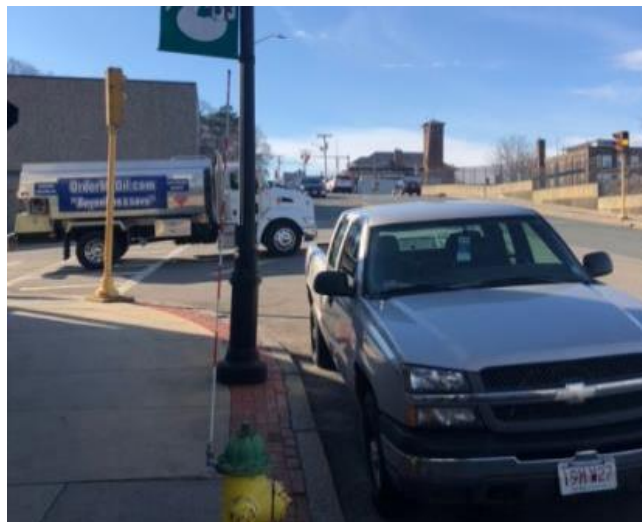
The intersection of Old Colony Avenue and Beale Street was observed to have sight distance limitations for vehicles turning from Old Colony Avenue. The primary sight distance constraints for this movement are the buildings on the southwest and southeast corners of the intersection. Vehicles were observed encroaching into the intersection before making a turn to overcome this limitation (**Figure 9**). When a vehicle on Old Colony Avenue northbound moves past the stop bar to extend their visibility, the steep grade on Beale Street becomes an additional sight distance constraint. It was noted by audit participants that there is a vehicle desire line from Old Colony Avenue to continue north on Newport Avenue, requiring vehicles to cross over to the rightmost lane on Beale Street.

**Figure 9 - Vehicles turning out of Old Colony Avenue**

In addition, the audit team noted that Old Colony Avenue is a popular cut-through route from Hancock Street to Newport Avenue and that the stop-control may not be sufficient to accommodate the traffic volume. The sight distance constraints and prevailing traffic patterns for cut-through volumes are all potentially factors for the nine angle crashes at this intersection.

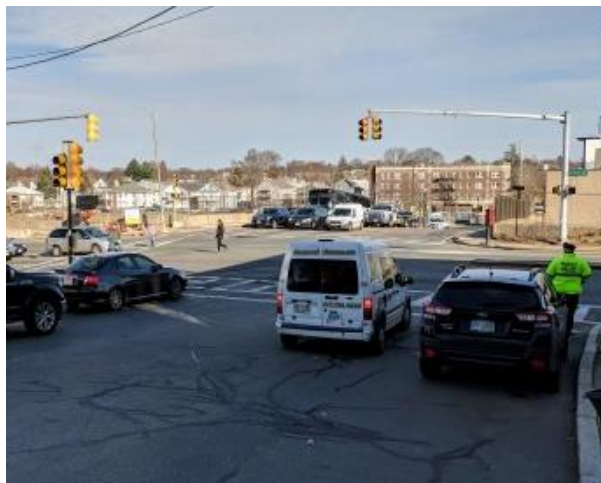
The median island on Newport Avenue northbound does not have any movement regulation signs. The audit team noted that a small in-street sign, possibly previously located on the median, was located on the sidewalk. The audit team noted that there is no movement regulation signs for the median island on the south leg Newport Avenue, even though they are provided at the median island on the west leg of Beale Street.

**Figure 10 - Lane movement markings not provided for Beale Street eastbound**

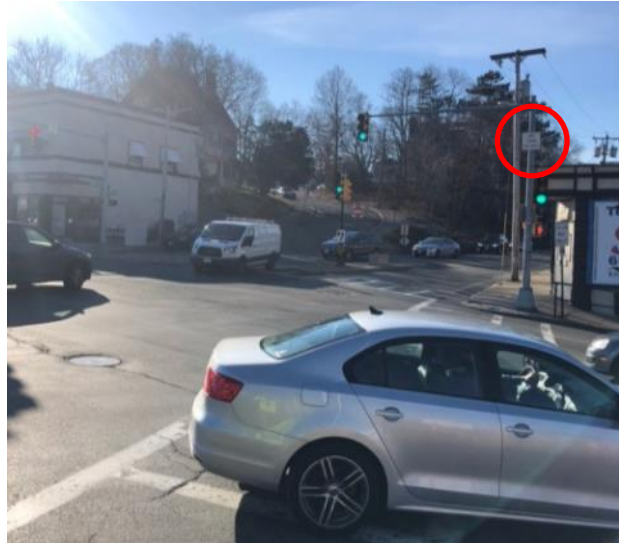
Figure 11 - "No Right Turn on Red" sign (circled)

The audit team observed that the westbound and southbound approaches each have a “No Right Turn On Red” sign that is difficult to see due to its location mounted high on the far side of the intersection and may be resulting in driver non-compliance (Figure 11).

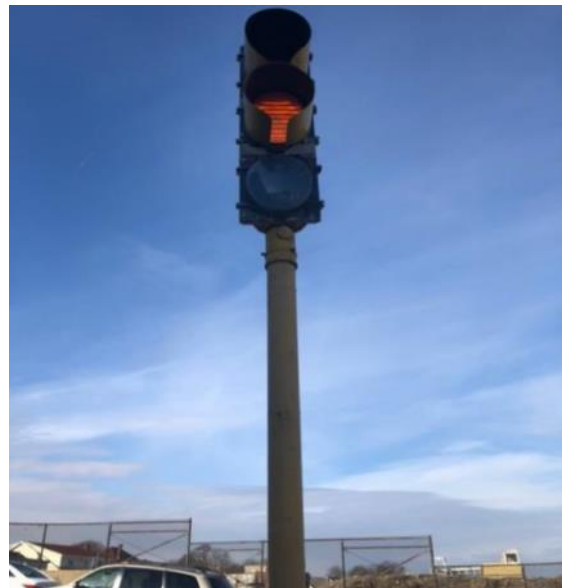
The audit team observed that all traffic signal heads lacked sufficient back plates and were difficult to see, noting sun glare as a significant issue. The eastbound approach from Grandview Avenue/Beale Street had one overhead signal and one near-side post mounted signal. The audit team observed that there was a missing signal head from the mast arm that would face the eastbound approach. At the intersection of Old Colony Avenue and Beale Street it was observed that a post mounted flashing yellow signal was facing Old Colony Avenue but should have been facing Beale Street westbound (**Figure 12**).

**Figure 12 - Flashing yellow facing the wrong direction (Old Colony Avenue)**

1. Consider providing back plates with retroreflective strips on all signal heads, including flashing signals at Old Colony Avenue, to provide better visibility of the signals.
2. Consider replacing missing signal head facing Grandview Avenue.
3. Evaluate use of flashing yellow arrow signal for permissive phases of protected/permitted left turns.
4. Re-install flashing signal on the southwest corner of Old Colony Avenue and Beale Street intersection so flashing yellow is facing Beale Street westbound.
5. Consider providing an overhead traffic signal head for each lane to improve visibility.

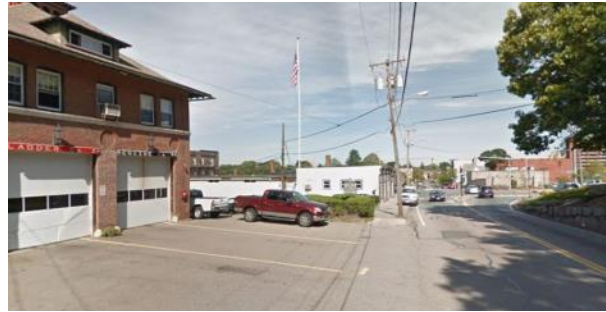
A fire station operated by Quincy Fire Department (QFD) is located at 111 Beale Street within the RSA study area. The station's driveway is on Beale Street, approximately 160 feet west of Newport Avenue (**Figure 13**) and as such fire trucks will frequently travel through the signal at Newport Avenue and Beale Street. The audit team noted that emergency vehicle signal preemption is not provided at the intersection of Newport Avenue and Beale Street, which creates safety issues for motorists and first-responses. Given the close proximity of the fire station to the signal, this is a consistent issue faced by fire trucks. To understand the unique issues faced by QFD, a description of emergency vehicle operations and issues was provided to the audit team by QFD personnel.

**Figure 13 - Fire Station driveway on the north side of Beale Street, west of Newport Avenue**

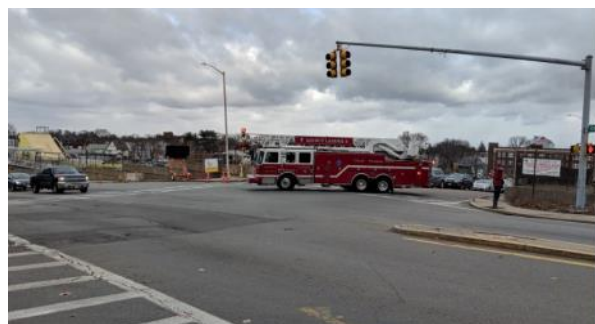
In addition to the lack of emergency vehicle preemption, QFD noted that congestion along eastbound Beale Street frequently blocks the fire station driveway and their eastbound egress route through the intersection. As a result, fire trucks responding to an incident will often run against the flow of traffic in the single westbound lane of Beale Street, which is a safety issue for both firefighters and motorists due to the lack of signal preemption. Further, it was also observed by QFD that eastbound traffic on Beale Street will sometimes move into the intersection and block traffic on Newport Avenue in order to make space for a departing fire truck, creating a conflict with traffic on Newport Avenue. The contraflow operations of fire trucks at the intersection are not limited to eastbound travel on Beale Street at the station driveway, and a fire truck was observed traveling contraflow on the eastern leg as well to circumvent stopped vehicles (**Figure 14**).

**Figure 14 - Fire truck running contraflow through the intersection**

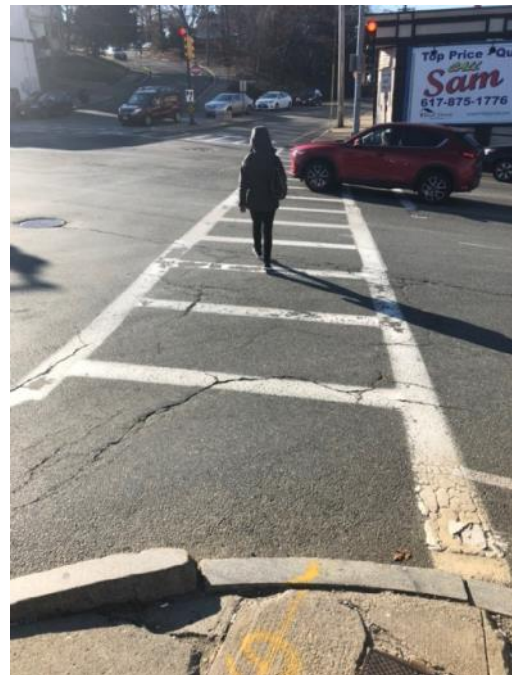
**Figure 15 - No wheelchair ramp at crosswalk and sidewalk deterioration**

The audit team observed that none of the pedestrian crosswalks at the intersection of Newport Avenue and Beale Street had ADA compliant wheelchair ramps provided. The southwest corner of the intersection was noted as the only corner with a ramp but it did not comply with ADA standards due to the ramp location on the apex of the corner between the two crosswalks. The northwest, northeast, and southeast corners of the intersection did not have wheelchair ramps (**Figure 15**).

4. Install/replace wheelchair ramps at all corners of the intersection to meet current ADA standards.
5. Consider installing new sidewalk to have a smooth continuous surface and level landings to prevent tripping hazards.

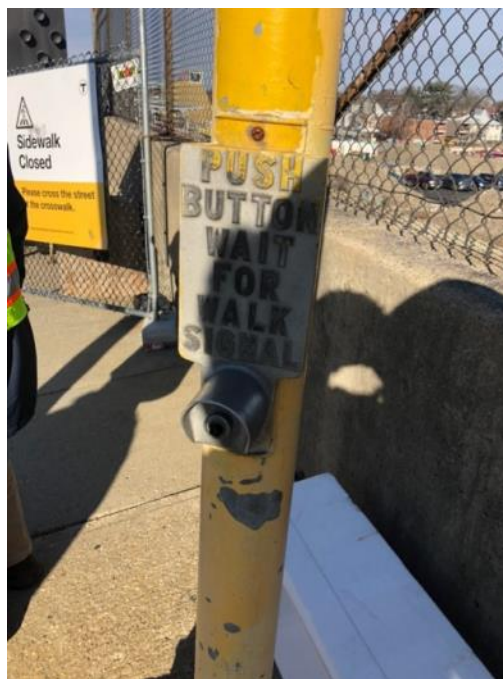
Pedestrian pushbuttons at the intersection of Newport Avenue and Beale Street were all outdated and did not meet current ADA and MUTCD standards (**Figure 16**), as none are Accessible Pedestrian Signals (APS) and lacked audible and/or vibro-tactile indications. In addition, the pushbutton on the southeast corner of the intersection is located too far from the southern crosswalk and is not compliant with MUTCD standards.

**Figure 16 - Non ADA Compliant Push Button**

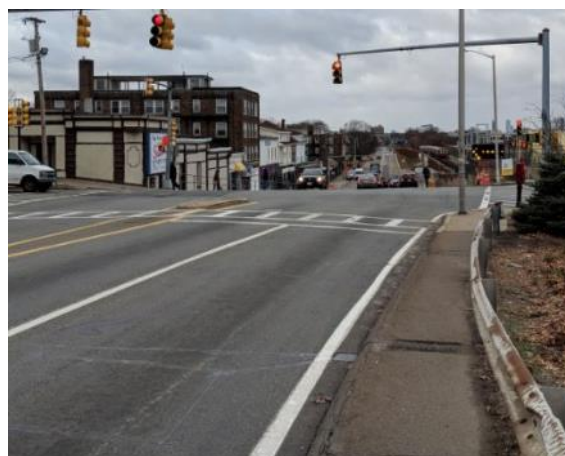
It was observed that some sidewalk sections at the intersection of Newport Avenue and Beale Street may not have the minimum required clearance of 3 feet, particularly at the northeast and southeast corners. Additionally, the portion of eastern sidewalk of Newport Avenue south of Beale Street that abuts a guard rail is too narrow and does not provide the minimum width required (**Figure 17**). The southern sidewalk section between Newport Avenue and Old Colony Avenue is in poor condition. The sidewalk does not have a smooth continuous surface, with significant cracks and heaving observed, creating tripping hazards for pedestrians, wheelchairs, and strollers. There is no sidewalk on the southern side of Beale Street for the approximately 600 feet west of Newport Avenue due to

**Figure 17 - Narrow sidewalk with guard rail on east side of Newport Avenue northbound approach.**
