VIRTUAL BIRMINGHAM HISTORIC DISTRICT COMMISSION MEETING

SUBJECT: Historic Design Review – 743 W. Frank – King-Argus House

The applicant has applied for a Design Review for the removal and replacement of 8 windows located on the front, side and rear of the house, as well as a new front door system and removal of the existing rear pergola to construct a new covered porch and pergola combo.

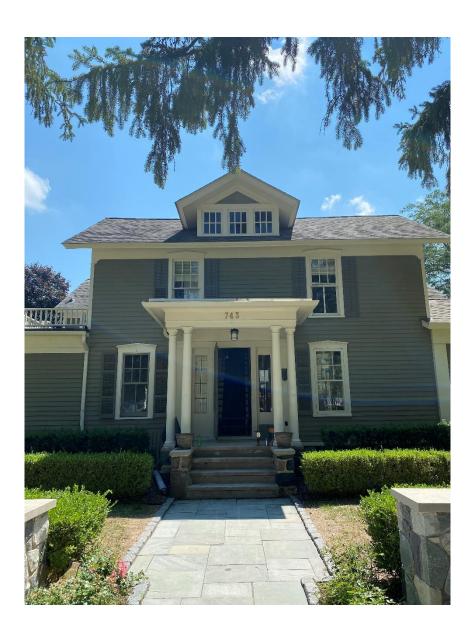
We would like to start off by letting you know the project is turning out great with the interior renovations currently underway. The new windows at the rear of the house have been replaced besides the door wall due to delayed shipment. With the extent of the renovation we would like to request three additional items that we would like to replace or modify.

Second the rear trellis is falling apart due to wood rot at critical structural points. Proposing to replace the trellis with a covered porch above the bluestone patio and build a new trellis over the driveway to match the existing.

Third proposed change would be updating the front door with a new stained door and sidelights. In this document we will highlight and go through each one of the areas in greater detail.

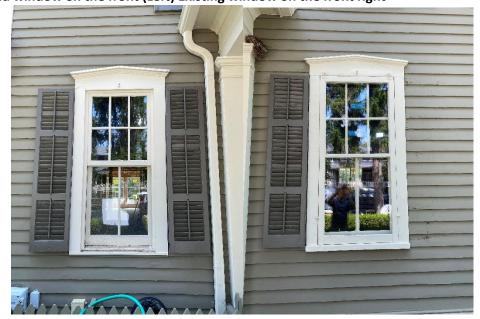
Window 1 Lower Front West

• Replaced window on the front (Left) Existing window on the front right

- o Current window does not operate due to layers of lead paint
- Integrity of sill and wood are compromised to a point rehabilitation would cause the window to fall apart
- Non insulated glass
- o Storm shutters caulked and painted shut

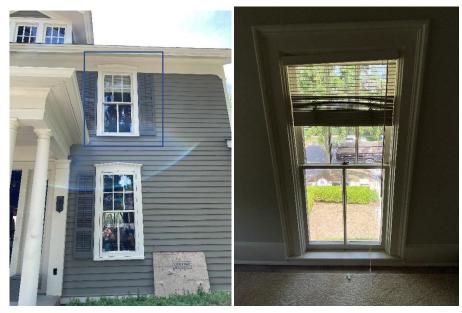
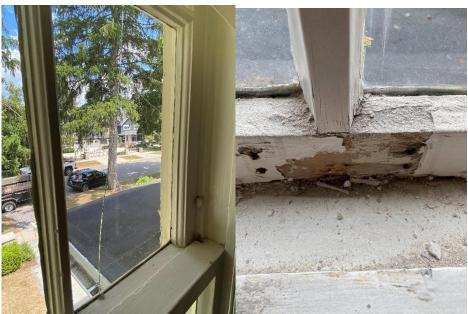
• Window 3 Upper Front West

- o Current glass is broken, and window does not operate
- Safety concern with kids' bedroom. The window is 5" off the finish floor. Glass is not tempered.
- Non-Insulated glass
- No safety device
- Window is painted shut with lead-based paint

Bottom sill is rotted

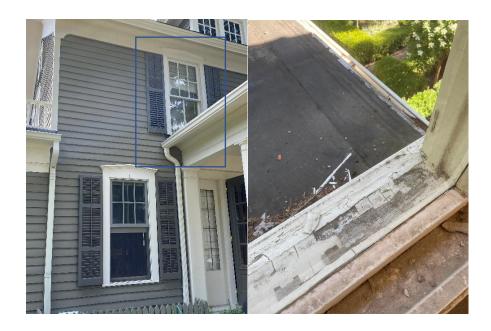
• Window 4 Upper Front East

- o Currently no egress in this bedroom due to both windows not operating.
- Safety concern with kids' bedroom. The window is 5" off the finish floor. Glass is not tempered.
- Non-Insulated glass
- o No safety device
- O Window is painted shut with lead-based paint
- o Bottom sill is rotted due to flat porch roof. Improper flashing detail

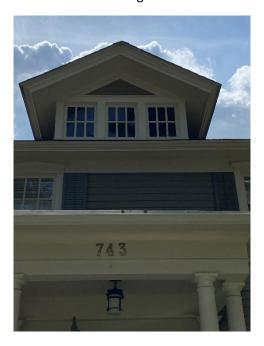
• Window 5 Attic 3 window section

- Window showing signs of rot around the frame
- o Glass panels have small cracks in the glass on several them

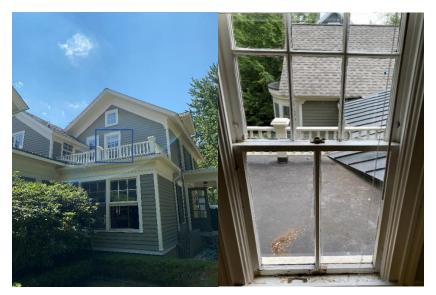
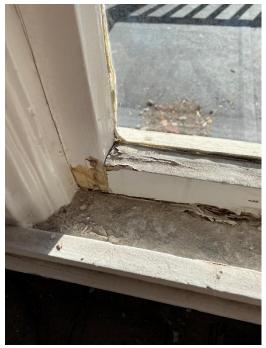
Window 6 Upper East

- o Currently no egress in this bedroom due to both windows not operating.
- o Lower sill is rotted due to in proper flashing at the flat roof area
- Safety concern with kids' bedroom. The window is 5" off the finish floor. Glass is not tempered.

- o Painted shut with layers of lead paint
- No safety device

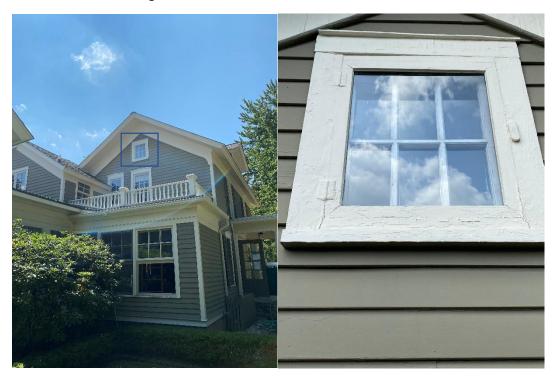
• Window 7 Small Upper East

- o Window shows signs of rot
- o Jamb is broken on the left and right side causing the windowpane to fall out
- Non insulated glass

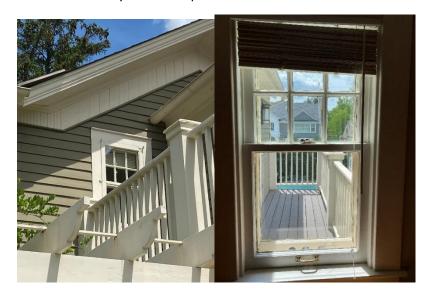
• Window 8 Rear upper

- Window does not operate
- o Caulked and painted shut on the outside
- Non insulated glass
- o Painted shut with layers of lead paint

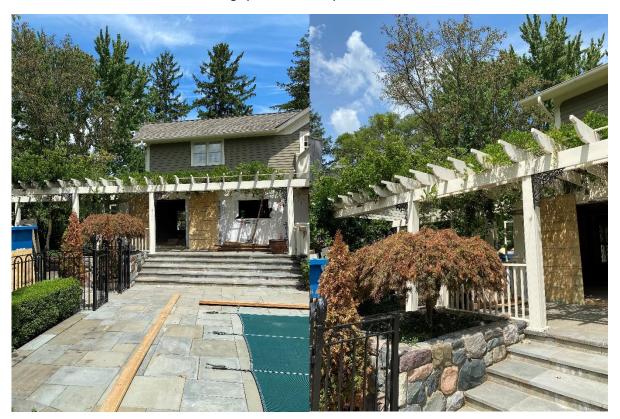
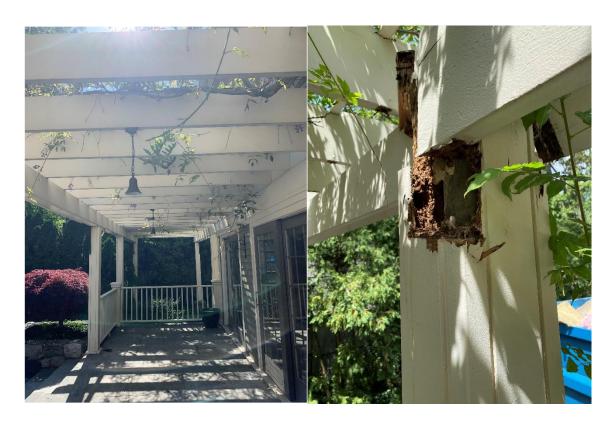
Rear Trellis/ Covered Porch

- Replace the existing trellis with a covered porch above the bluestone.
- Elevation will remain the same with the overall thickness of the roof not extending the 19" in height of the existing structure
- EPDM flat roof on top
- Gutter to match existing going around
- V groove ceiling detail on the underside of the porch
- Color to match existing trim color of the house
- Over the driveway the trellis will be replaced one for one due to structural integrity of the existing structure
- Additional construction drawings provided, and photos shown below

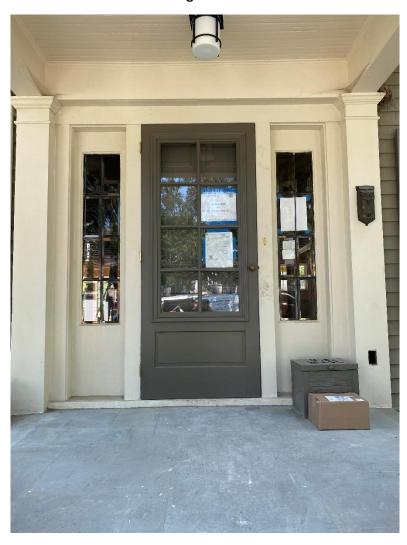
Existing Front Door

The existing front door is of wood construction with French door style windows and sidelights. The applicant is proposing to replace the existing door and sidelights with a new system of the same style. The pane and muntin system (number of divisions) appear to change slightly from existing to proposed. The new door material is proposed as wood with a dark walnut finish and $\frac{3}{4}$ in. muntins.

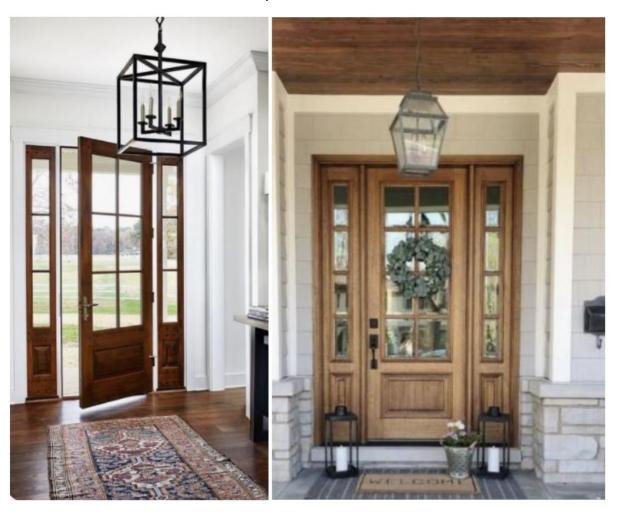
Proposed Front door

- Color Dark walnut
- Material wood
- Size: Match existing height and width
- Mullions to be ¾"

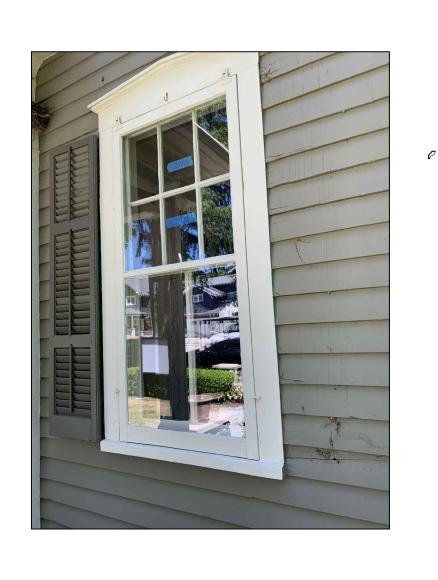
EX LIV RM EAST

Line #: 1 Qty: 1 Mark Unit: Ex Liv Rm East Product Line: Ultimate Wood Unit Description: Double Hung Rough Opening: 30 1/2" X 64 9/32" Frame Size: 29 1/2" X 63 25/32" Exterior Finish: Primed Species: Pine Interior Finish: Primed Unit Type: Double Hung Call Number: None Glass Information: IG, Low E2 w/Argon, Stainless Divider Type: 7/8" Rectangular SDL W/ Spacer - Stainless Hardware Type: Sash Lock, Lift Type: None, No Finger Pull Screen Type: Aluminum Screen Hardware Color: White Screen Surround Color: Coconut Cream Screen Mesh Type: Charcoal Fiberglass Mesh Jamb Depth: 4 9/16"

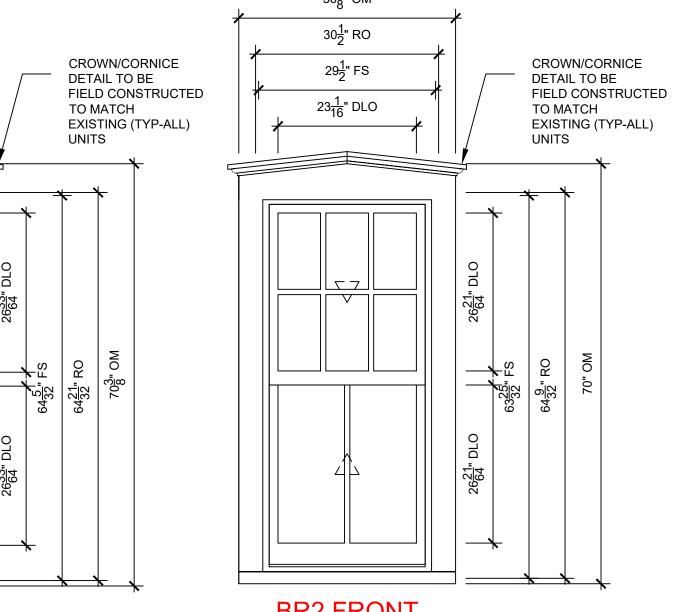
BR2 FRONT SCALE: 3/4" = 1'-0"

Line #: 3 Qty: 1 Mark Unit: BR2 Front Product Line: Ultimate Wood Unit Description: Double Hung Rough Opening: 30 1/2" X 64 9/32" Frame Size: 29 1/2" X 63 25/32" Exterior Finish: Primed Species: Pine Interior Finish: Primed Unit Type: Double Hung Call Number: None Glass Information: IG, Low E2 w/Argon, Stainless, Tempered Low E2 w/Argon Divider Type: 7/8" Rectangular SDL W/ Spacer - Stainless Hardware Type: Sash Lock, Lift Type: None, No Finger Pull Screen Type: Aluminum Screen Hardware Color: White Screen Surround Color: Coconut Cream Screen Mesh Type: Charcoal Fiberglass Mesh
