REGULAR MEETING OF THE BIRMINGHAM PLANNING BOARD WEDNESDAY MAY 25, 2022 – 7:30 PM

- F. Rezoning Applications
- G. Community Impact Studies
 - 1. 320 Martin St. Request for new 5-story mixed-use building addition.
- H. Special Land Use Permits

320 Martin Street - ADDITION

PROPERTY CONDITION REPORT

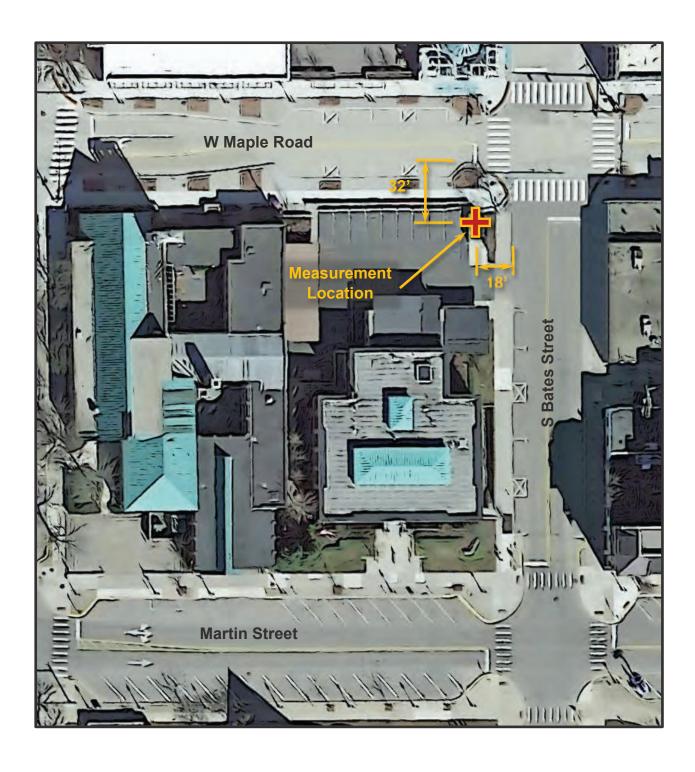
SITE PLAN SHOWING THE LOCATION OF AMBIENT SOUND LEVEL MEASUREMENTS FOR A COMMUNITY IMPACT STUDY OF THE 320 MARTIN DEVELOPMENT

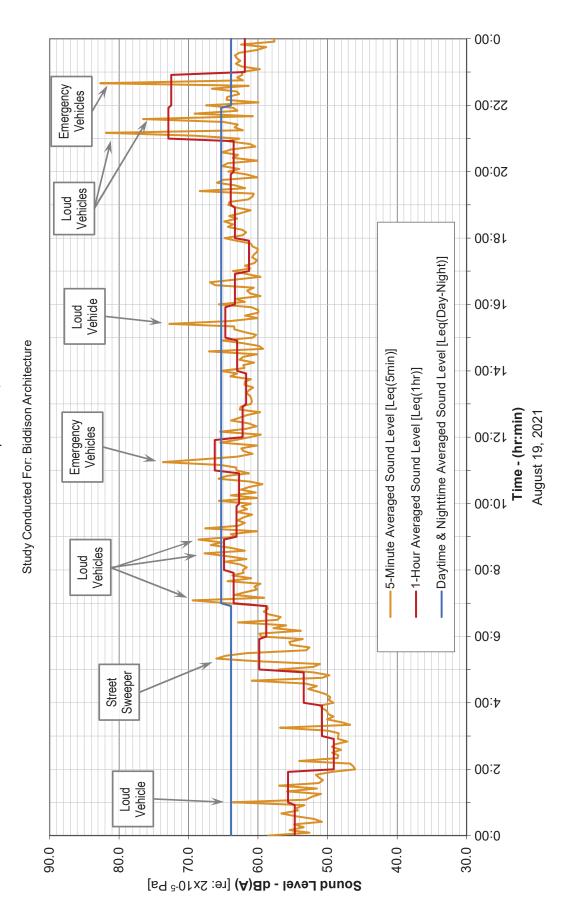
EXHIBIT 2

Ambient Sound Levels at the Proposed 320 Martin Development Site

Measured at a Position 32-ft South of W Maple Road, and 18-ft West of Bates Street
