AGENDA
BIRMINGHAM HISTORIC DISTRICT COMMISSION
WEDNESDAY – JUNE 7, 2023
BIRMINGHAM CITY HALL, 151 MARTIN ST., COMMISSION ROOM #205*
******* 7:00 PM*******

**Historic District Commission
Minutes Of May 17, 2023**

Historic District Design Guidelines

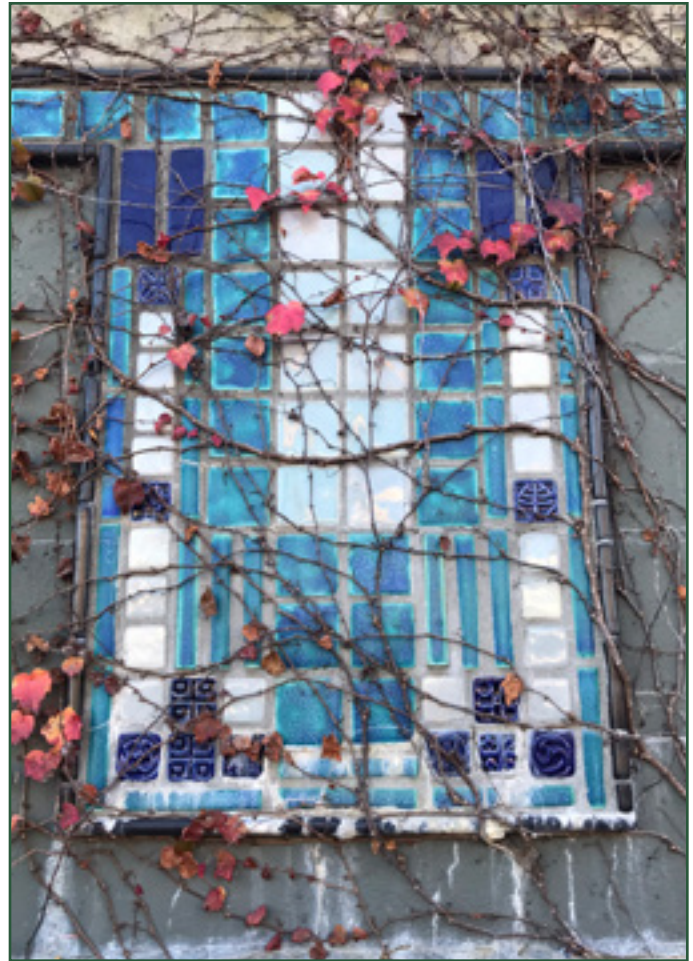
Historic Pewabic tile on the Shain Townhouses in the Central Business Historic District. City of Birmingham, photo by KDG, 2022.

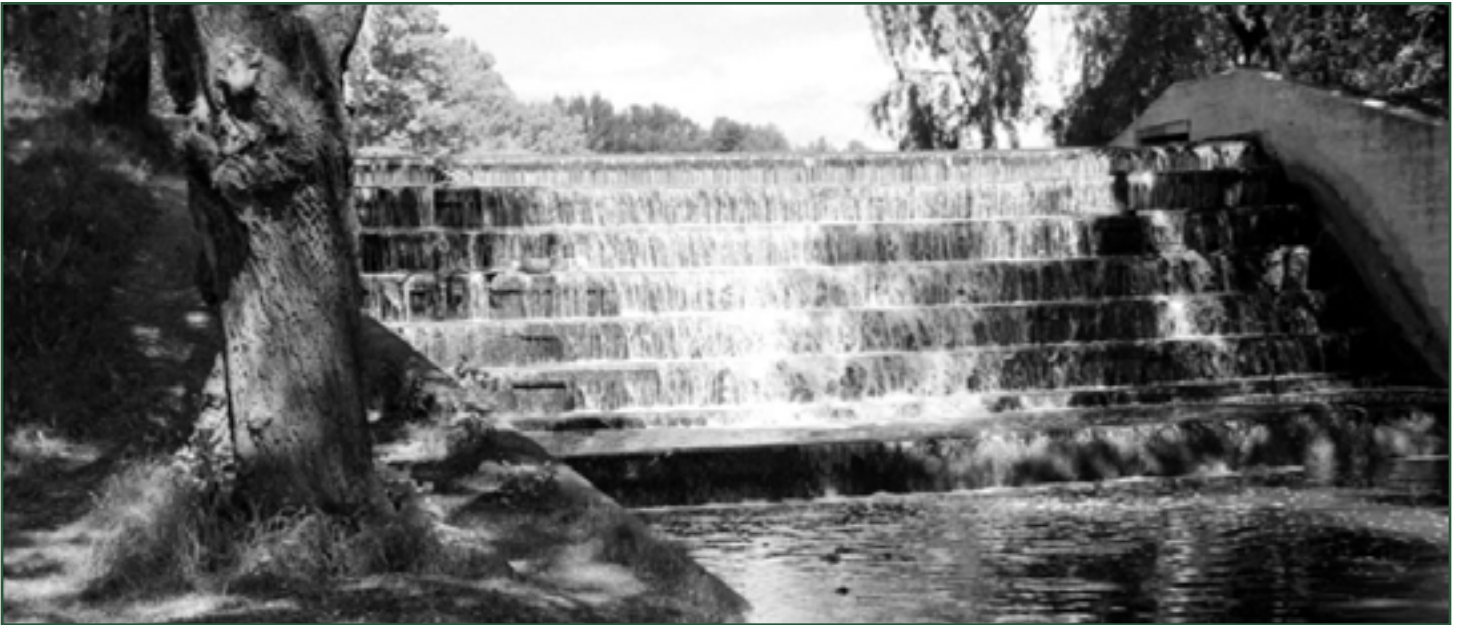
Historic landscape elements are character defining features in historic districts, such as this stepped waterfall in the Mill Pond Historic District. Shown here in 1957. Photo courtesy of the Walter P. Reuther Library, Archives of Labor and Urban Affairs, Wayne State University.

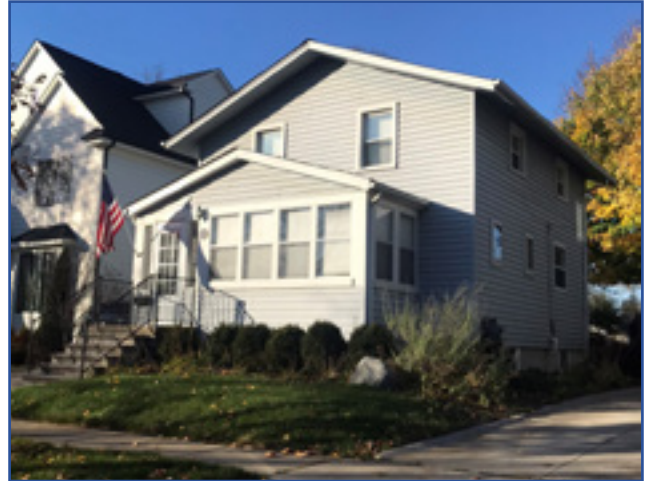
Example of Folk, before 1850-1930, City of Birmingham, photo by KDG, 2022.

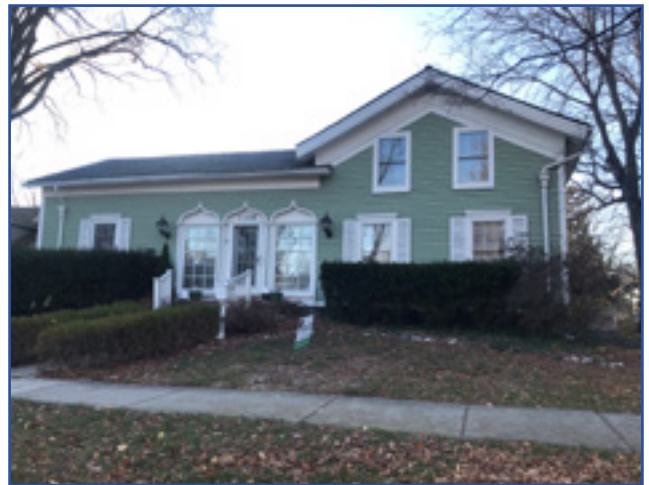
Example of Greek Revival, 1825-1860, City of Birmingham, photo by KDG, 2022.

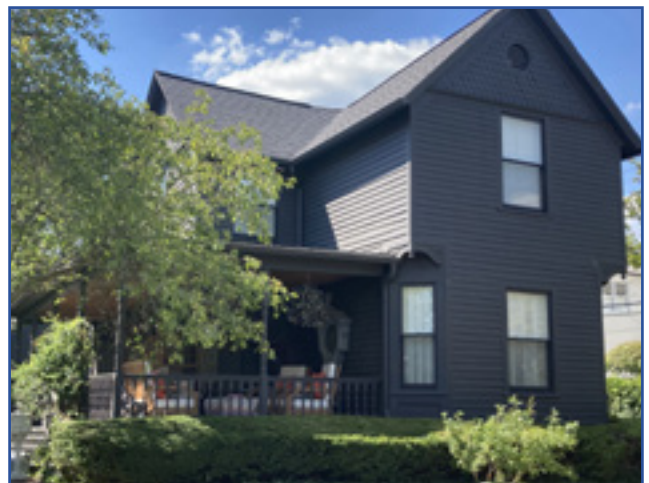
Example of Folk Victorian, ca.1870-1910, City of Birmingham, photo by KDG, 2022.

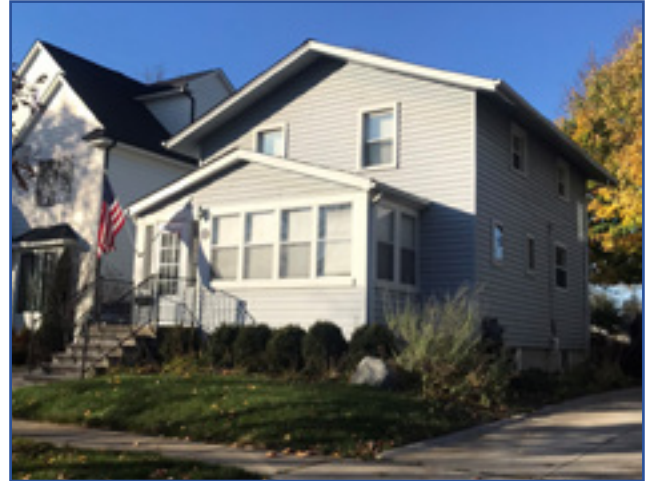
A Gable Fronter from the early-twentieth century with very minimal decoration. City of Birmingham, photo by KDG, 2022.

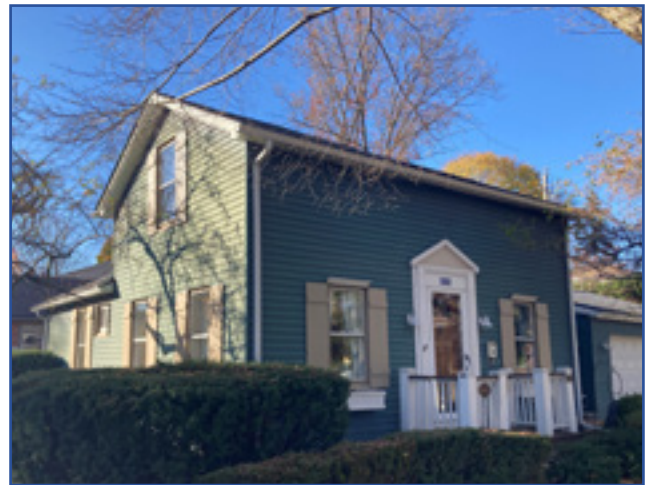
A one-and-a-half-story Folk house reminiscent of the I-house from the mid-nineteenth century. City of Birmingham, photo by KDG, 2022.

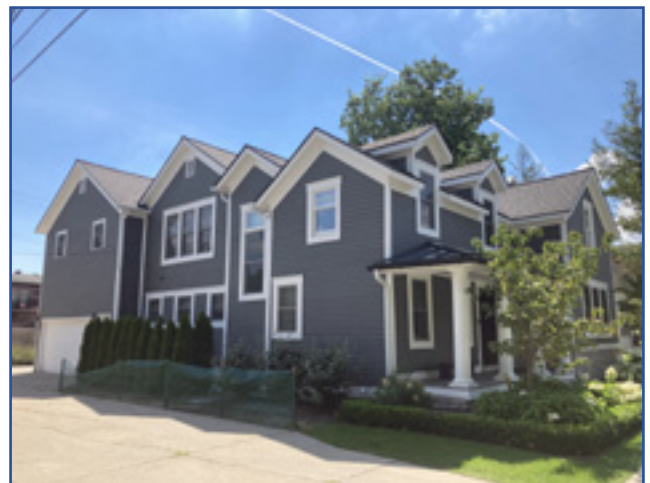
The original portion of this house is an Upright and Wing. City of Birmingham, photo by KDG, 2022.

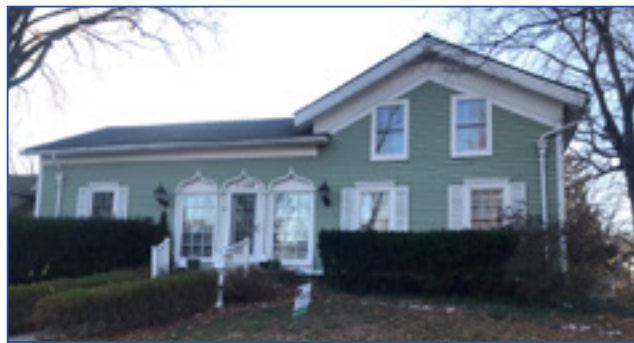
The Daniels House is an example of the Greek Revival style with its prominent entablature, 6-over-6 windows, and shallow gable roof. The ogee arches near the center of the building would have once been open, accessing a loggia. The Upright and Wing form is characteristic of Folk architecture in southeastern Michigan. City of Birmingham, photo by KDG, 2022.

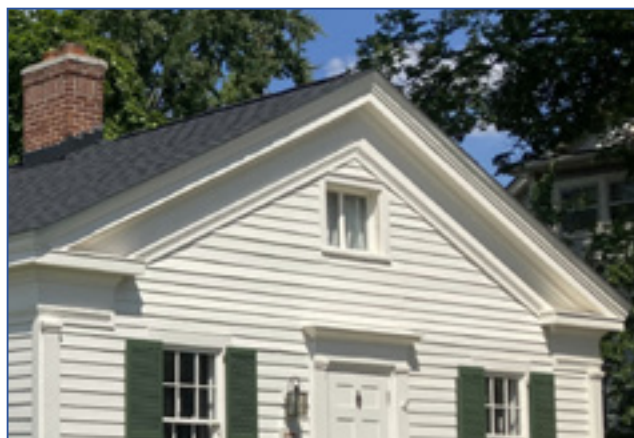
The prominent entablature and cornice returns on the gable end of the Greek Revival Hunter House. City of Birmingham, photo by KDG, 2022.

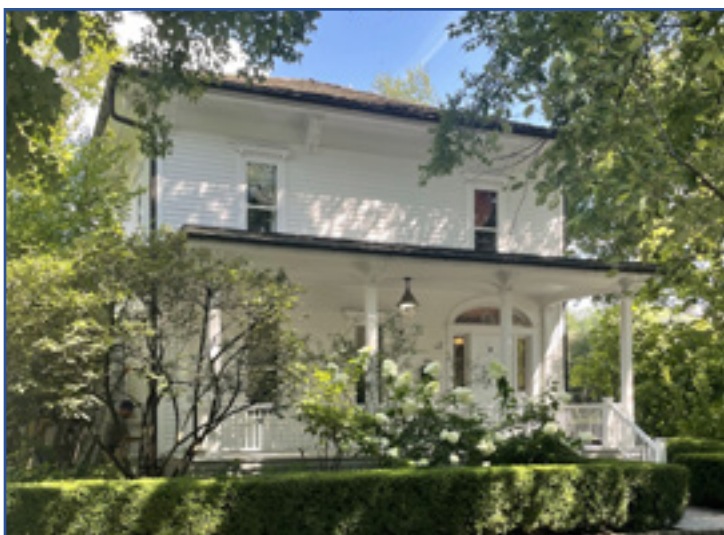
The John W. Perry House in the Bates Street Historic District is an Italianate style house with over hanging eaves, brackets, and tall, narrow windows. City of Birmingham, photo by KDG, 2022.

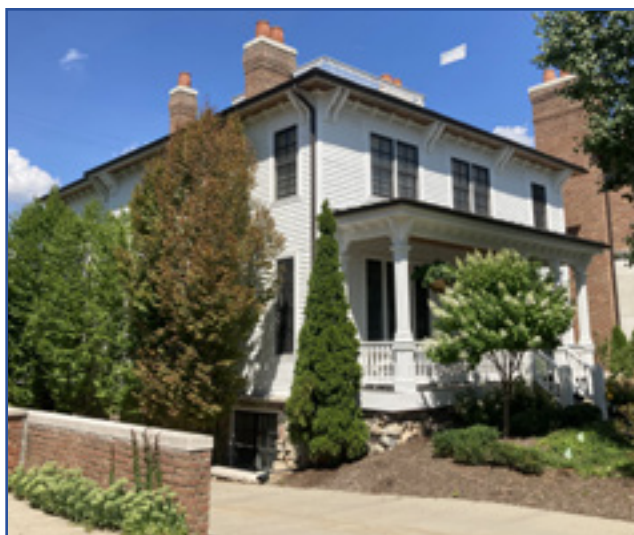
The Schuyler House in the Merrill-Townsend-Brown Neighborhood is an Italianate style house with over hanging eaves, brackets, and tall, narrow windows. City of Birmingham, photo by KDG, 2022.

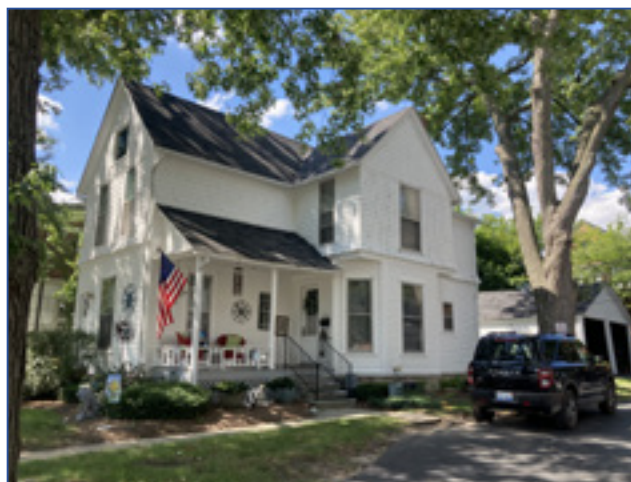
The cross-gable form was incredibly popular for Folk Victorian houses throughout Michigan and the Midwest. City of Birmingham, photo by KDG, 2022.

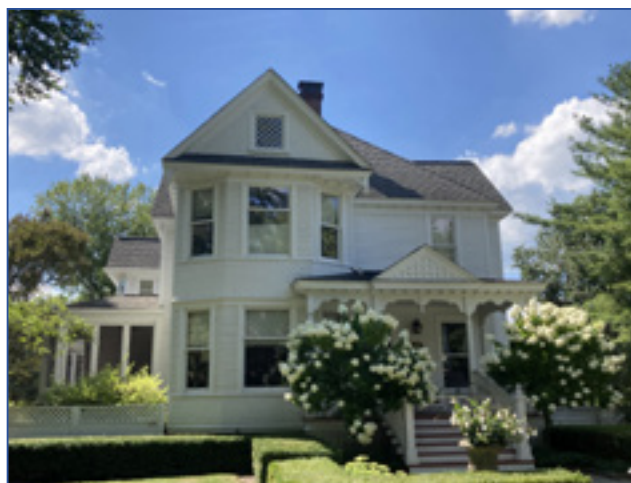
The hipped roof with lower cross gables, mixture of wood shingles and weatherboard, large porch, bay window, and irregular shape are characteristic of the Queen Anne style. City of Birmingham, photo by KDG, 2022.

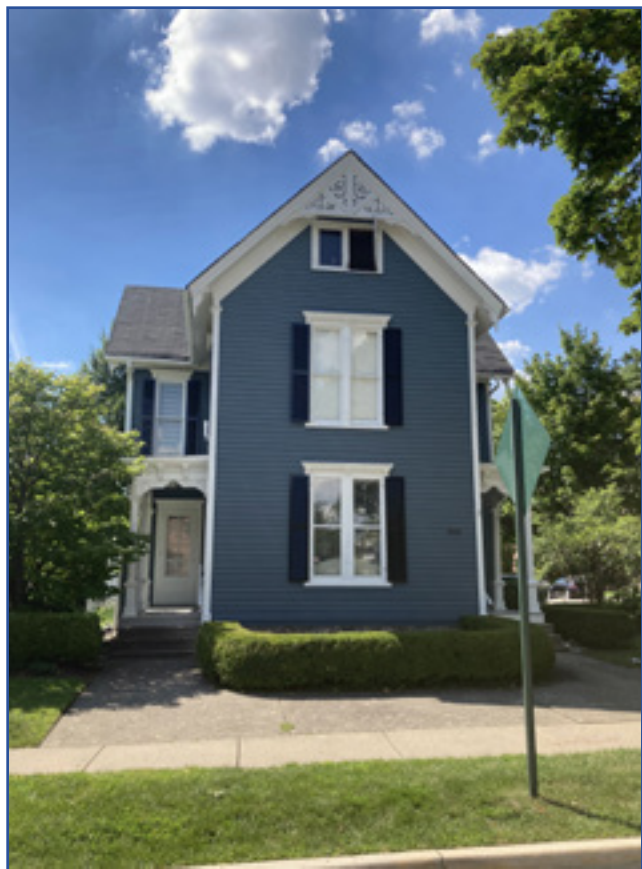
The presence of frieze work, gable decoration, tall and narrow rectangular windows, and decorative window cornices indicate the Folk Victorian style. City of Birmingham, photo by KDG, 2022.

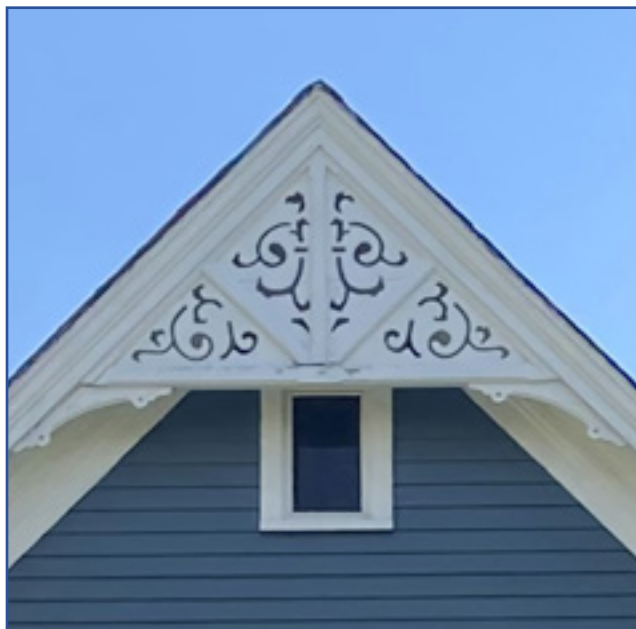
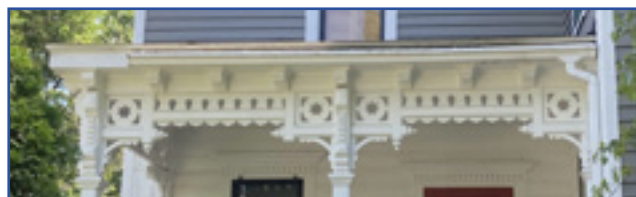
Porch frieze work and gable decoration. City of Birmingham, photo by KDG, 2022.

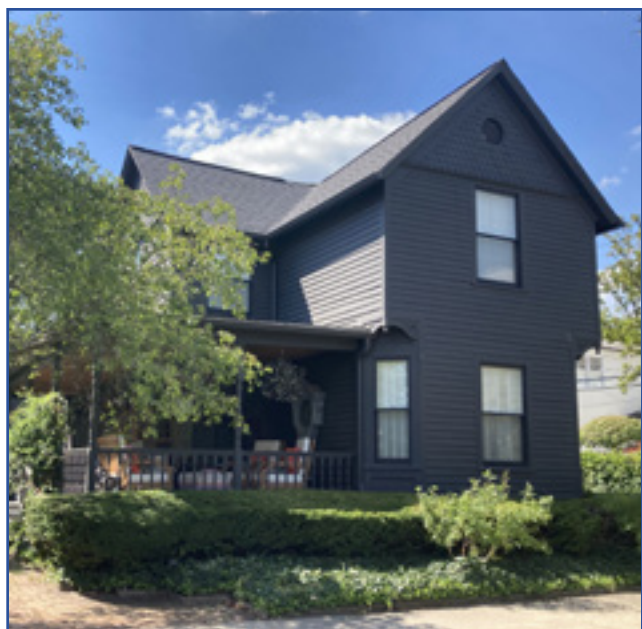
Folk Victorian with minimal decoration. City of Birmingham, photo by KDG, 2022.

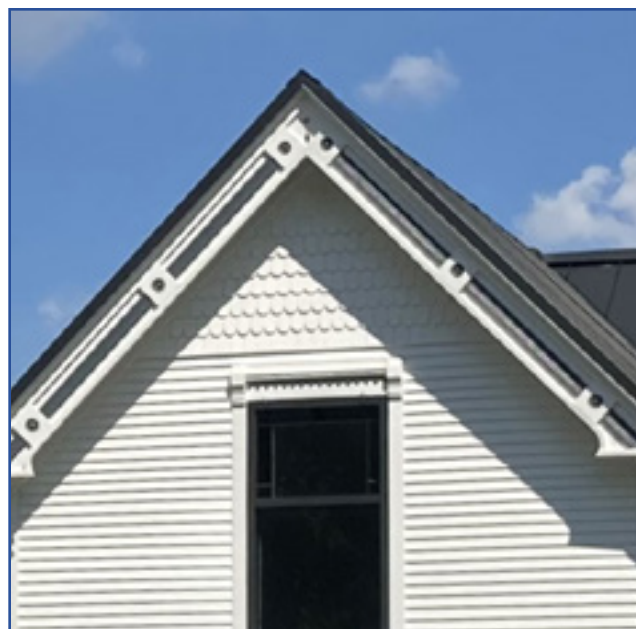
Bargeboard decorating the gable end. City of Birmingham, photo by KDG, 2022.

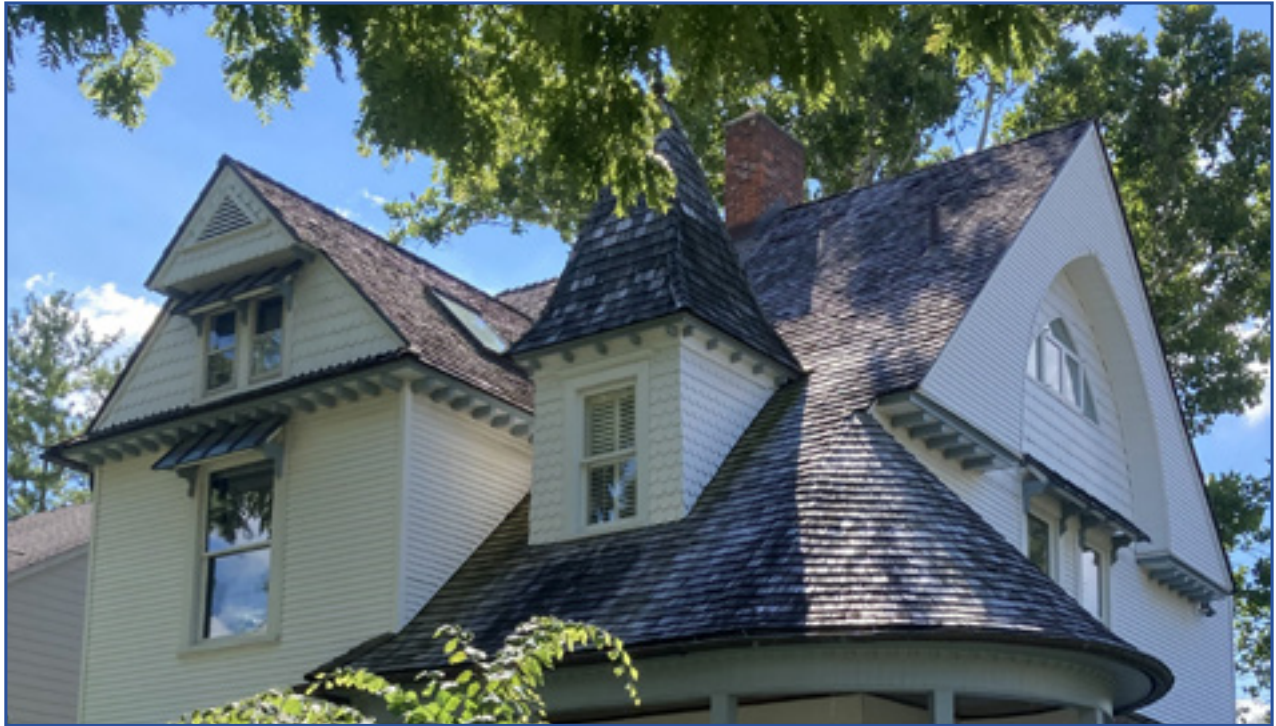
Multiple roof shapes are characteristic of the Queen Anne style. City of Birmingham, photo by KDG, 2022.

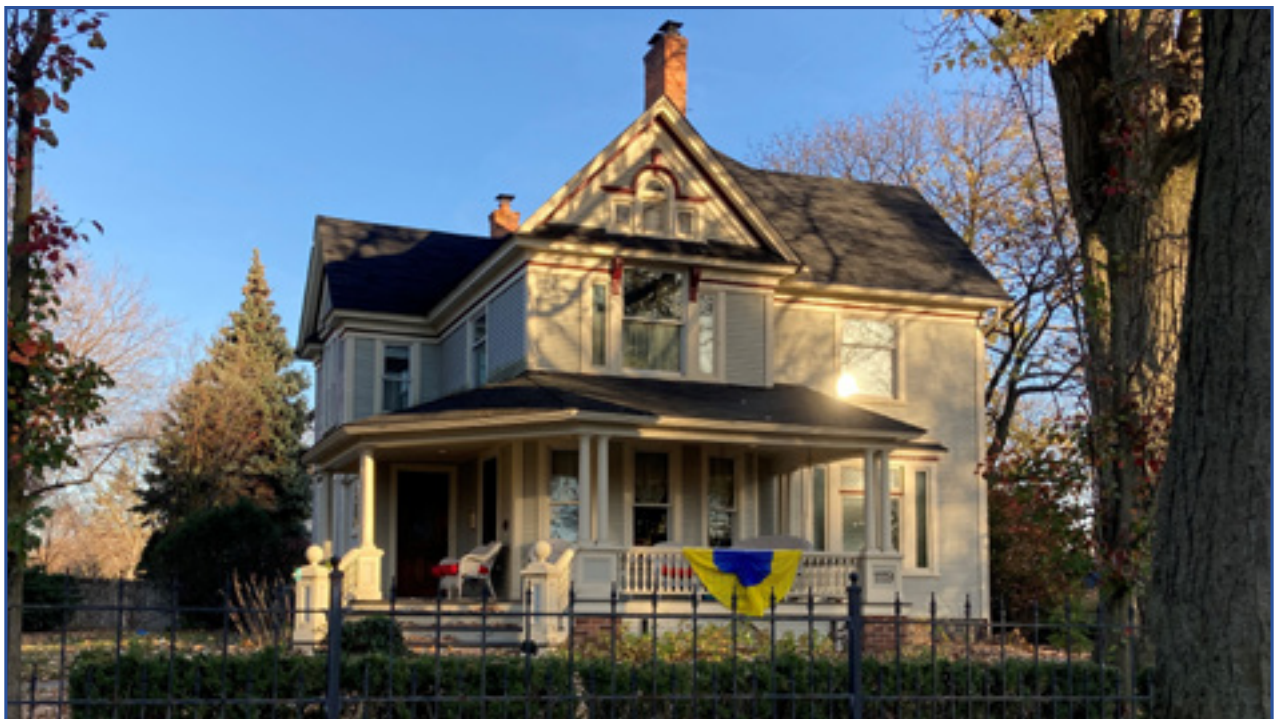
The Richard Erwin House, a large Queen Anne example. City of Birmingham, photo by KDG, 2022.

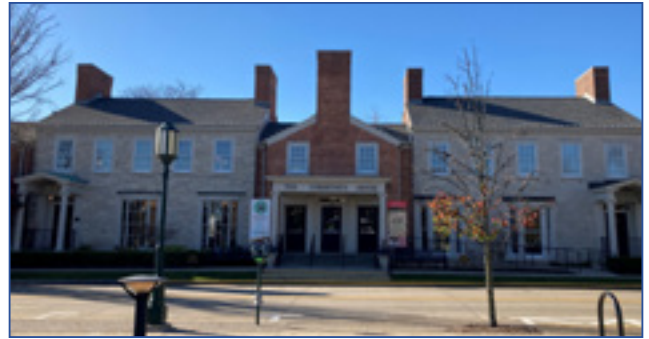
Birmingham's Community House exemplifies the Colonial Revival style with its classically inspired portico and entrance, denticulated cornice, 8-over-8 windows, and incorporation of large bay windows not usually found in original colonial buildings. Portions of this building are contemporary additions constructed in the Colonial Revival style to match the historic core building. City of Birmingham, photo by KDG, 2022.

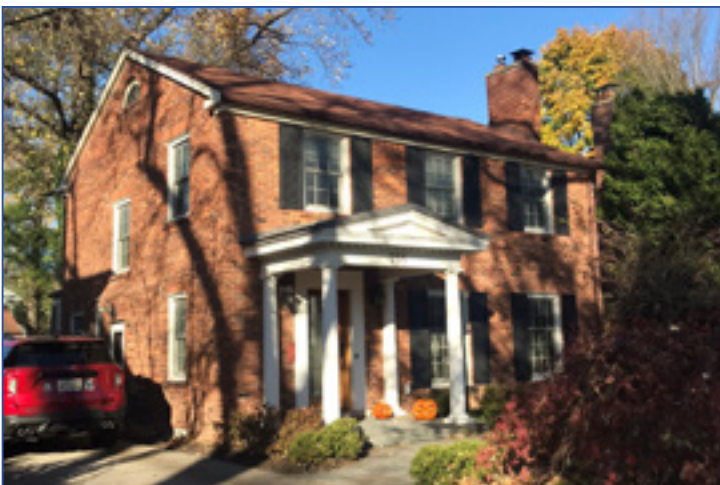
A Colonial Revival example clad in brick veneer. City of Birmingham, photo by KDG, 2022.

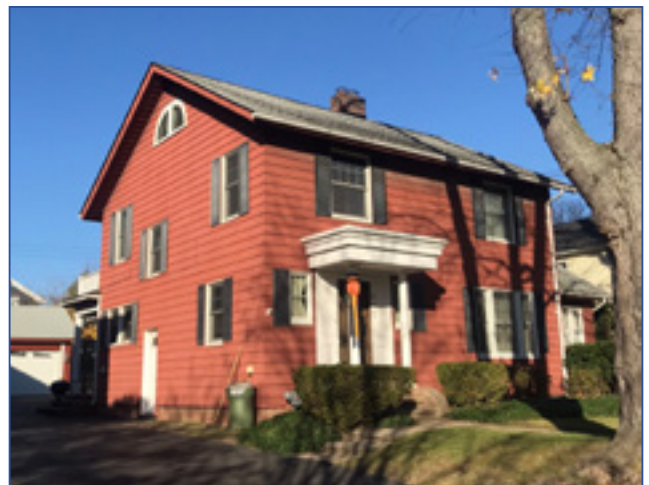
A modest Colonial Revival house with an elaborated entrance, non-functioning shutters, simple square footprint, and side gable roof. City of Birmingham, photo by KDG, 2022.

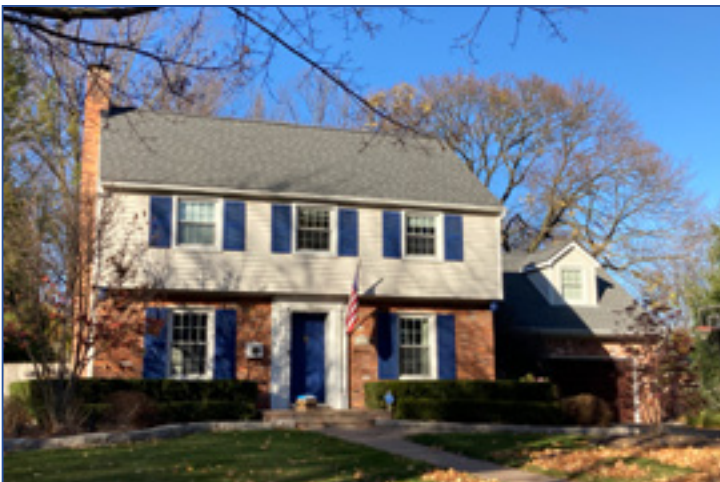
The cantilevered second story, shutters, classical entrance, and side gable roof indicate the Colonial Revival style. City of Birmingham, photo by KDG, 2022.

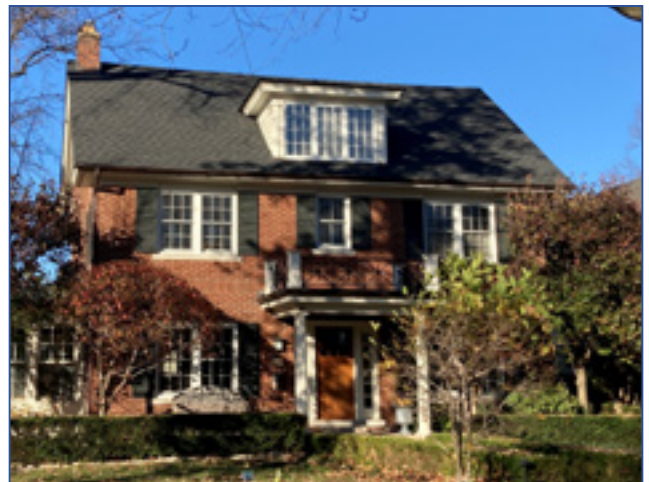
The paired, 6-over-6 windows, shutters, portico, symmetrical façade, and side gable roof are indicative of the style. City of Birmingham, photo by KDG, 2022.

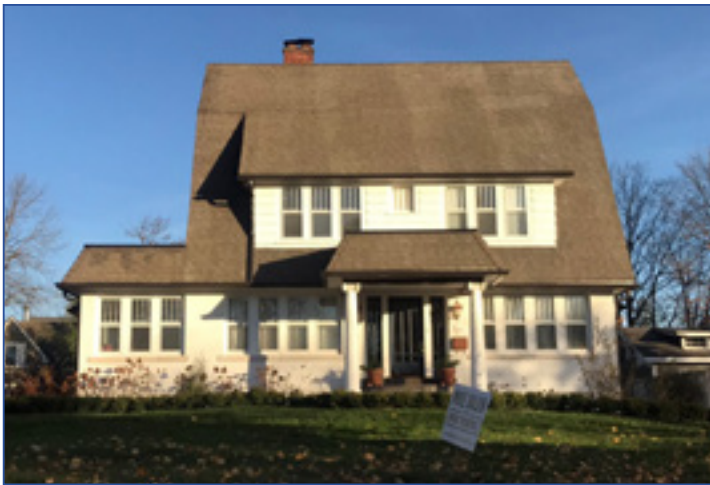
A large gambrel roof with a shed roof dormer. The facades of Dutch Colonial Revival houses are often symmetrical. City of Birmingham, photo by KDG, 2022.

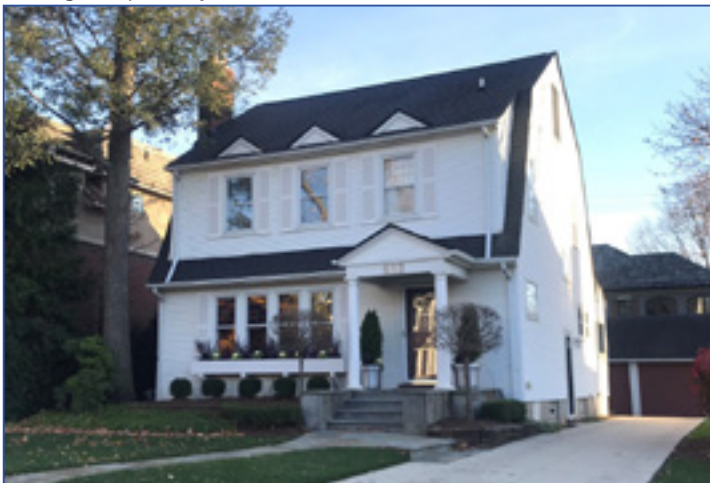
Another example of a Dutch Colonial Revival house with a gambrel roof and shed roof dormer. City of Birmingham, photo by KDG, 2022.

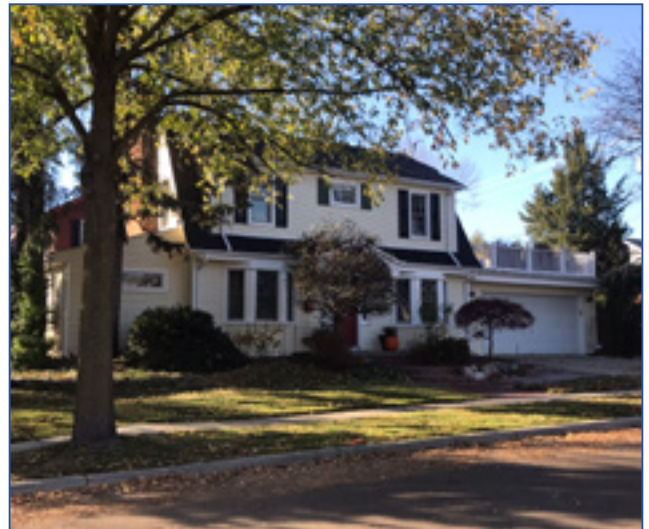
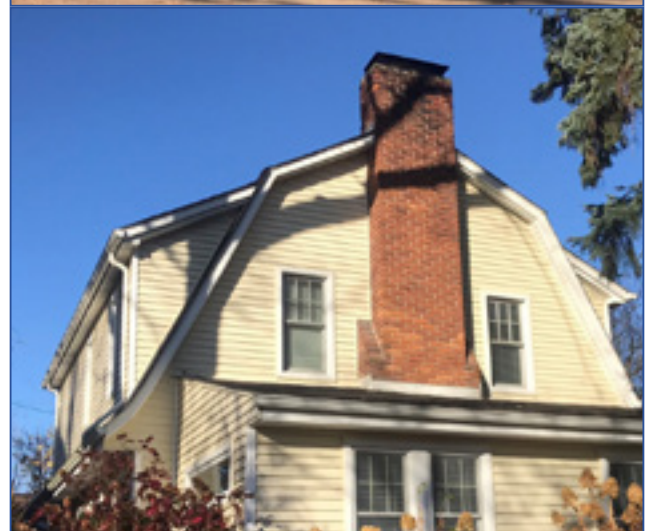
The gambrel roof with flared eaves paired with a large, shed roof dormer are characteristic of the Dutch Colonial Revival style. City of Birmingham, photo by KDG, 2022.

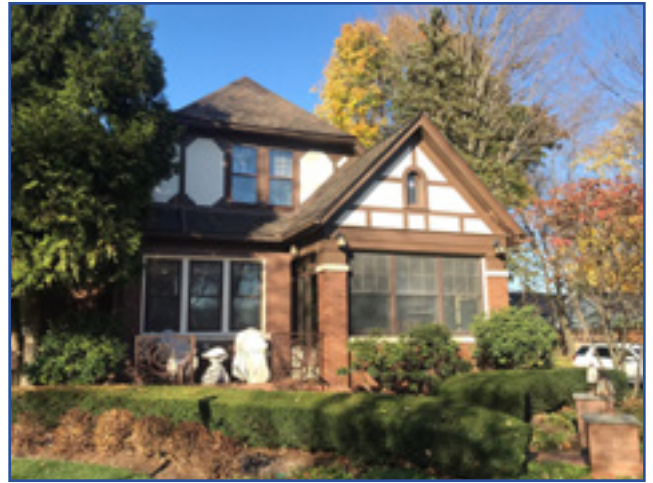
Tudor Revival house with a prominent, front-facing gable and decorative half-timbering. City of Birmingham, photo by KDG, 2022.

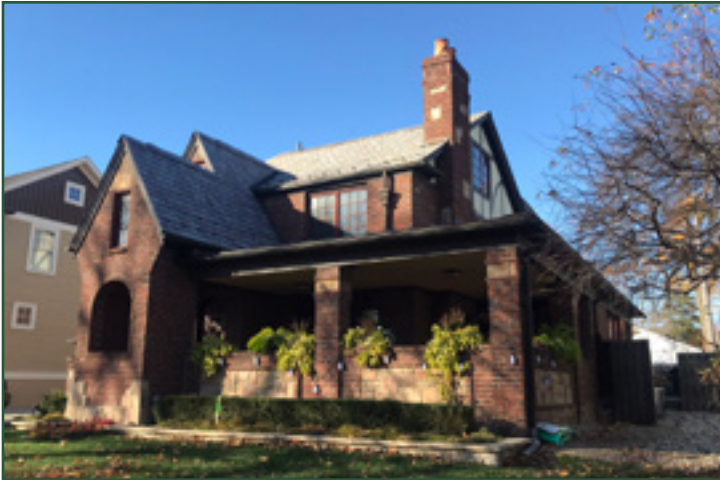
The use of multiple exterior cladding materials, prominent gables, and decorative chimney pots illustrate the Tudor Revival style. City of Birmingham, photo by KDG, 2022.

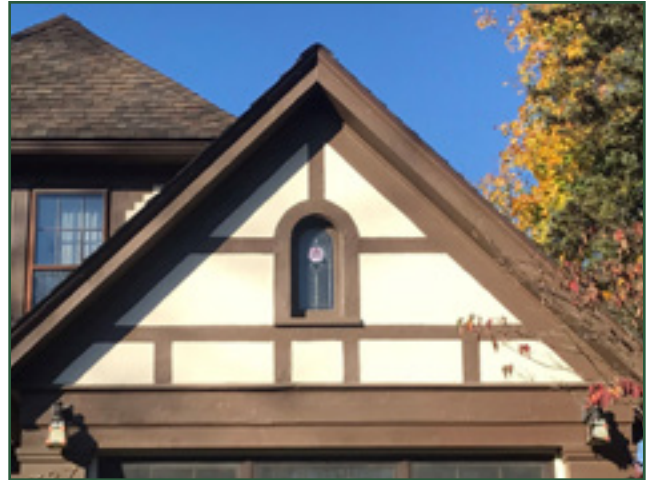
Detailed view of decorative half-timbering. City of Birmingham, photo by KDG, 2022.

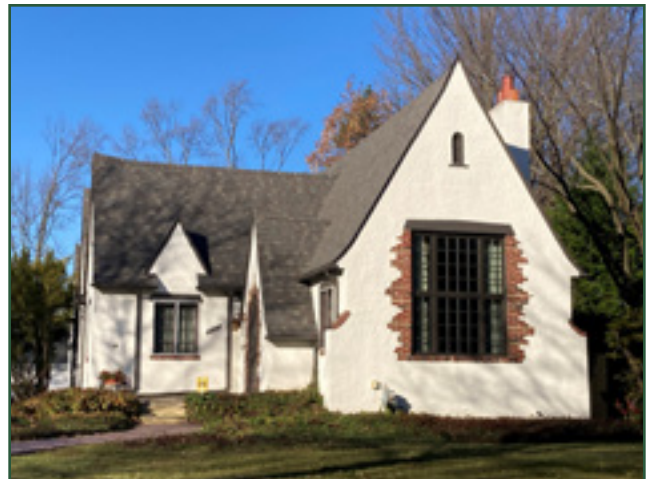
A stucco exterior clads this Tudor Revival with a large, front-facing gable and brick accents around window and door openings. City of Birmingham, photo by KDG, 2022.

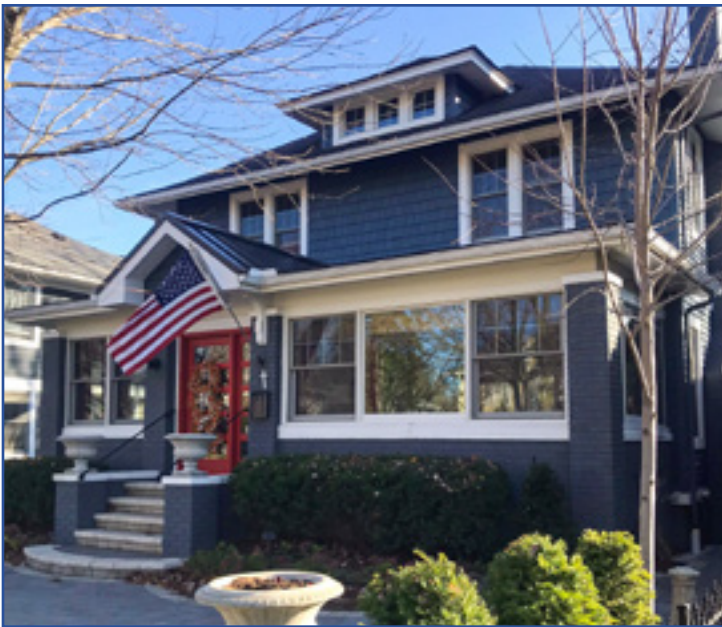
American Foursquare in the Prairie style. City of Birmingham, photo by KDG, 2022.

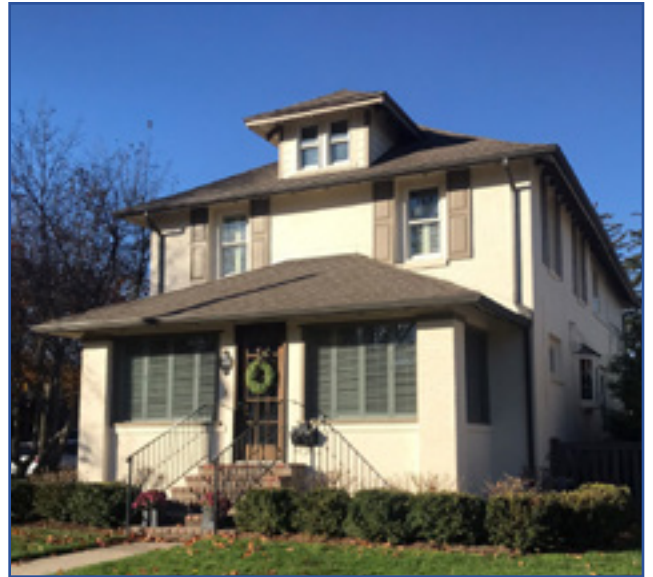
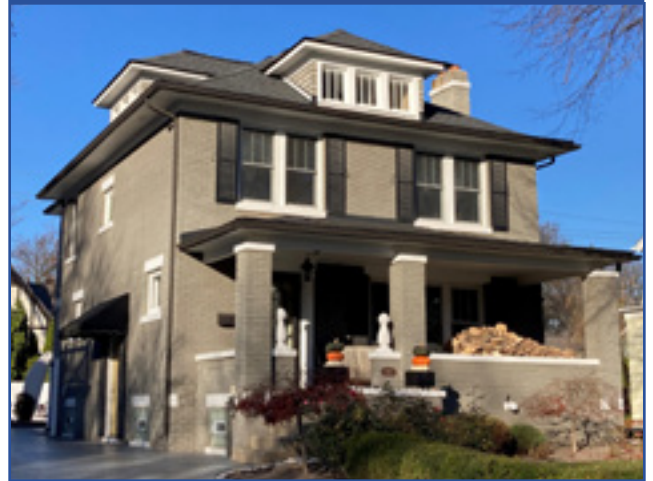
The Prairie style, with the characteristic hipped roof, hipped roof dormers, widely overhanging eaves, and large porch, is often applied to the American Foursquare form. City of Birmingham, photo by KDG, 2022.

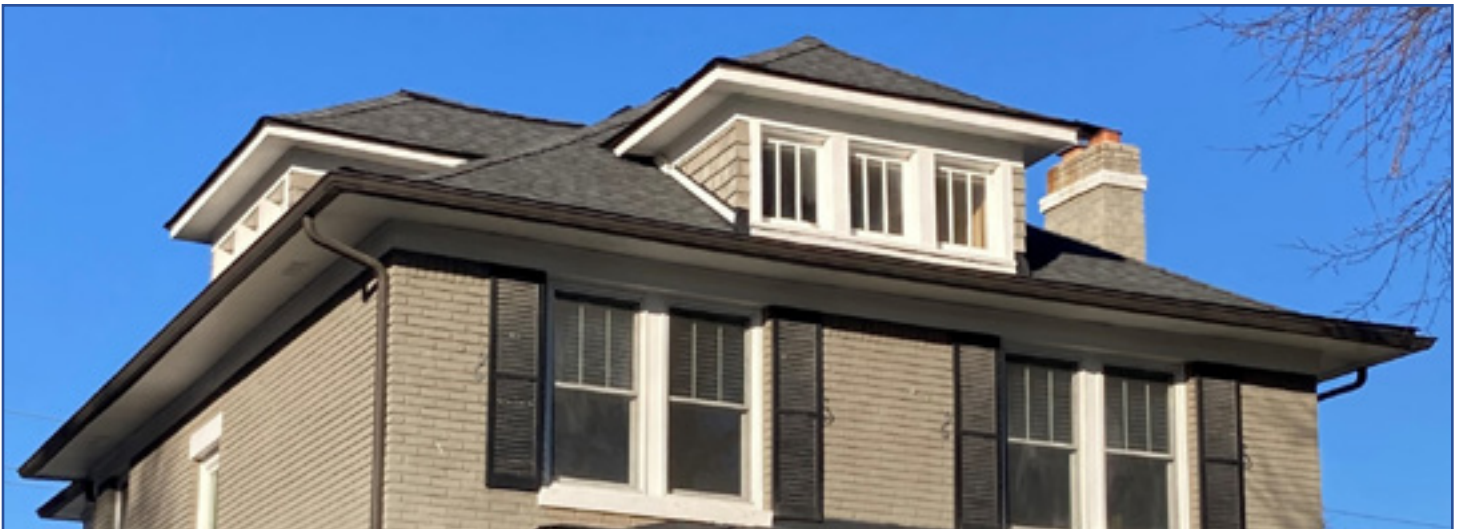
Closeup image of the hipped roof, hipped roof dormers, widely overhanging eaves, and 3-over-1 windows. City of Birmingham, photo by KDG, 2022.

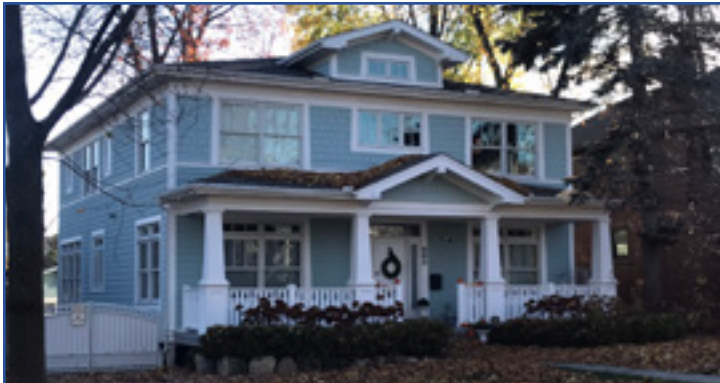
Battered wood piers, a large full-width porch, 3-over-1 windows, and protruding roof beams are some of the Craftsman details applied to this large Foursquare form. City of Birmingham, photo by KDG, 2022.

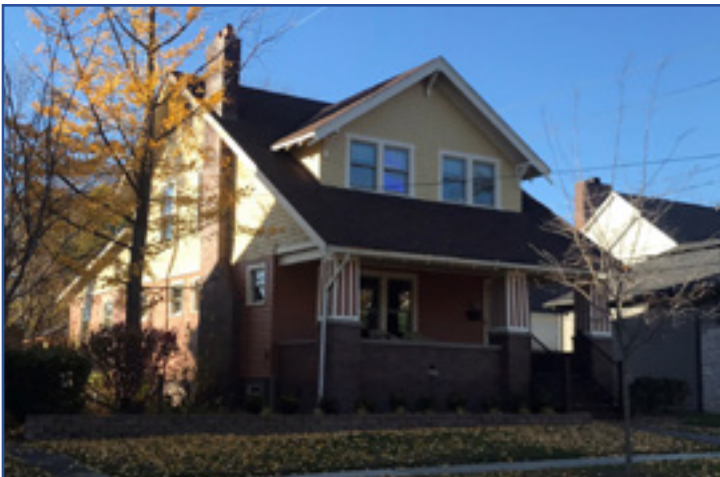
A large Craftsman Bungalow with a front gable dormer, full-width porch with brick piers topped with battered wood piers, and extended eaves with rafter tails and knee brackets. City of Birmingham, photo by KDG, 2022.

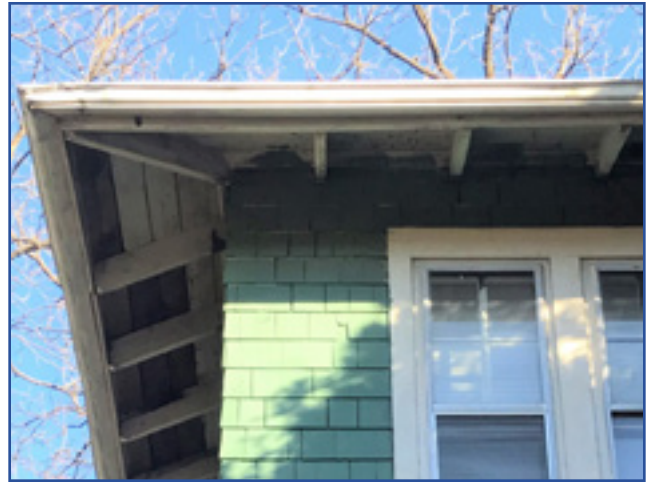
Exposed, extended eaves with visible rafters are characteristics of the Craftsman style. City of Birmingham, photo by KDG, 2022.

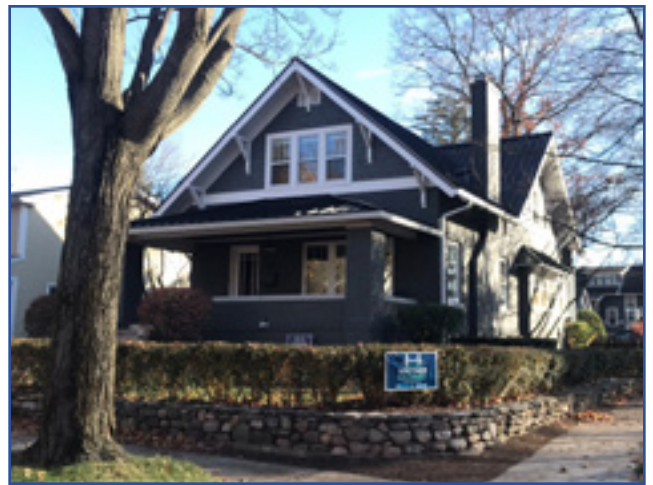
This Craftsman style house has knee brackets, a large porch with massive brick piers, a gabled roof, and 3-over-1 windows. City of Birmingham, photo by KDG, 2022.

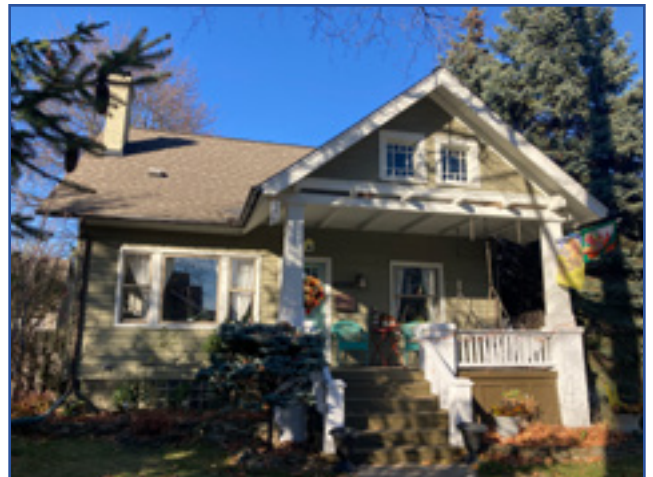
A Craftsman Bungalow with a gabled porch with battered wood piers resting on brick piers, rafter tails, and decorative windows in the gable end. City of Birmingham, photo by KDG, 2022.

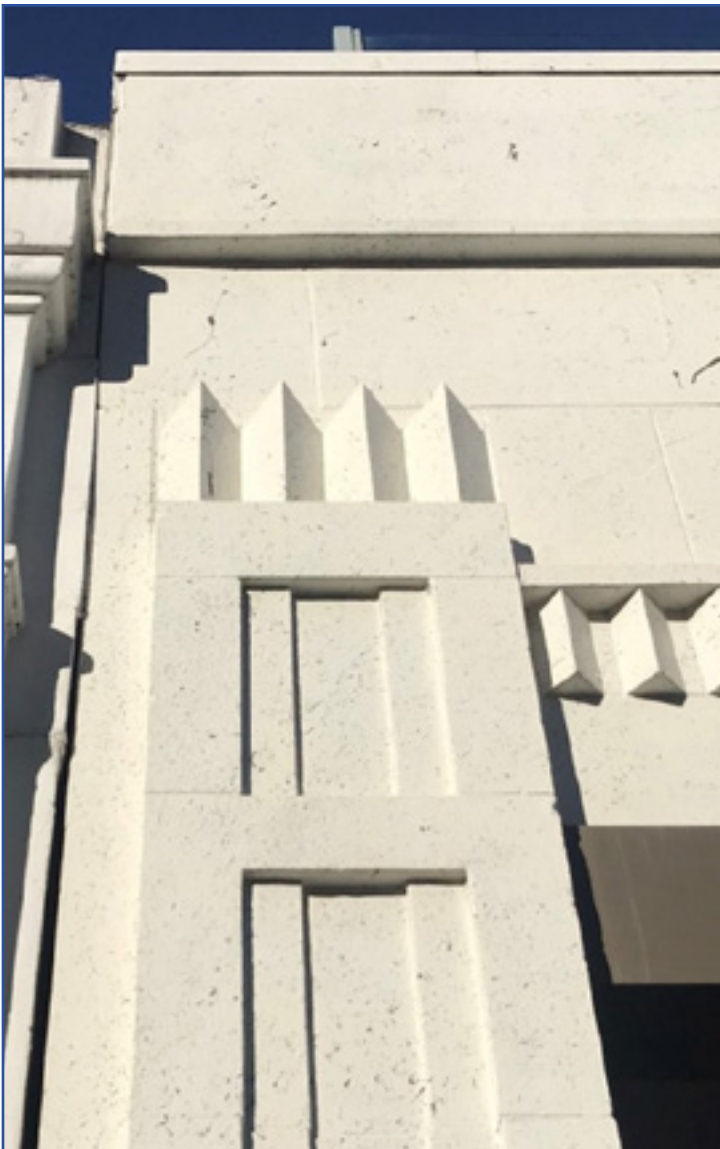
Closeup view of the geometric motifs on an Art Deco building. City of Birmingham, photo by KDG, 2022.

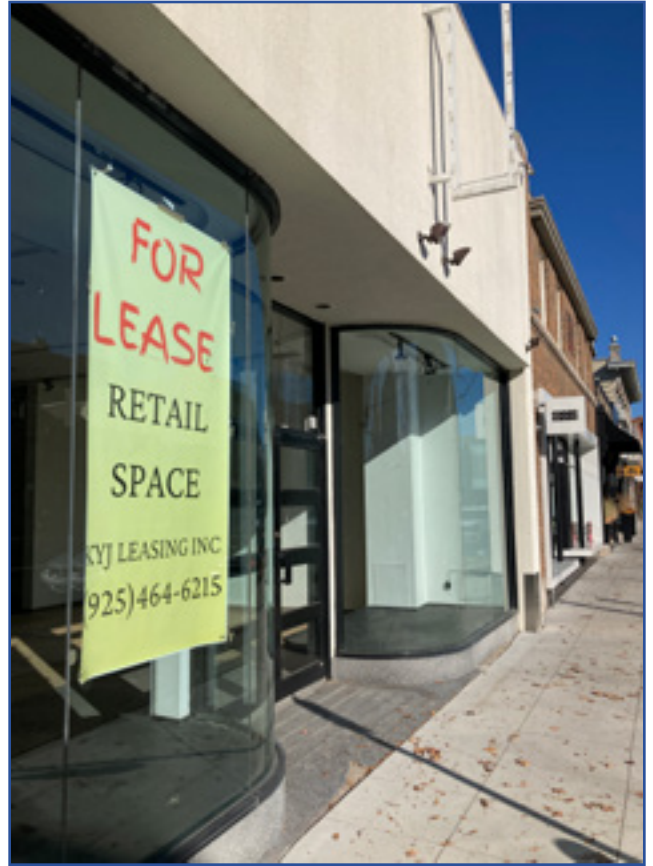
The curved corners with curved glass and stark façade are indicative of Streamline Moderne. City of Birmingham, photo by KDG, 2022.

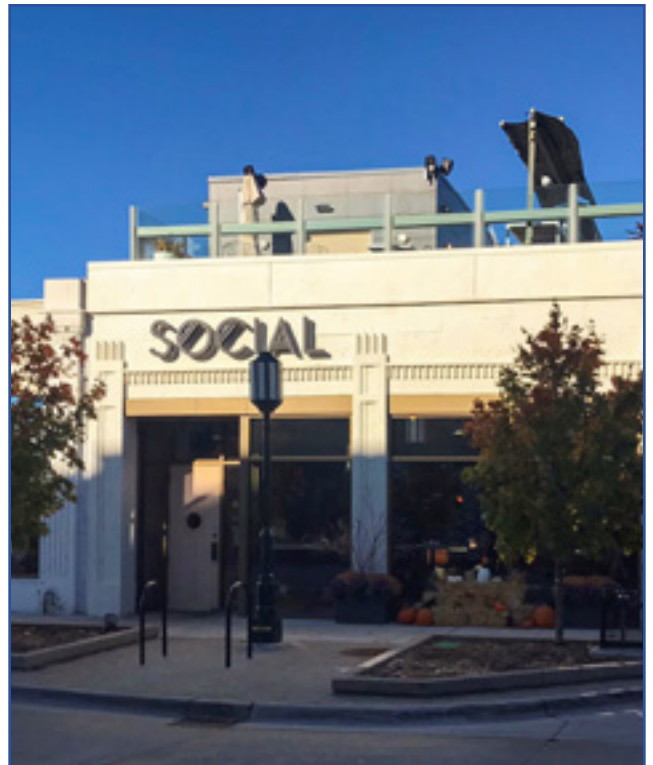
Small Art Deco building with geometric motifs paired with a smooth wall surface. City of Birmingham, photo by KDG, 2022.

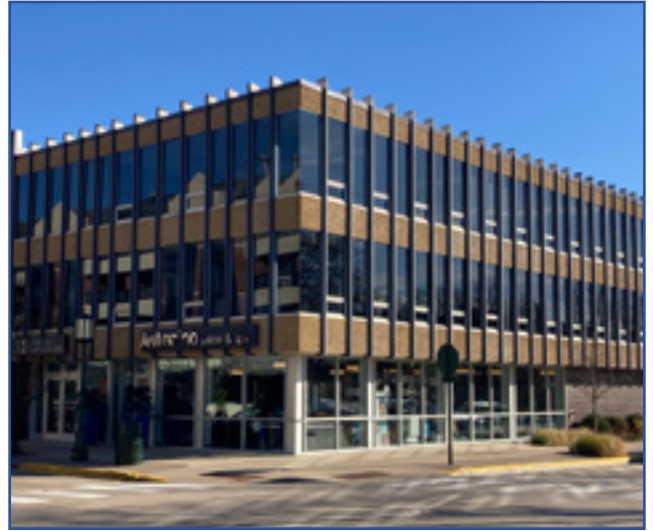
Modern buildings often incorporate new materials, with the building above incorporating expanses of glass and pebbled spandrels into the design. City of Birmingham, photo by KDG, 2022.

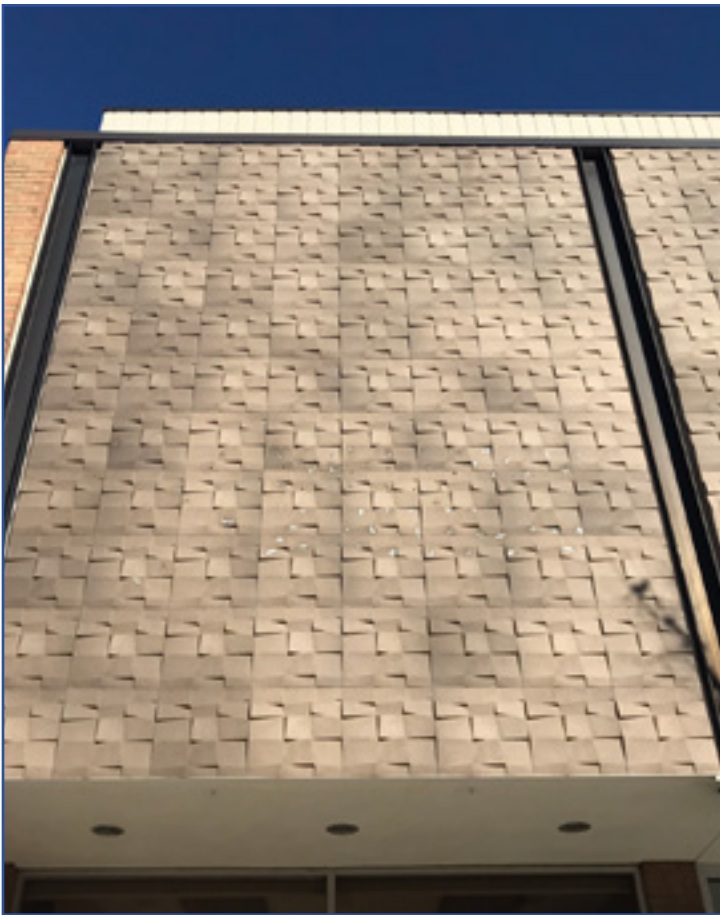
View of textured panels. City of Birmingham, photo by KDG, 2022.

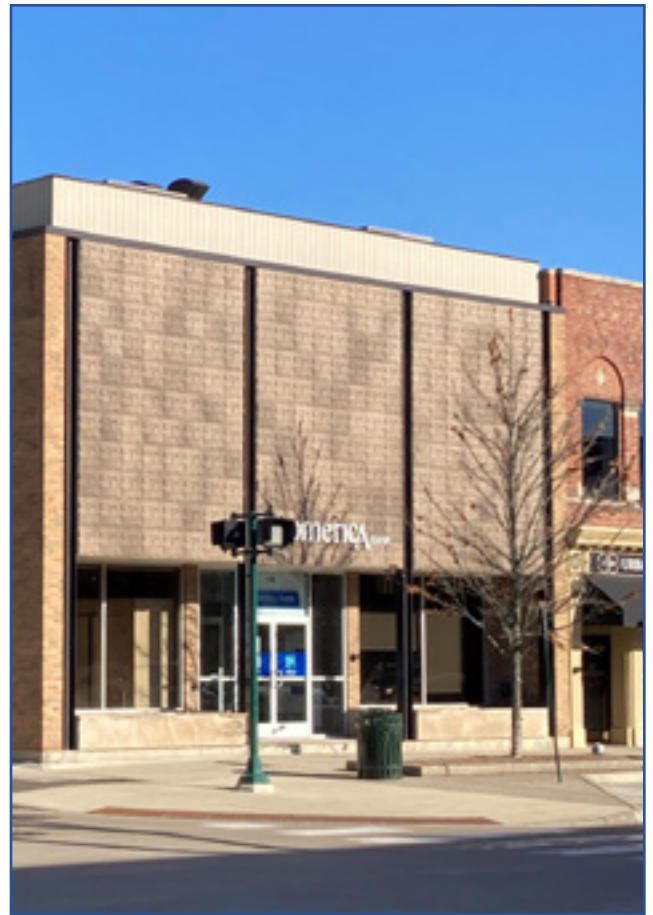
Verticality is emphasized by the narrow windows and solid spandrels organized in columns on the side elevation. The use of molded, textured panels on the façade is also characteristic of Modern buildings. City of Birmingham, photo by KDG, 2022.

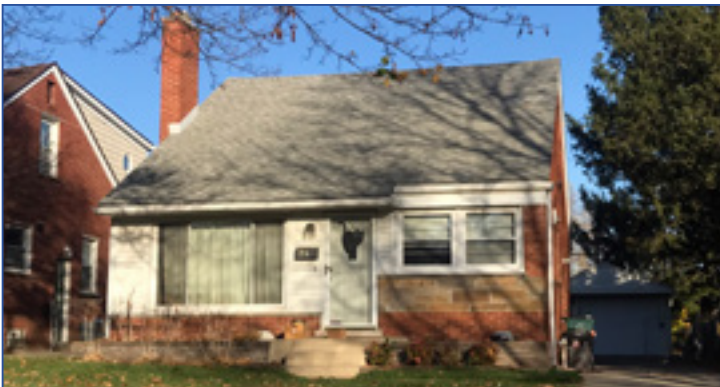
Small houses with minimal decoration and side gable roofs are indicative of the Minimal Traditional style. Brick and stone veneer and siding are incorporated into the exterior cladding on this example. City of Birmingham, photo by KDG, 2022.
