AGENDA
BIRMINGHAM HISTORIC DISTRICT COMMISSION
WEDNESDAY – JUNE 7, 2023
BIRMINGHAM CITY HALL, 151 MARTIN ST., COMMISSION ROOM #205*
******* 7:00 PM*******

**Historic District Commission
Minutes Of May 17, 2023**

Historic District Design Guidelines

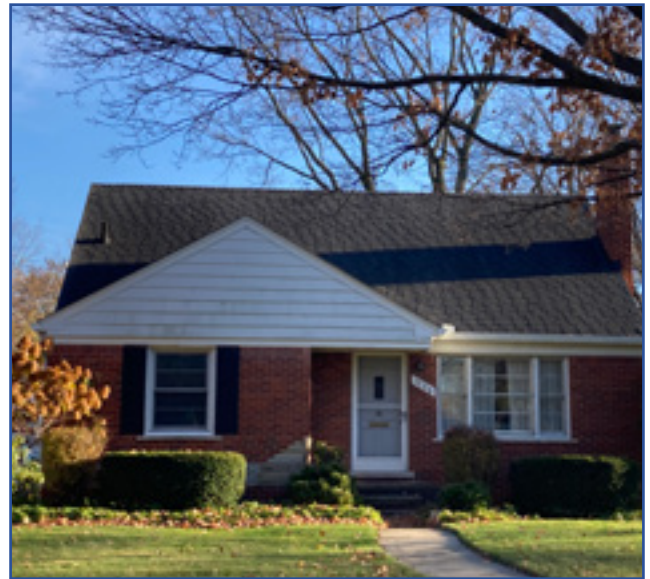
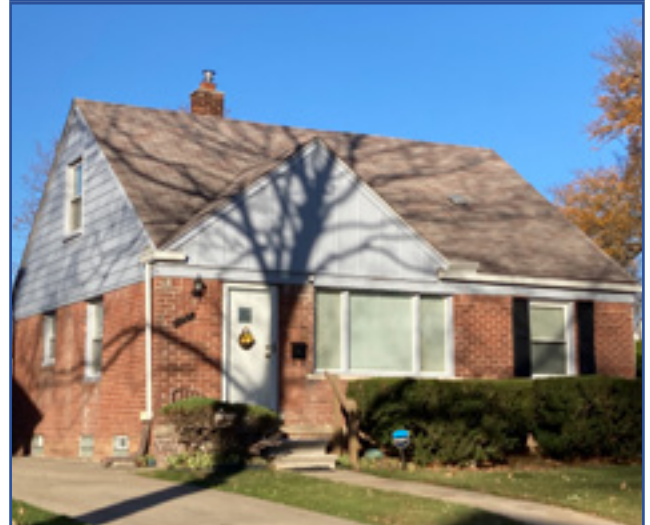
These examples illustrate the small front-facing gable often found on Minimal Traditional houses. City of Birmingham, photo by KDG, 2022.

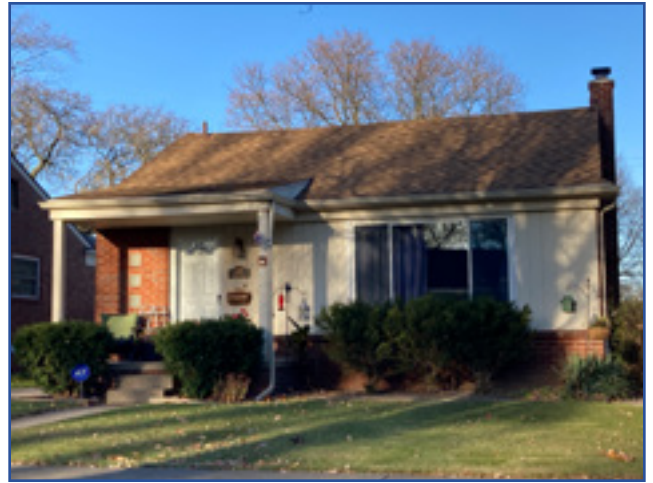
This small, Ranch style house has a side gable roof, large picture window, and cladding includes brick veneer and siding. City of Birmingham, photo by KDG, 2022.

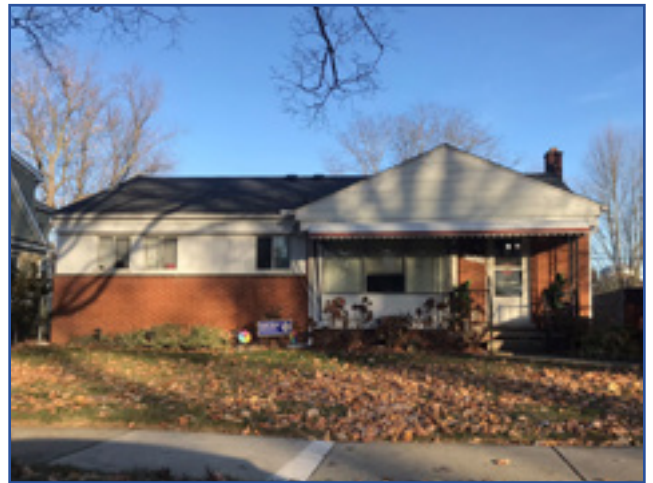
A low, Ranch style house with brick veneer and siding, a large picture window, and a front-facing gable. City of Birmingham, photo by KDG, 2022.

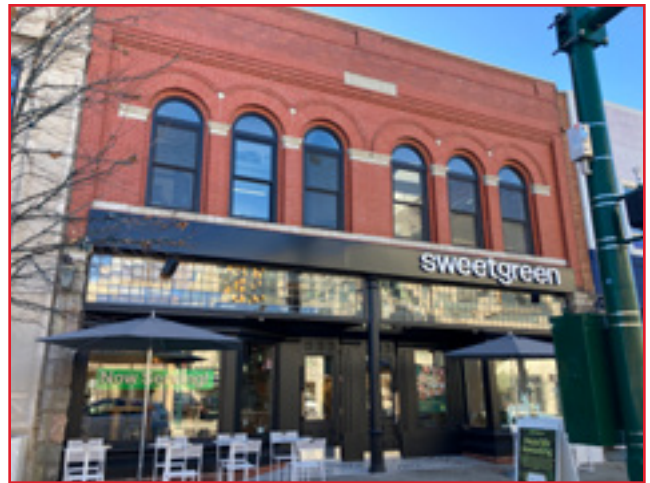
A typical historic storefront in the Central Business Historic District, with recessed entrances and large glass windows, City of Birmingham, photo by KDG, 2022.

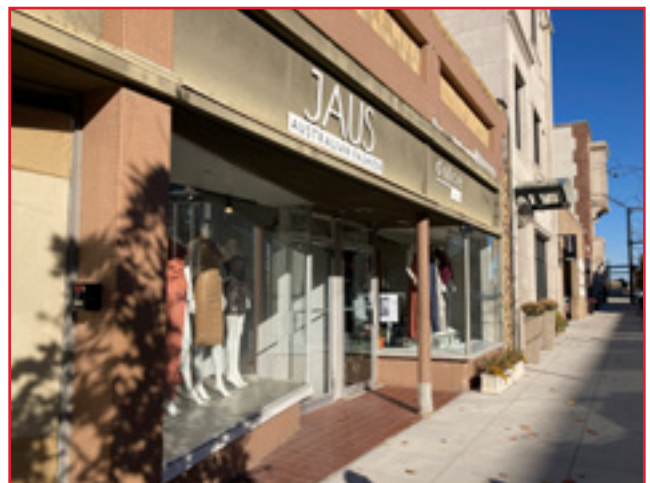
A mid-century storefront in the Central Business Historic District likely replaced an earlier storefront design. The new storefront utilizes large expanses of glass and a recessed entrance. City of Birmingham, photo by KDG, 2022.

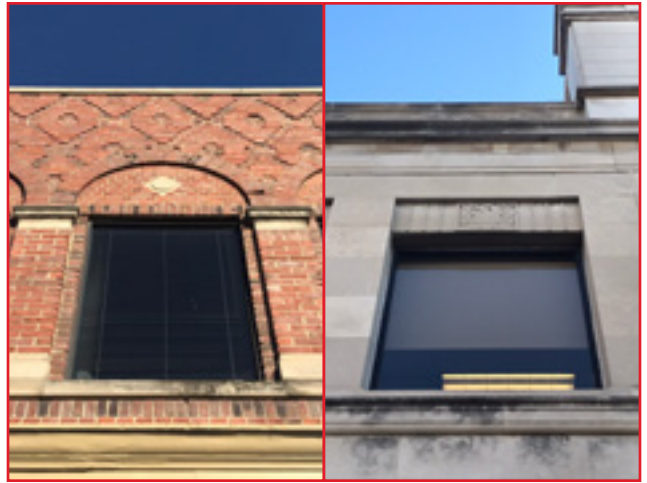
The replacement of historic windows with modern, fixed-sash windows is not recommended as it alters historic, character defining features of the building. Central Business Historic District, City of Birmingham, photo by KDG, 2022.

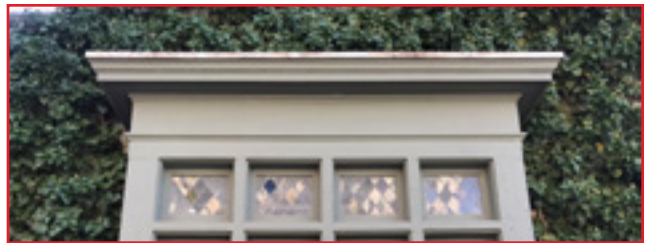
Maintaining and repairing historic windows is recommended. Where possible, the diamond pane leaded glass windows have been preserved. Central Business Historic District, City of Birmingham, photo by KDG, 2022.

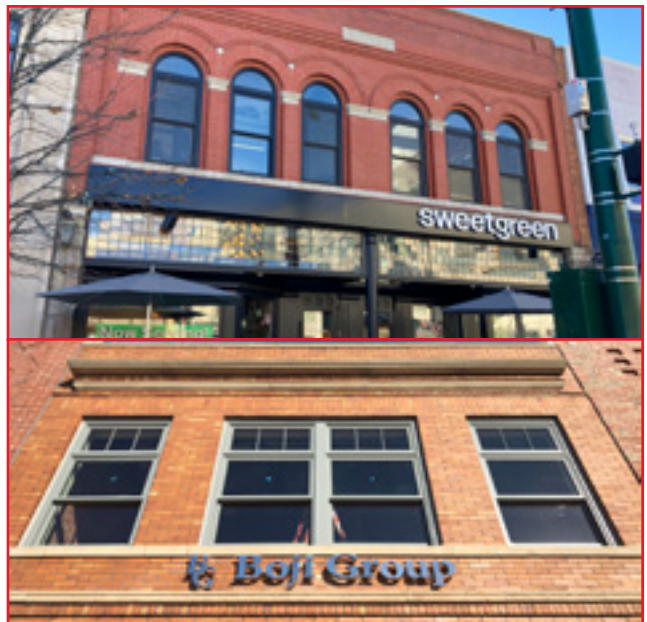
If historic windows are deteriorated beyond repair and cannot be replaced in-kind, modern replacement windows that mimic the originals are acceptable. Central Business Historic District, City of Birmingham, photo by KDG, 2022.

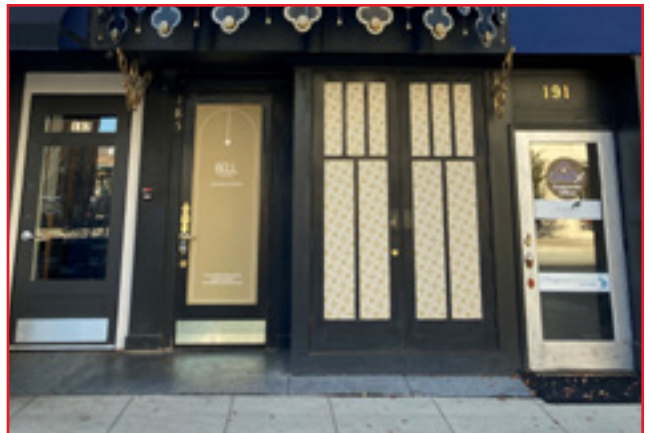
Although it is recommended that historic doors be maintained and repaired, if this cannot be done, replacement with a modern door that is complementary to the design and era of the building is acceptable. Central Business Historic District, City of Birmingham, photo by KDG, 2022.

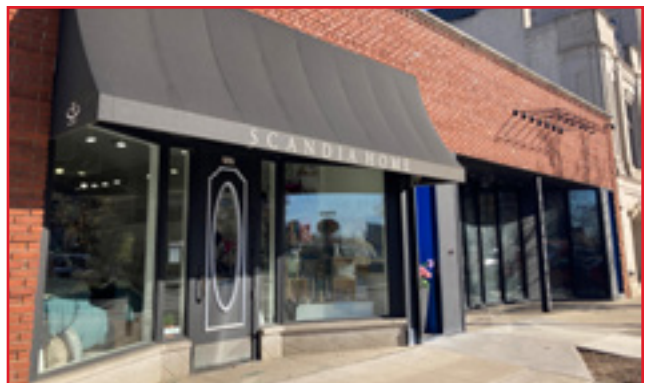
The replacement door above is not complementary to the historic building's style, and is therefore not recommended. Central Business Historic District, City of Birmingham, photo by KDG, 2022.

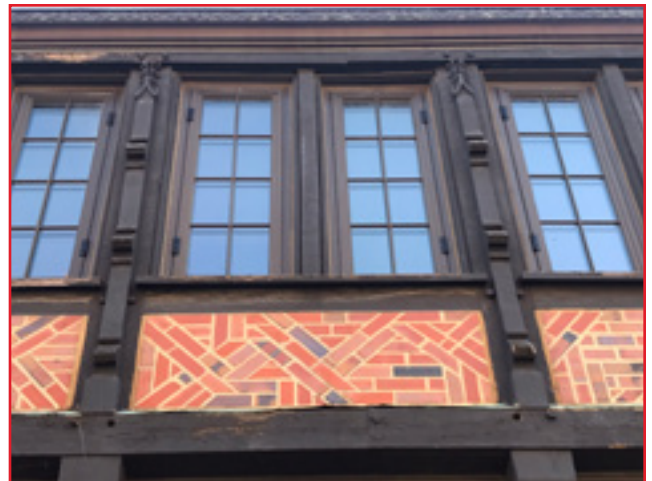
Maintenance and repair of original wood exterior details is key. The wood in the image above requires some repair from water damage and repainting. City of Birmingham, photo by KDG, 2022.

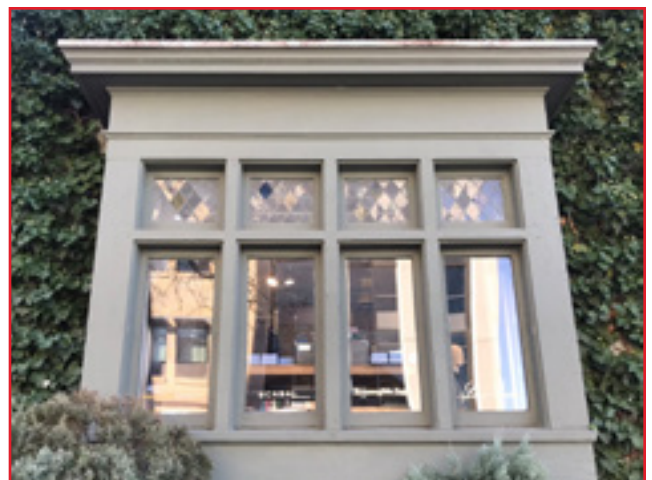
Exterior wood maintained with adequate painting. City of Birmingham, photo by KDG, 2022.

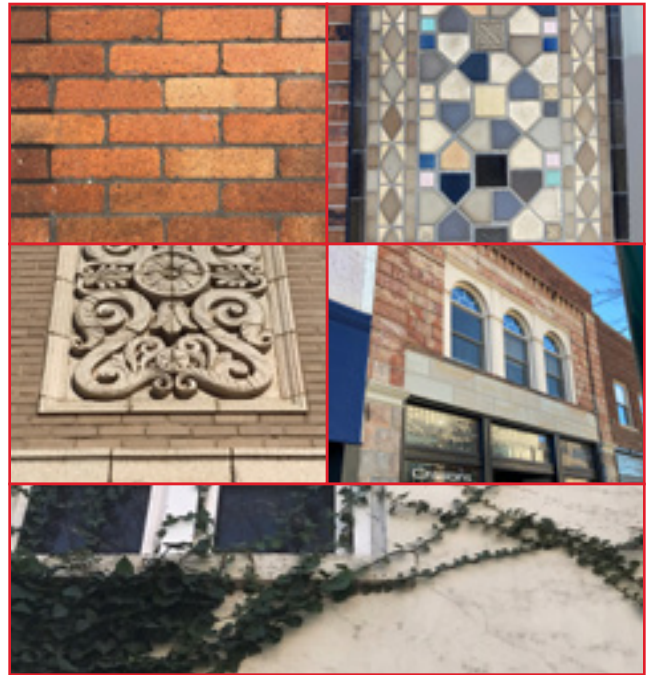
Masonry materials include, from left to right, brick, tile, terracotta, stone, and stucco. City of Birmingham, photo by KDG, 2022.

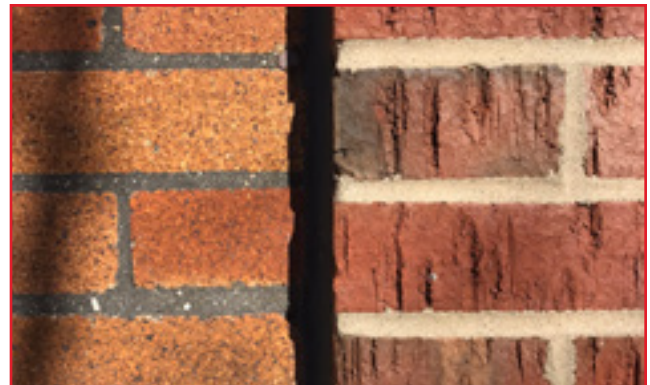
The maintenance and repair of historic brick and mortar is recommended. City of Birmingham, photo by KDG, 2022.

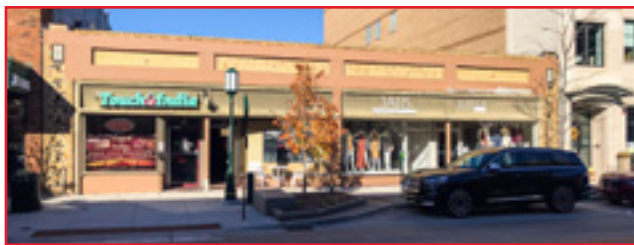
Commercial buildings typically have flat roofs that are obscured by masonry parapets, shielding the roof from view. City of Birmingham, photo by KDG, 2022.

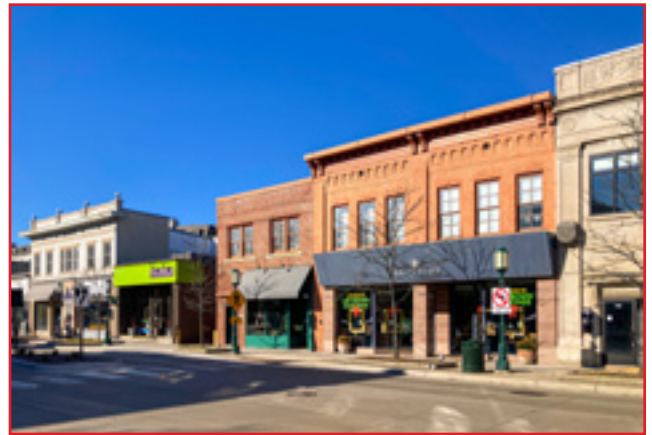
Rooftop mechanical equipment and penthouses that are present on these buildings within Birmingham's Commercial Historic District are positioned such that they are not visible from the public-right-of-way. Positioning rooftop mechanical equipment and penthouses in this manner is recommended. City of Birmingham, photo by KDG, 2022.

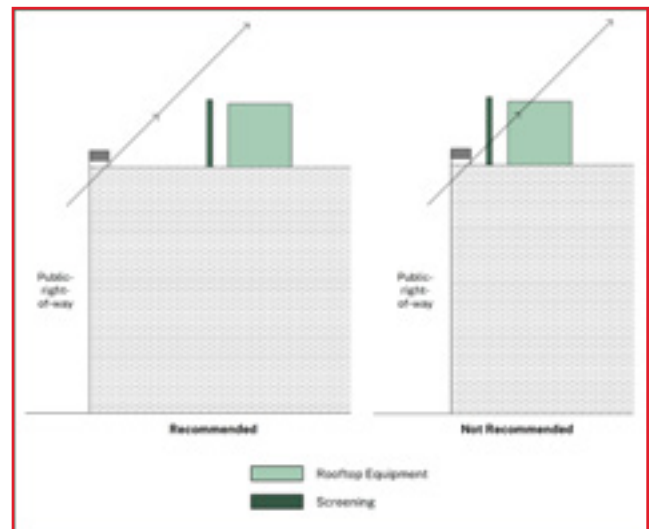
It is recommended that rooftop equipment and screening be situated so that it is not visible from the public right-of-way or adjacent buildings. It is not recommended that rooftop equipment and screening be visible

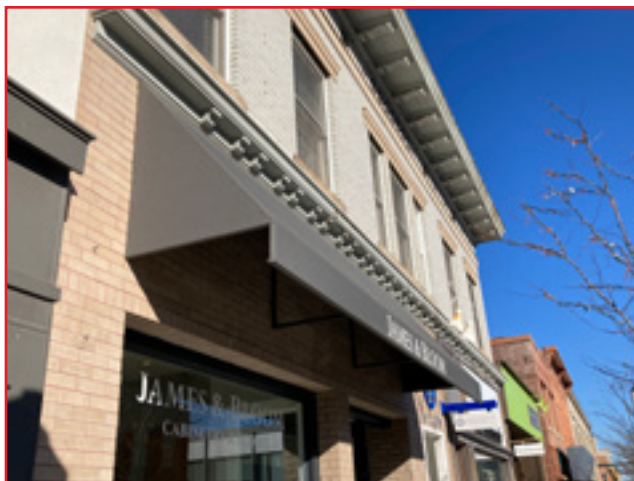
Historic awnings were generally triangularly shaped and extended outward at the base to shelter the façade. An awning may not have existed on this building historically, but this type of modern awning is acceptable. City of Birmingham, photo by KDG, 2022.

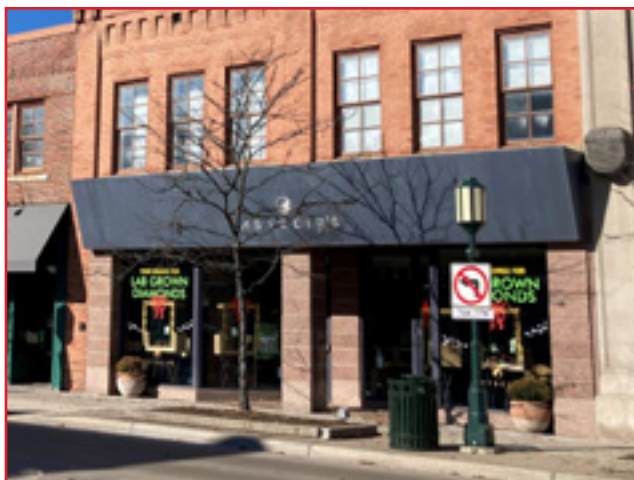
The modern awning here is an inverted version of the historic awning and is not recommended for use on historic buildings. City of Birmingham, photo by KDG, 2022.

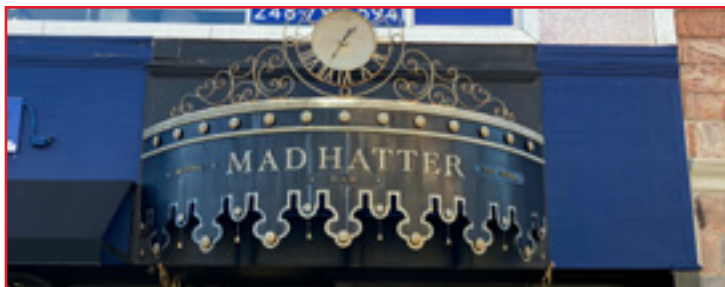
Canopies of unique design are acceptable on historic commercial buildings as long as they respect the scale and size of nearby canopies and do not harm historic materials or obscure historic building details. City of Birmingham, photo by KDG, 2022.

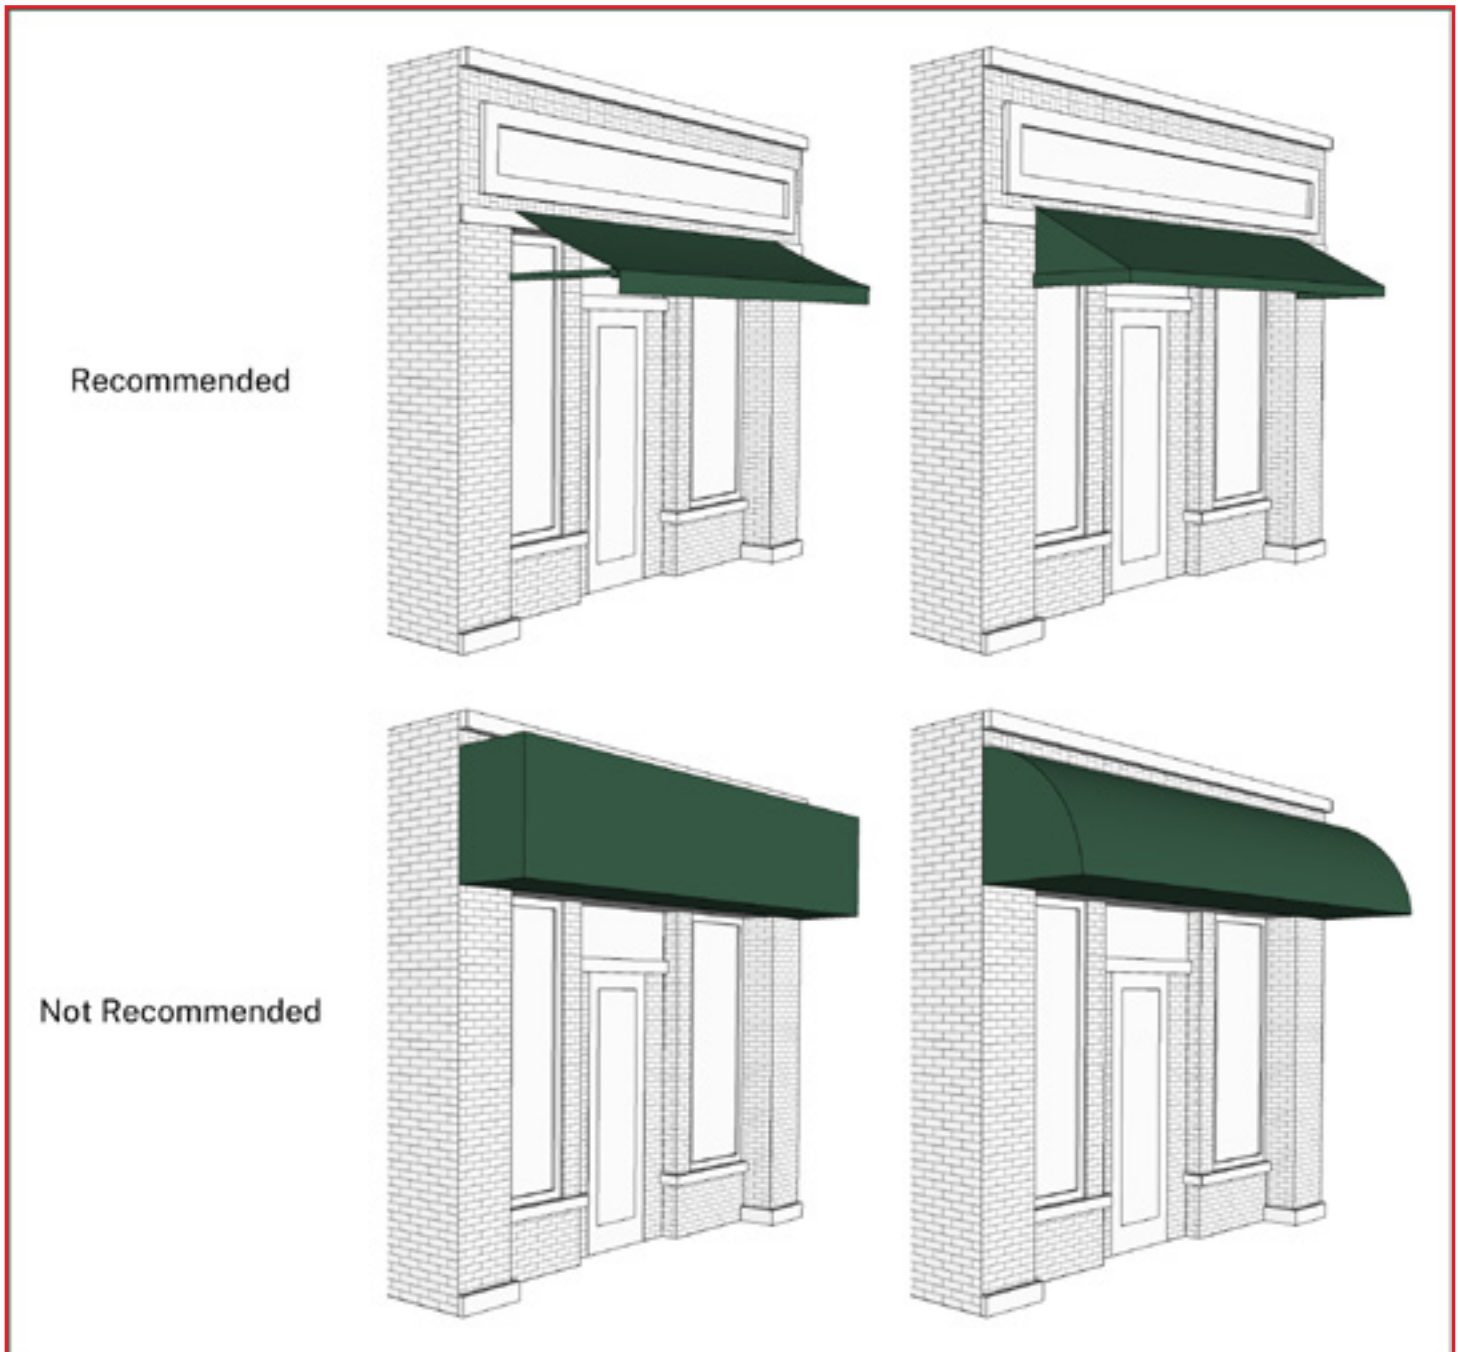
Awnings and Canopies

Triangular awnings are recommended for historic commercial districts, as these types of awnings were historically used in commercial districts. Boxed, waterfall, and bubble awnings and backlighting are not recommended as these are not historically accurate.

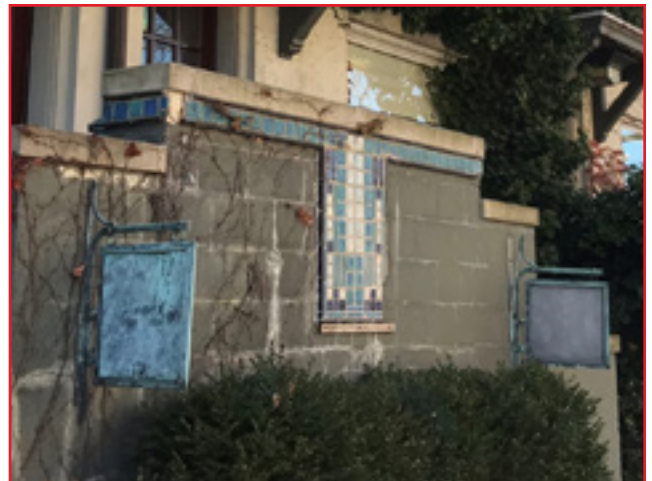
The retention of historic hanging signs on the Shain Townhouses is recommended, City of Birmingham, photo by KDG, 2022.

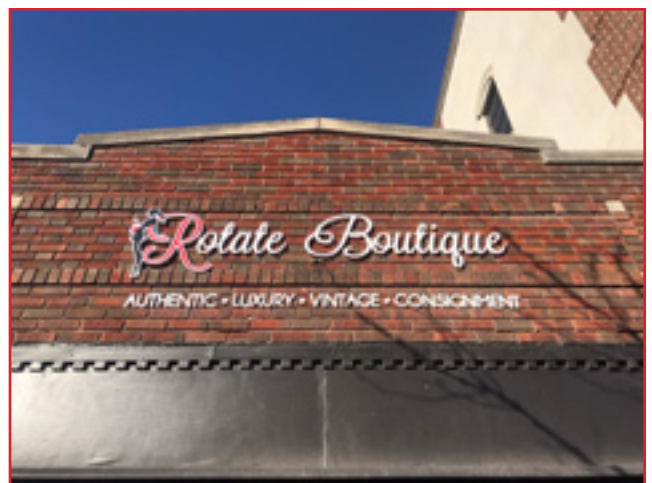
Placing signage above a designated signage band obscures the historic brick and is not recommended, City of Birmingham, photo by KDG, 2022.

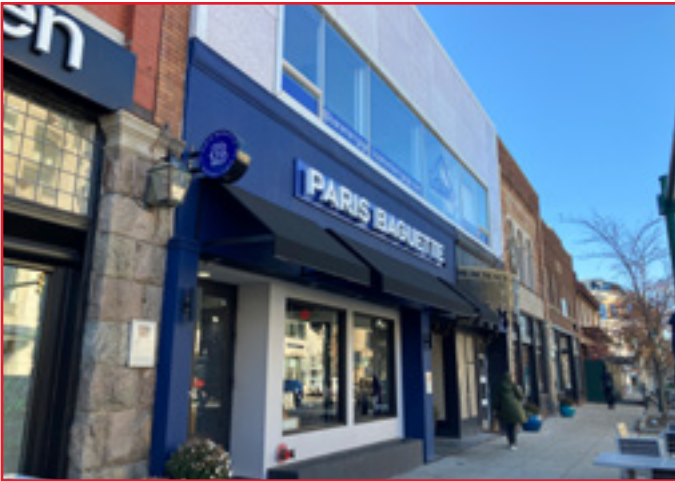
Placement of signage in the signage band above storefront windows is recommended. City of Birmingham, photo by KDG, 2022.

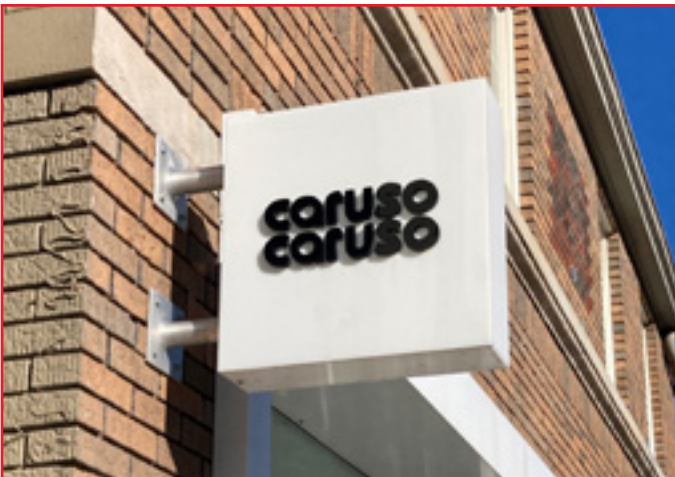
The use of small, unobtrusive yet visible blade signs is recommended. City of Birmingham, photo by KDG, 2022.

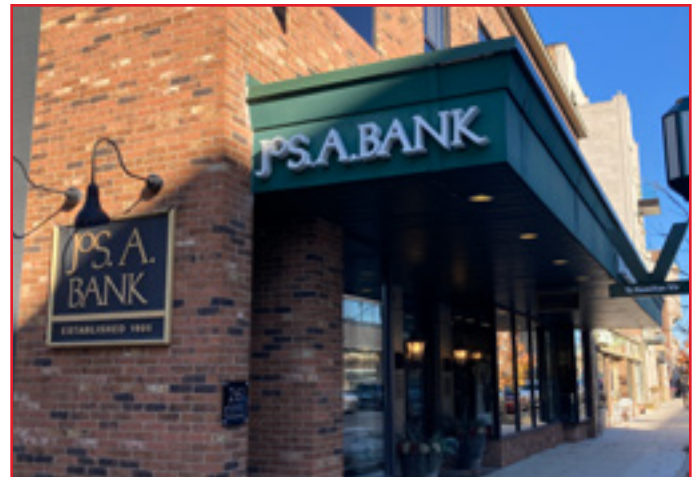
A small plaque sign along with signage on the canopy coordinates with historic signage in the Central Business District. City of Birmingham, photo by KDG, 2022.

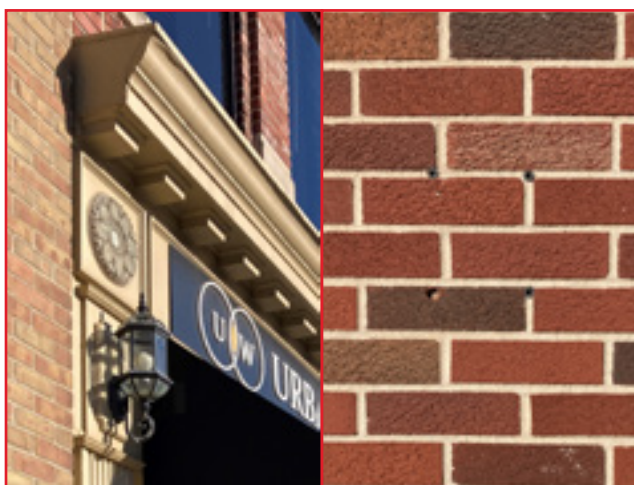
Historically appropriate lighting is shown at the left. At right shows where previous light fixtures were attached to the exterior. It is not recommended that historic material, such as the brick, be damaged when installing lighting. Lighting should be affixed at the mortar joints, City of Birmingham, photo by KDG, 2022.

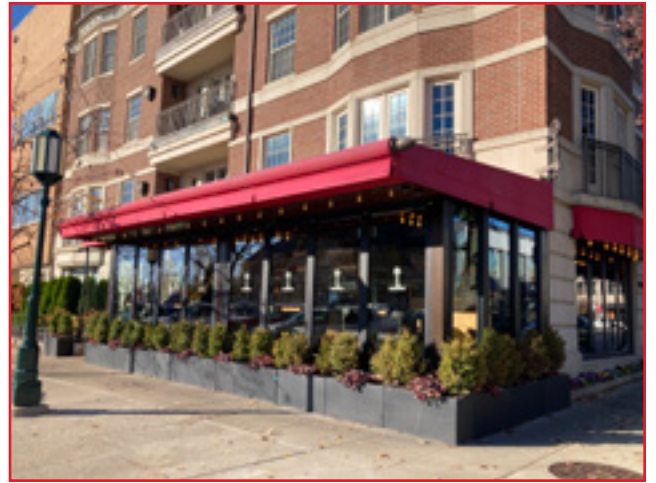
Patios such as this with a historically sensitive awning, use of finished materials, and appropriate scale are recommended, City of Birmingham, photo by KDG, 2022.

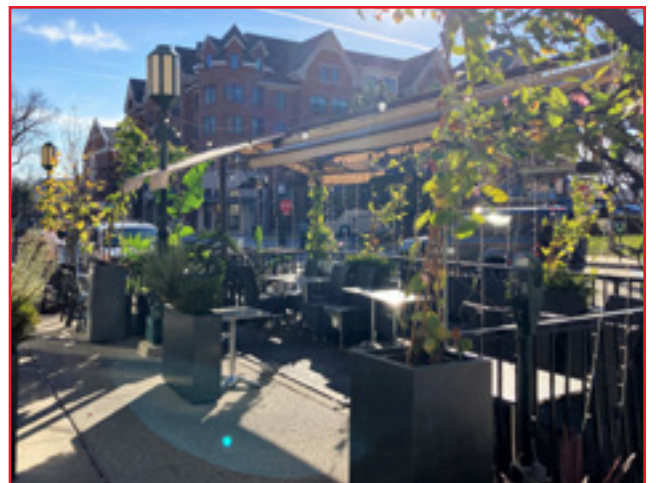
Sidewalk cafe and patio that is set away from the building like this one does not damage or obscure character defining features and is recommended. City of Birmingham, photo by KDG, 2022.

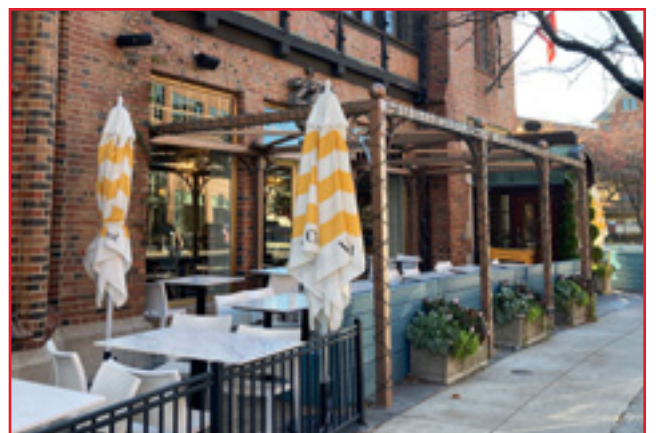
Cafe patio construction that is fastened/mounted to the building is not recommended. City of Birmingham, photo by KDG, 2022.

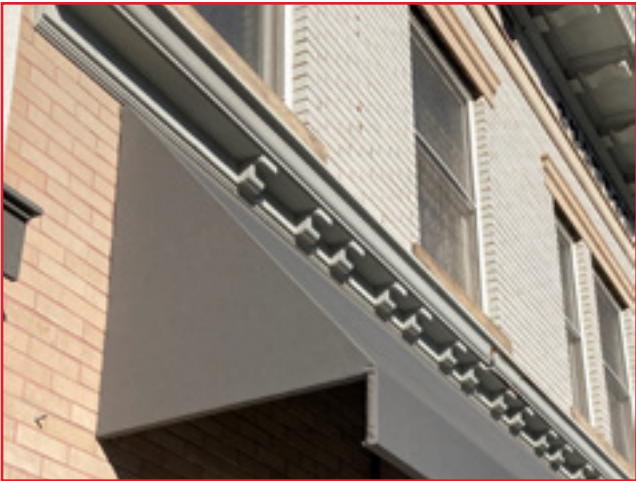
Close inspection, repeatedly completed, is key for a preventative maintenance plan. This storefront is missing modillions, likely a result of deferred maintenance, City of Birmingham, photo by KDG, 2022.

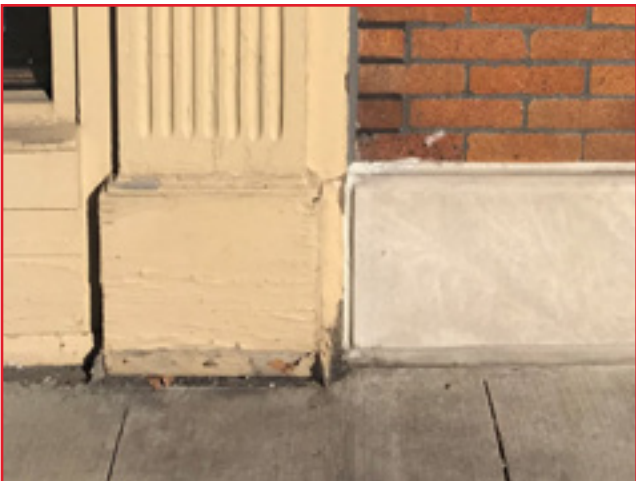
Peeling exterior paint and missing wood trim are indicative of needed maintenance, City of Birmingham, photo by KDG, 2022.

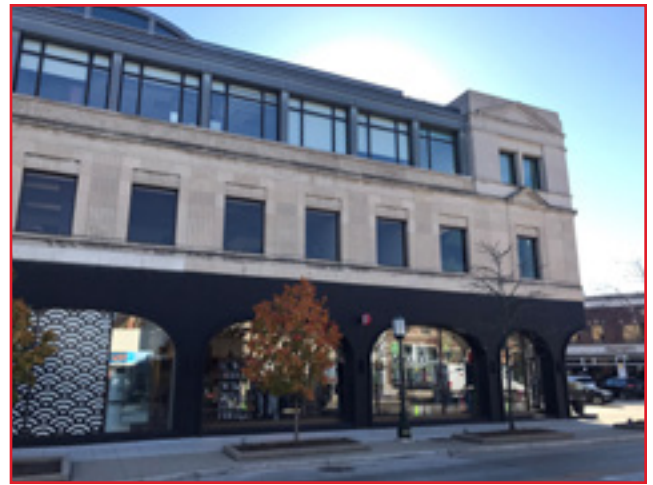
Large and prominent additions that are visible on the primary facades are not recommended, City of Birmingham, photo by KDG, 2022.

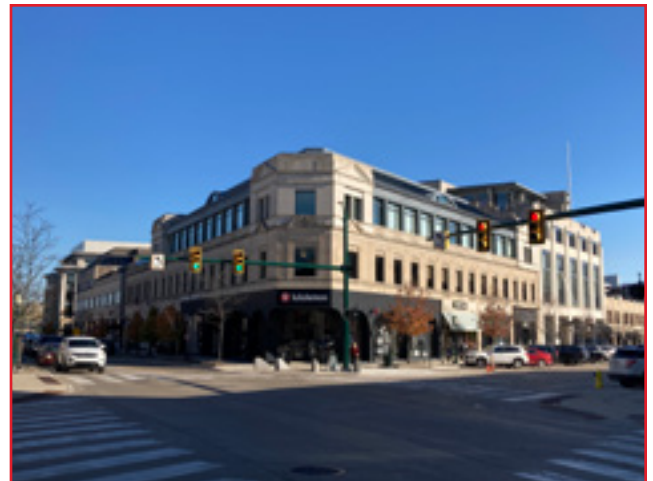
Large and prominent additions that are visible on the primary facades are not recommended, City of Birmingham, photo by KDG, 2022.

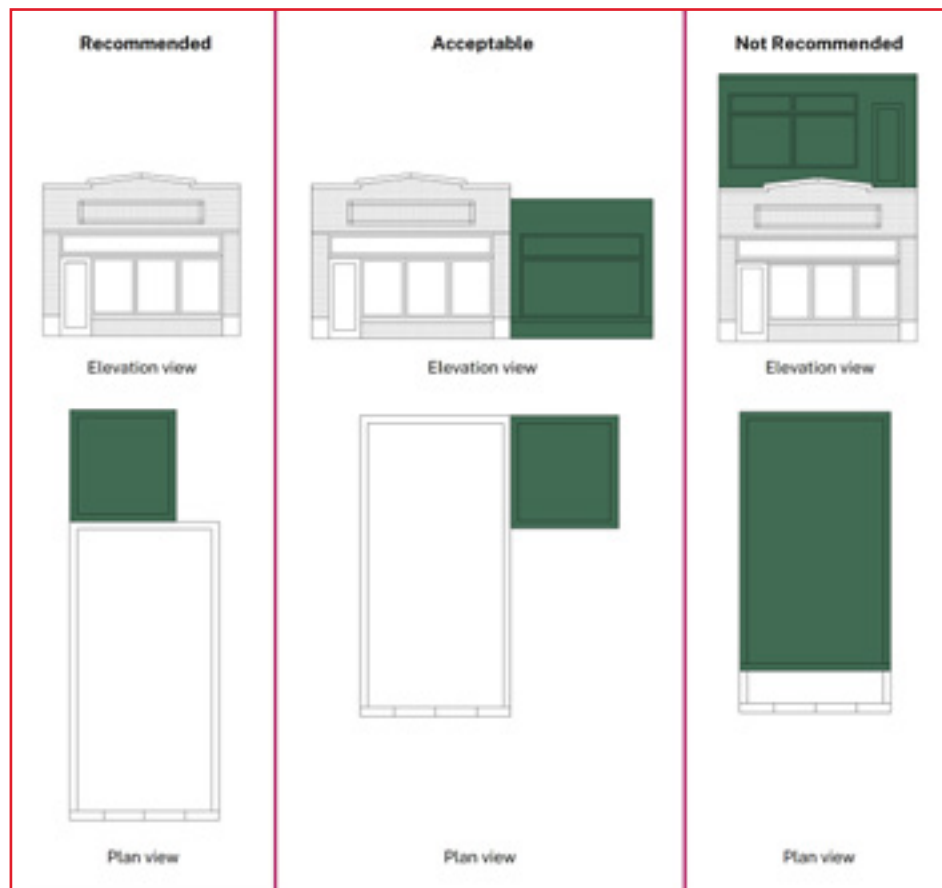
Additions located at the rear of a commercial building are recommended, small scale additions to the side elevations are acceptable, and additions that are highly visible and subsume the historic commercial building are not recommended.

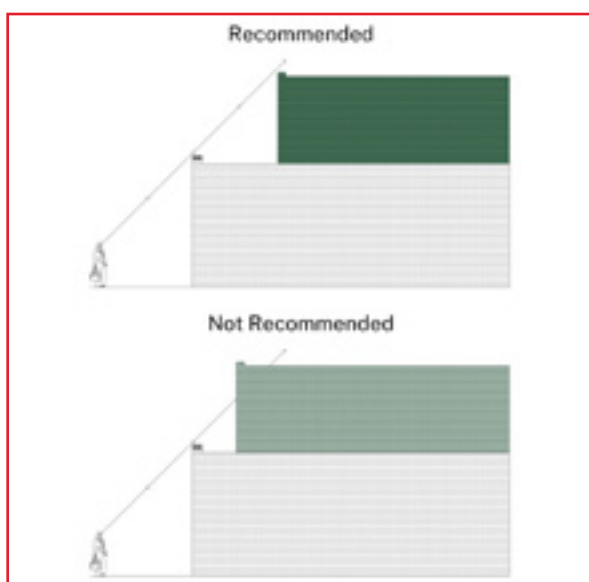
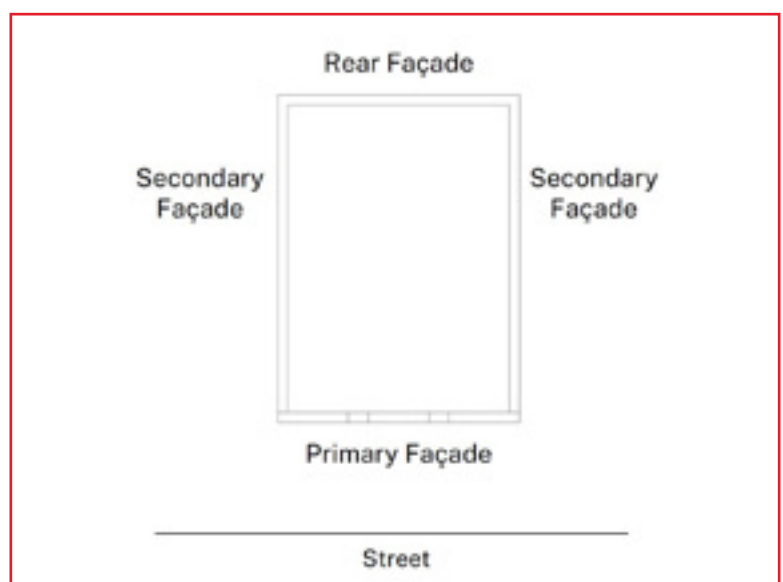
Something to keep in mind regarding commercial rooftop additions is a pedestrian's line of sight from the sidewalk. It is recommended that rooftop additions and the installation of any mechanical equipment not be visible from the right-of-way.

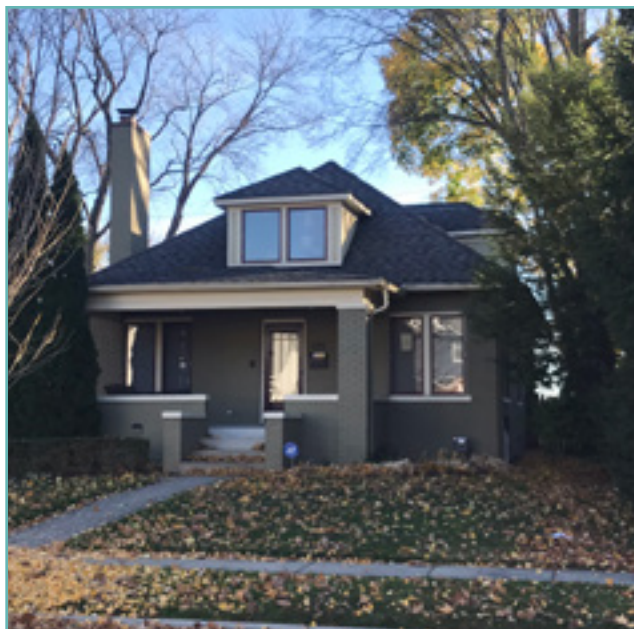
If circumstances require that modern window replacements are used, it is recommended that replacement windows match the historic windows as closely as possible. The replacement windows shown above would not be recommended as they are fixed sash windows without muntins, which do not match the historic 3-over-1 windows that were originally present. City of Birmingham, photo by KDG, 2022.

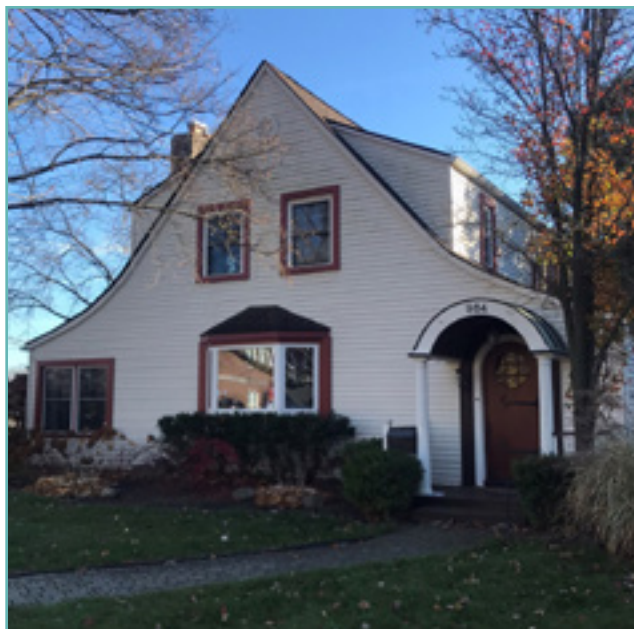
The replacement of historic windows with a modern, vinyl bay window with no muntins is not recommended as it does not match the historic window. City of Birmingham, photo by KDG, 2022.

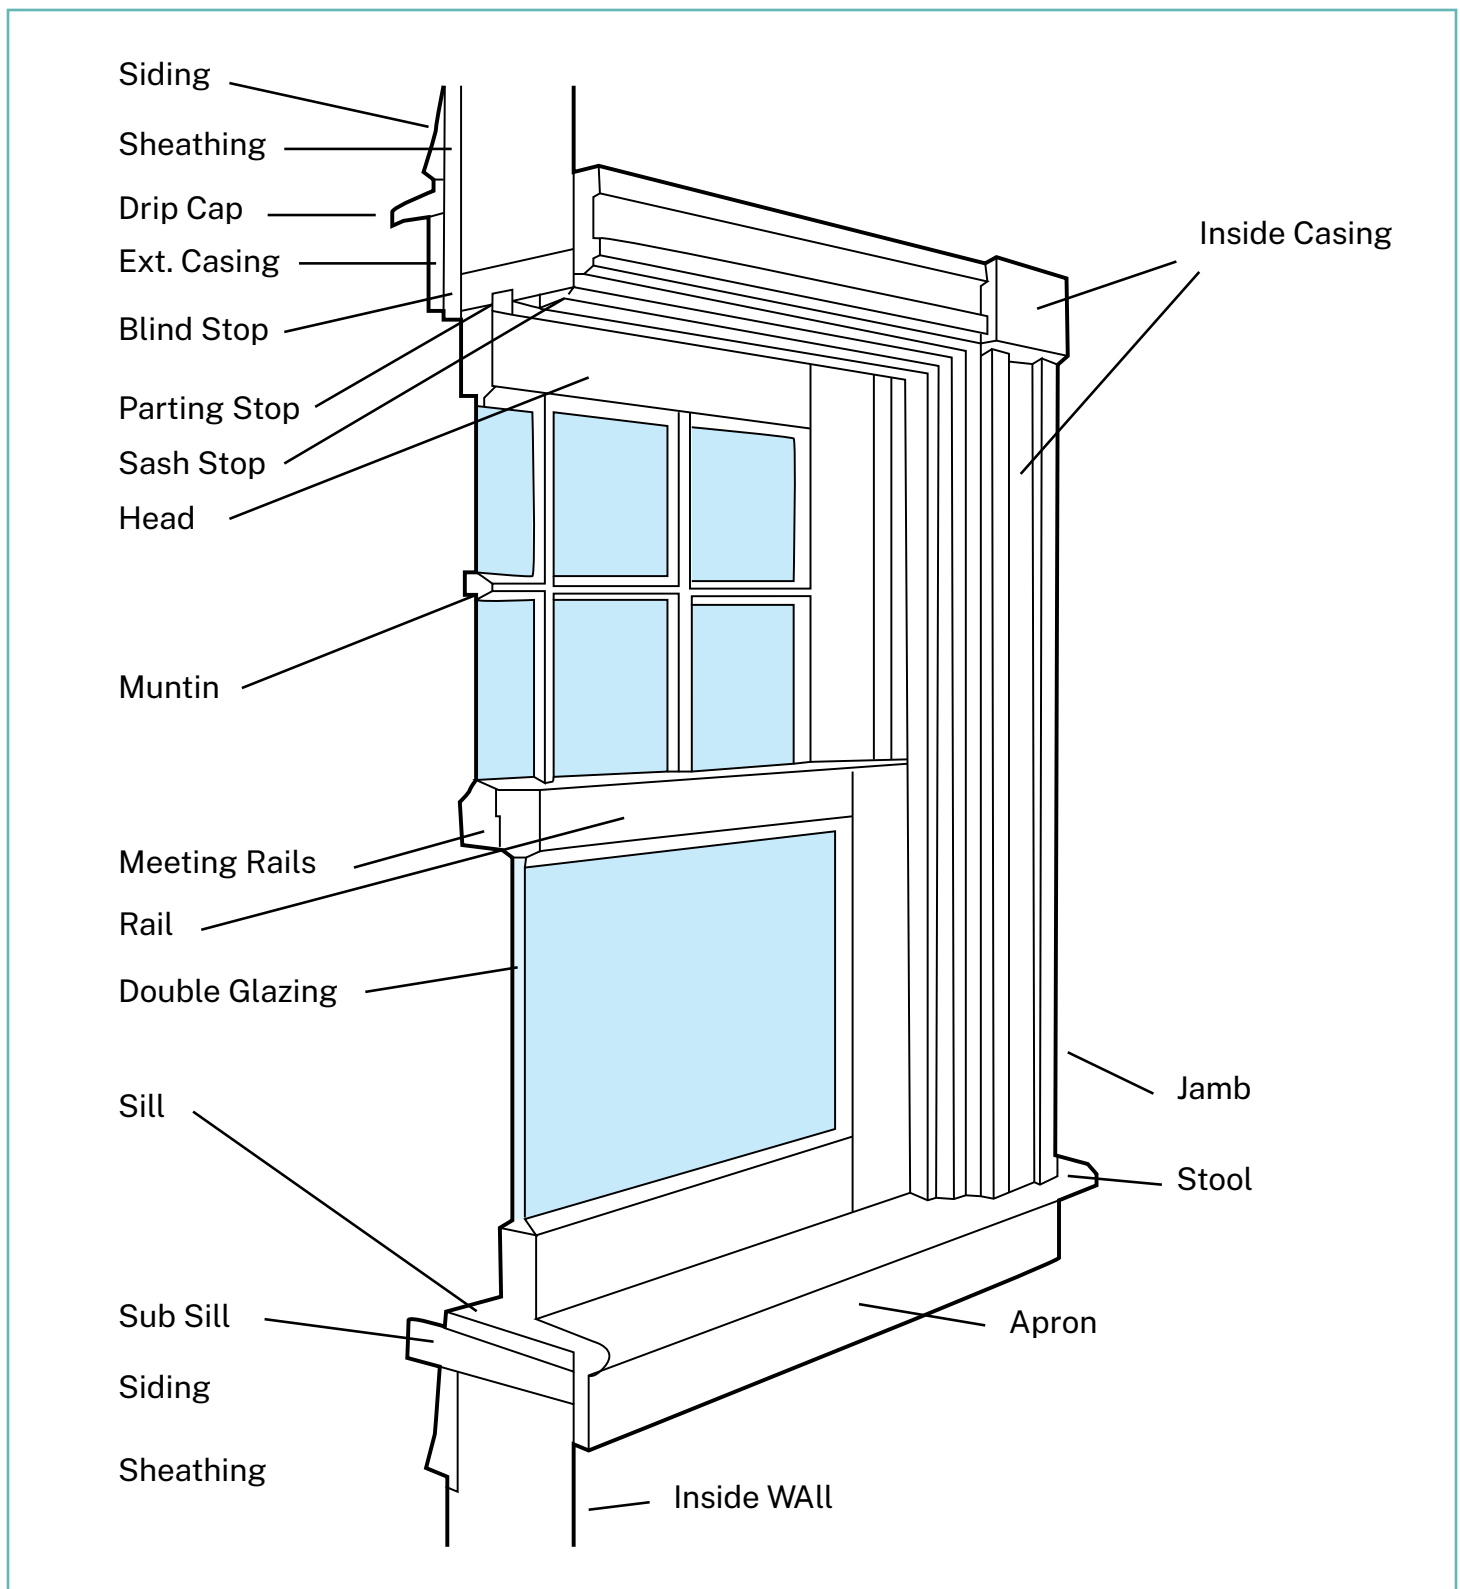
Typical components of a historic window

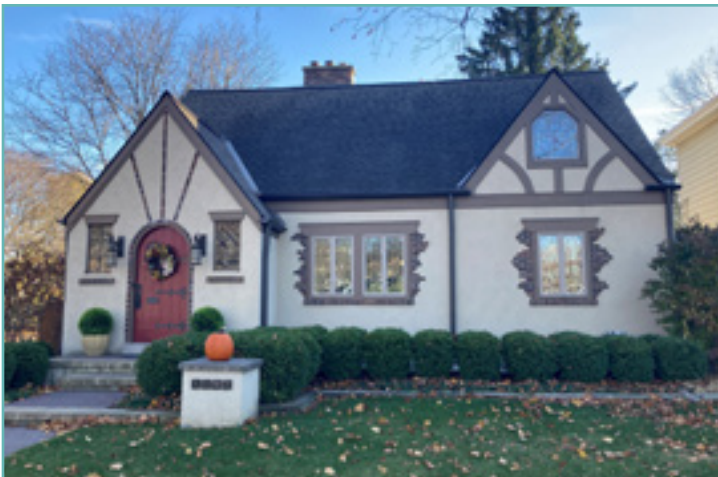
The storm windows above are not recommended as their color does not match the window sashes. City of Birmingham, photo by KDG, 2022.

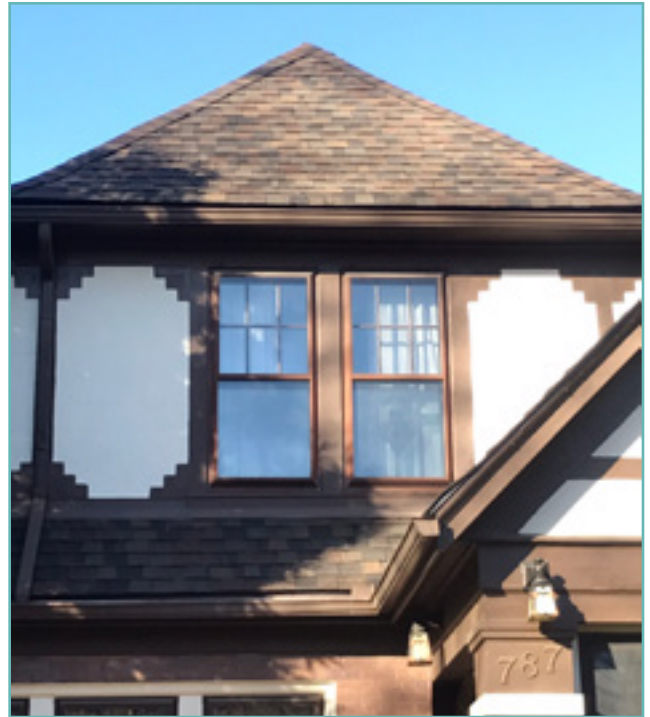
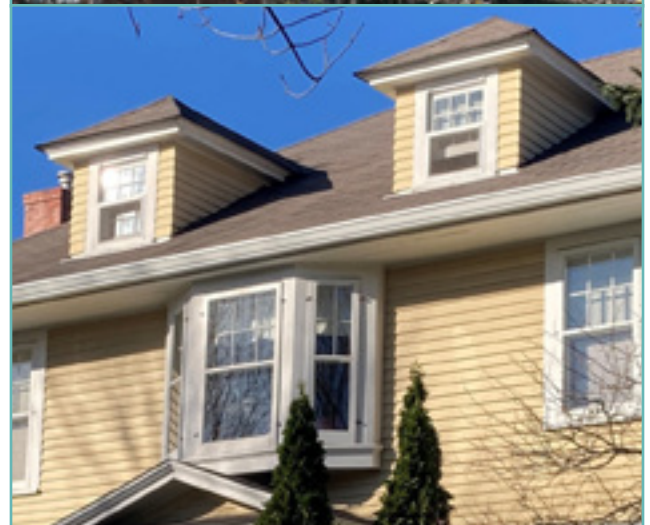
Storm windows such as these are recommended as they match the color of the historic window, and the division line matches the sash line of the historic window. City of Birmingham, photo by KDG, 2022.

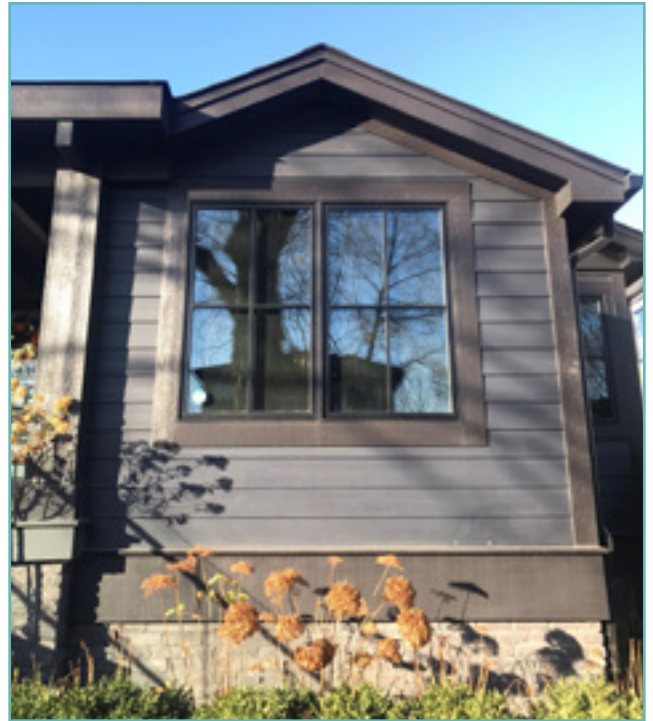
Although this modern replacement siding has a different finish than historic wood siding, the texture and dimensions make it a viable replacement for wood cladding too deteriorated to repair or preserve. City of Birmingham, photo by KDG, 2022.

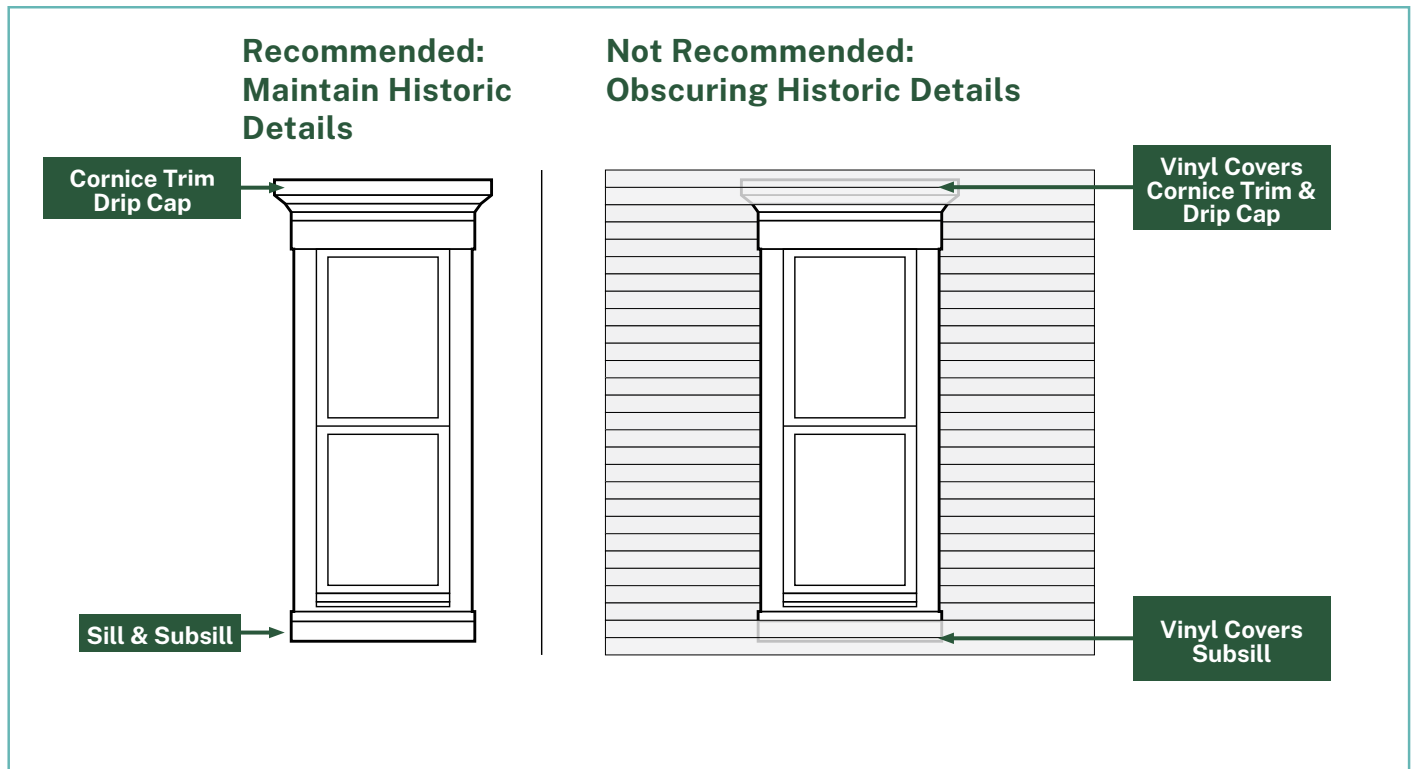
Installation of modern siding often obscures or results in the removal of character defining details.

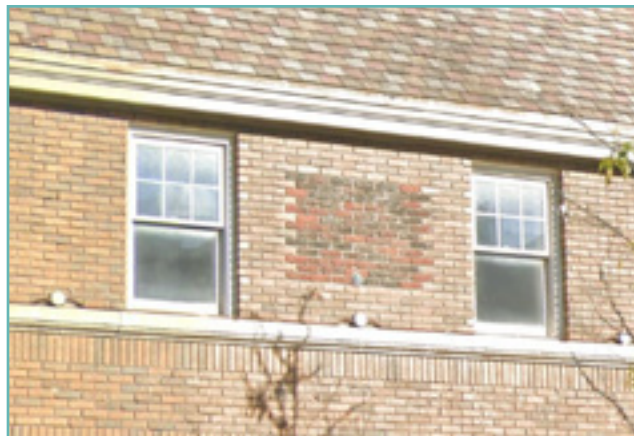
Patching historic brick with modern brick of a different color or texture on a highly visible elevation is not recommended. City of Birmingham, photo by KDG, 2022.

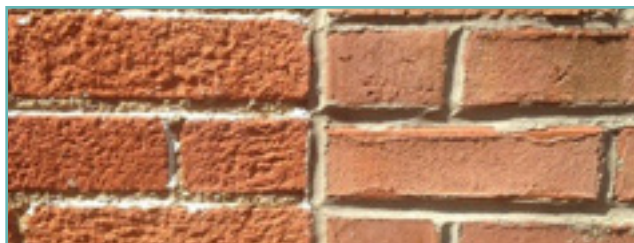
Sandblasting and other abrasive cleaning methods will severely damage historic masonry as seen here at left. The hard exterior shell of the brick, known as the fire skin, has been destroyed. This brick will begin taking on water and will deteriorate quickly. City of Birmingham, photo by KDG, 2022.

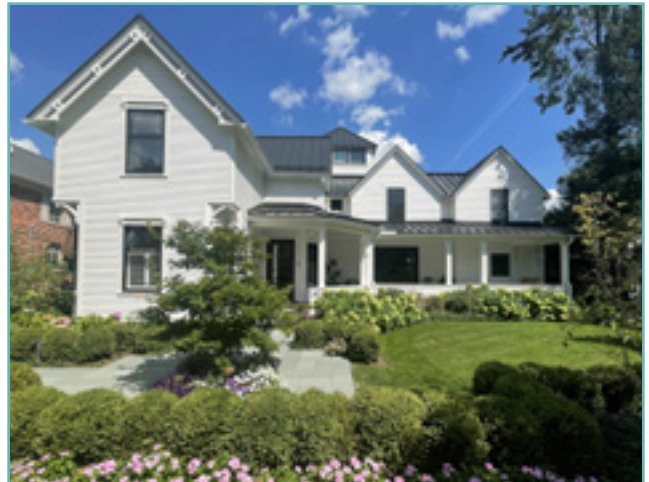
Installation of a standing seam metal roof is not recommended on historic houses where a metal roof did not exist historically. City of Birmingham, photo by KDG, 2022.
