AGENDA
BIRMINGHAM HISTORIC DISTRICT COMMISSION
WEDNESDAY – JUNE 7, 2023
BIRMINGHAM CITY HALL, 151 MARTIN ST., COMMISSION ROOM #205*
******* 7:00 PM*******

**Historic District Commission
Minutes Of May 17, 2023**

Historic District Design Guidelines

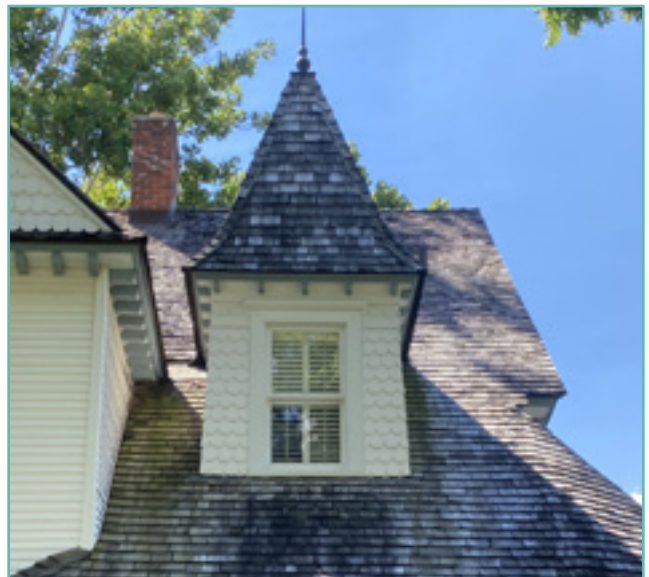
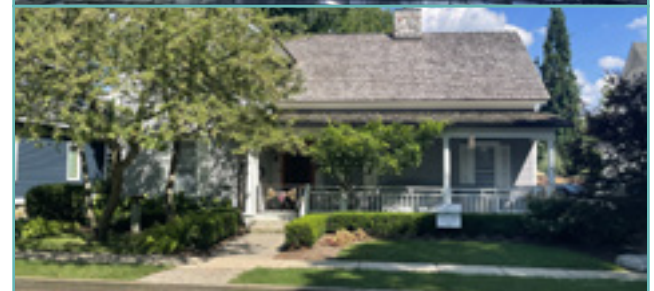
The maintenance, repair, and preservation of wood shingle roofs is recommended. City of Birmingham, photo by KDG, 2022.

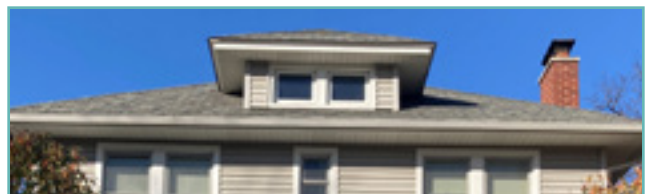
Hipped roof dormers are character defining elements of Craftsman style and Prairie style houses. City of Birmingham, photo by KDG, 2022.

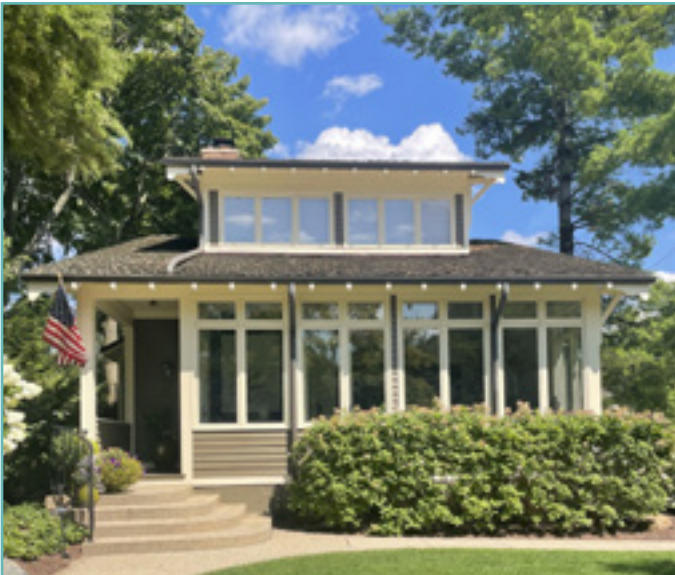
It is not recommended that porches be enclosed, especially on the façade or highly visible elevations. City of Birmingham, photo by KDG, 2022.

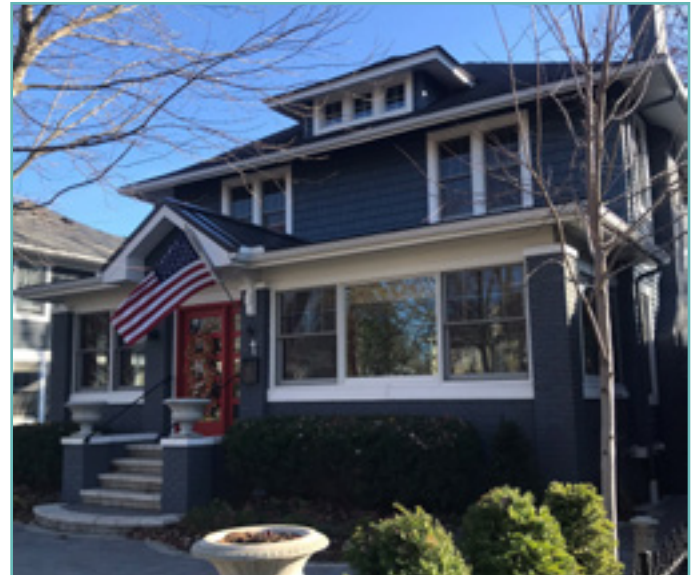
It is not recommended that porches be enclosed, especially on the façade or highly visible elevations. City of Birmingham, photo by KDG, 2022.

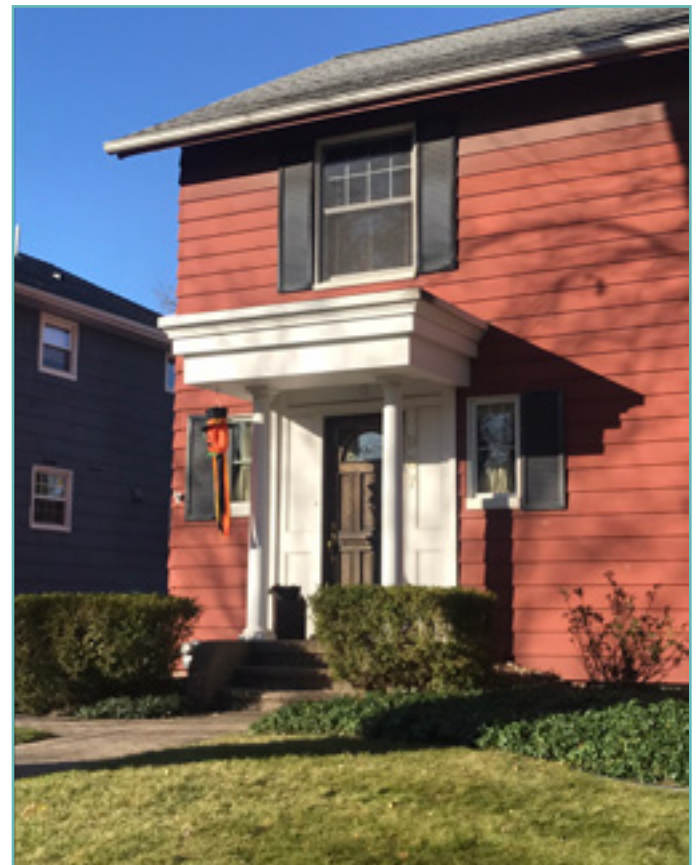
Replacement of the original porch columns is acceptable if the original columns are deteriorated beyond repair; however, it is recommended that replacement columns match the originals in terms of dimensions and detail. In the example above, the replacement columns are too slender for the porch. City of Birmingham, photo by KDG, 2022.

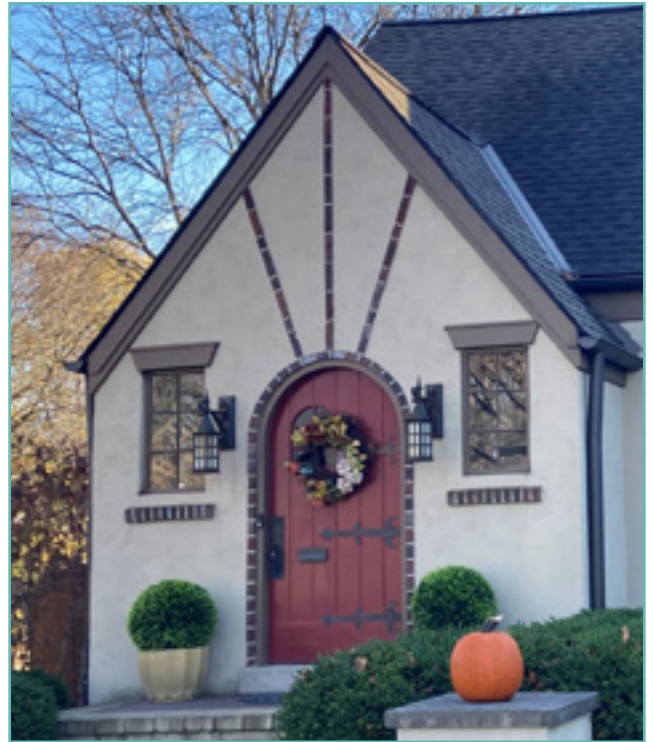
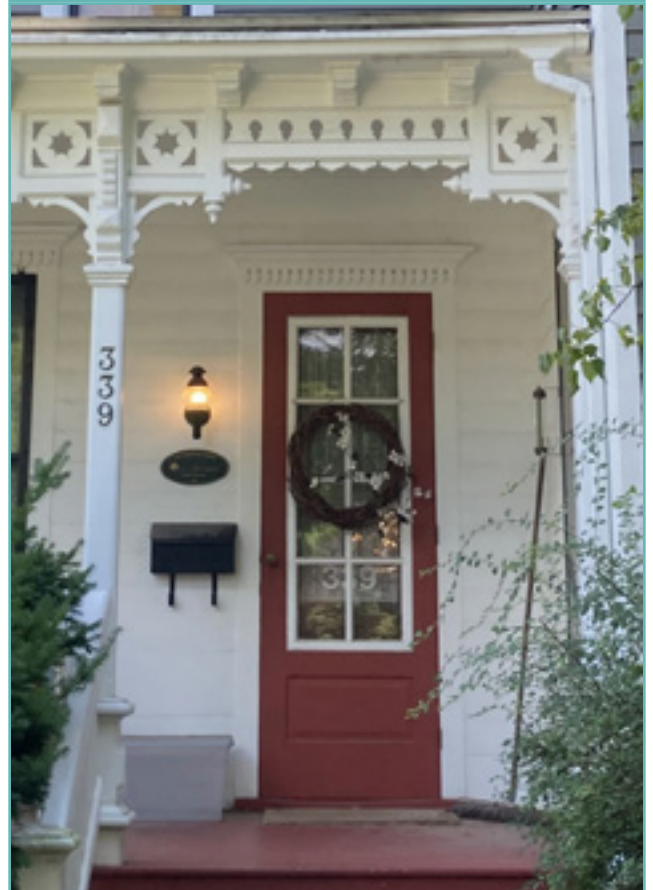
The use of exterior lighting as shown on this page is recommended. The design of the fixtures complements the style of each house, the size of each fixture is appropriate, and the lights are not overly bright. City of Birmingham, photos by KDG, 2022.

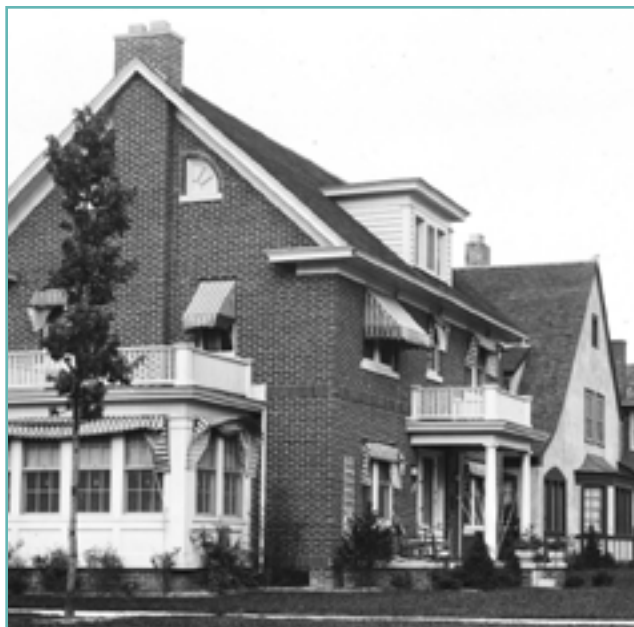
Historic residential awnings are illustrated in the above image. Triangular, striped fabric awnings with scalloped edges were commonly used on residences. Image is used courtesy of the Walter P. Reuther Library, Archives of Labor and Urban Affairs, Wayne State University. City of Birmingham, photo by KDG, 2022.

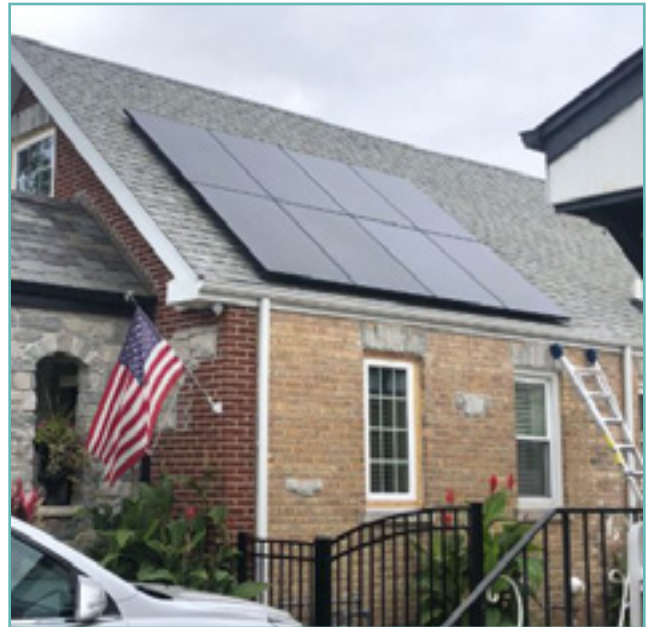
Solar panels placed in an acceptable location on the secondary plane of a side gabled roof, Google Image, 2022.

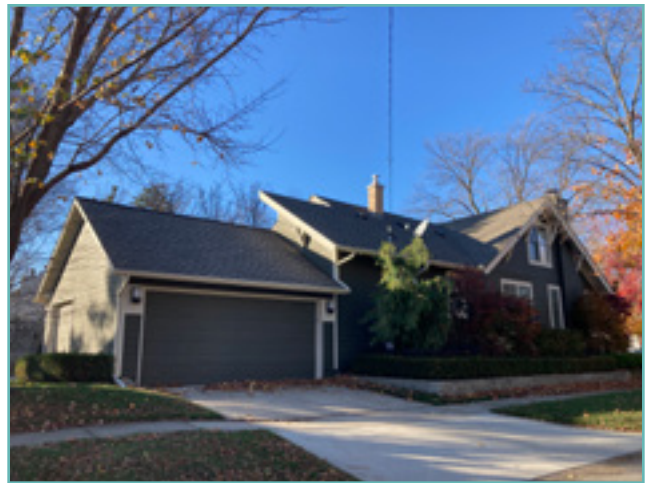
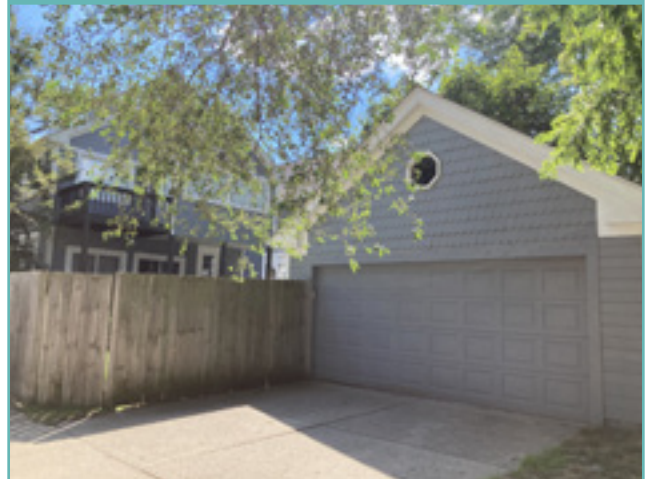
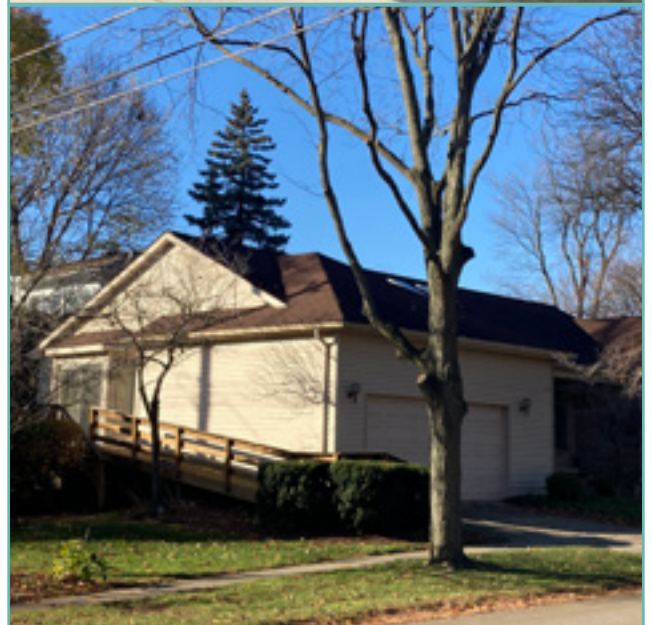
It is recommended that accessory structures such as garages be secondary to the historic house and complementary in terms of scale, design, and color scheme. In the images above the garages are located at the rear of the property, behind the historic house. City of Birmingham, photos by KDG, 2022.

The recommended garage placement is at the rear of the property, where it is secondary to the house and may be visible from the street, as this placement follows historic norms of garage placement from the early-twentieth century. It is acceptable to attach the garage to the rear of the historic house. It is not recommended that the garage be placed near the front of the house in a highly visible location as the garage then detracts from the primacy of the historic house.

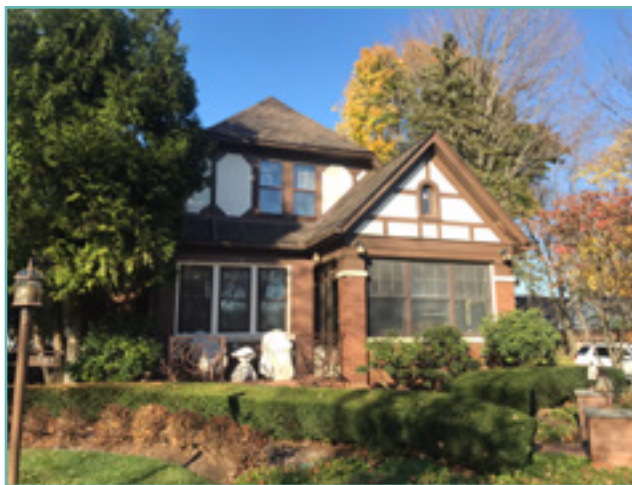
The screened and glazed porch of this Tudor Revival style house may have originally been open. City of Birmingham, photo by KDG, 2022.

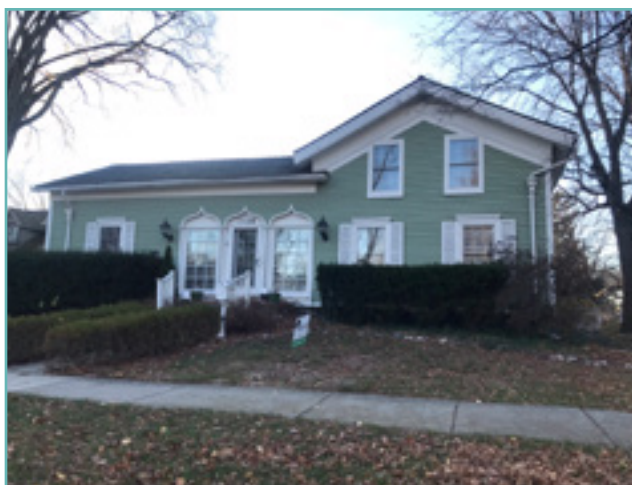
The enclosure of the historic, ogee arch loggia on this Greek Revival house occurred long ago and may now be considered part of the historic character of the house.

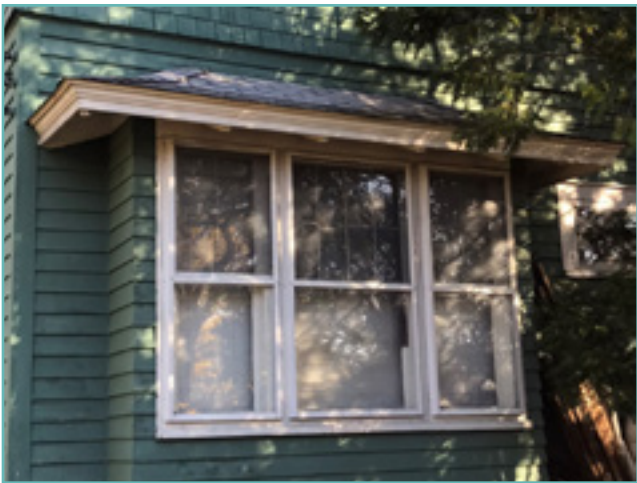
Maintaining the paint of exterior wood materials is a key component of historic house maintenance. Here, the exterior wood cladding, wood window trim wood windows, and storm windows require basic maintenance to continue functioning properly. City of Birmingham, photos by KDG, 2022.

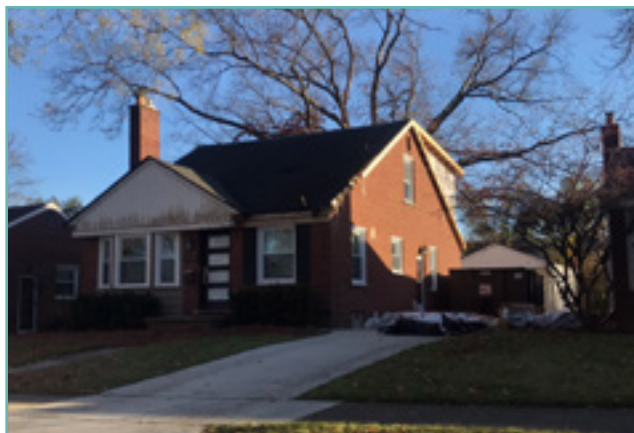
The addition of a large, shed roof dormer on the rear elevation is a recommended method for incorporating an addition into a historic resource. City of Birmingham, photo by KDG, 2022.

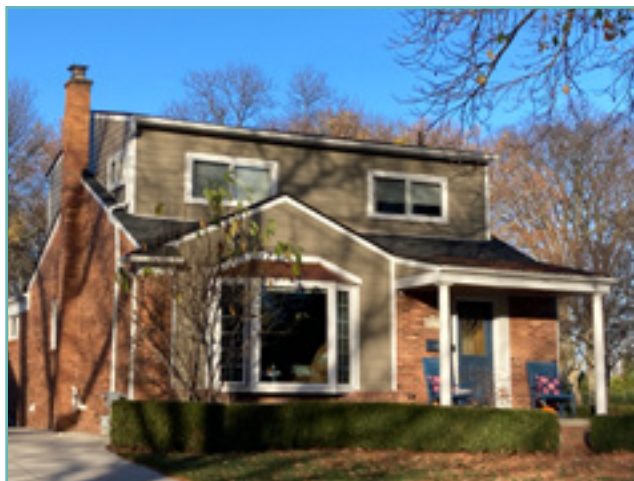
This second-story addition would not be recommended as it is highly visible. City of Birmingham, photo by KDG, 2022.

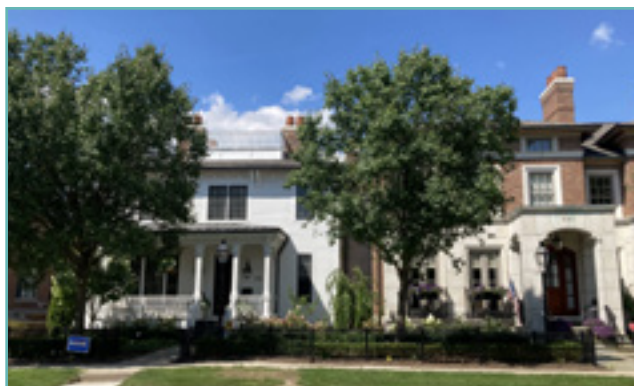
Incorporating an addition onto the side elevation of a historic ensure the addition remains secondary to the house is acceptable. City of Birmingham, photo by KDG, 2022.

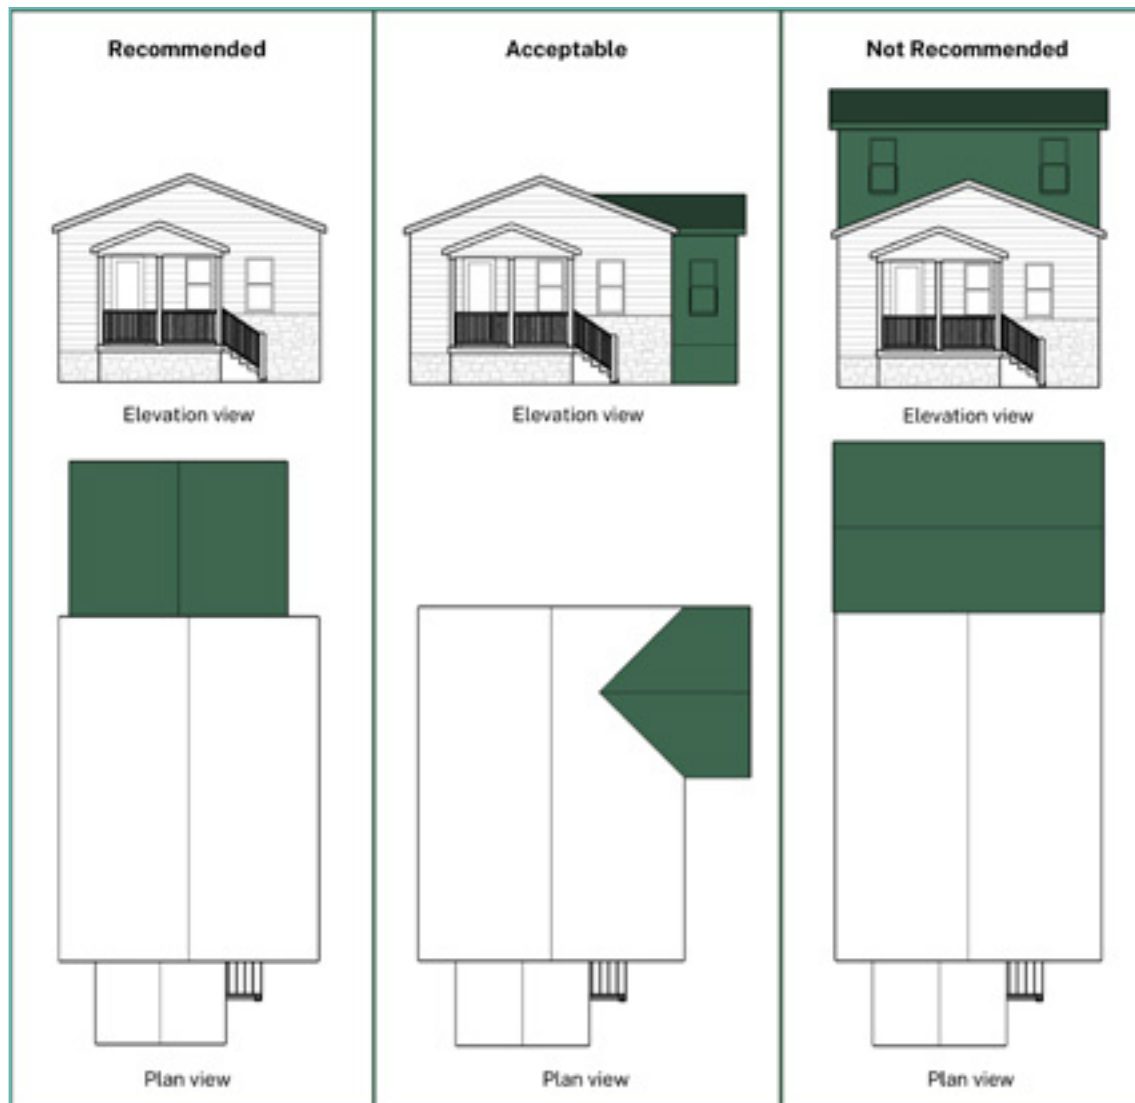
Additions located at the rear of a house are recommended, small scale additions to the side elevations of a house are acceptable, and additions that are highly visible and subsume the historic house are not recommended.

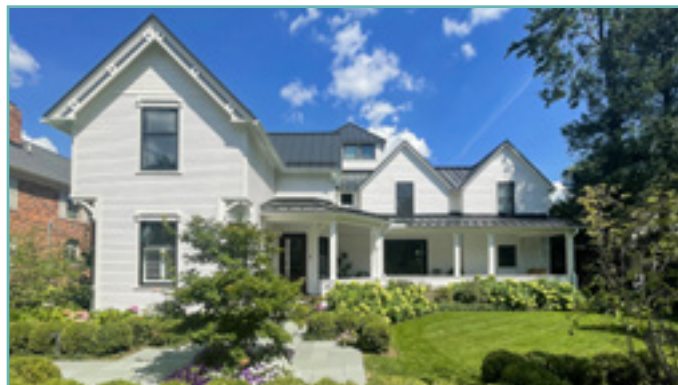
The right-half of the house pictured here is an addition that overwhelms and subsumes the historic residence. Additions that make the historic portion of the house appear secondary are not recommended. City of Birmingham, photo by KDG, 2022.

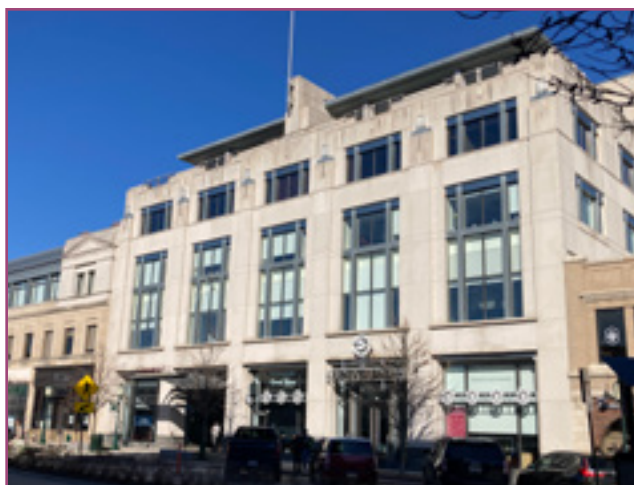
The scale and massing of this newer, non-historic building significantly differs in size from the surrounding Central Business District Historic District as it is both taller than any of the historic structures and much larger. The historic buildings in the Central Business District are primarily comprised of two and three story buildings. City of Birmingham, photo by KDG, 2022.

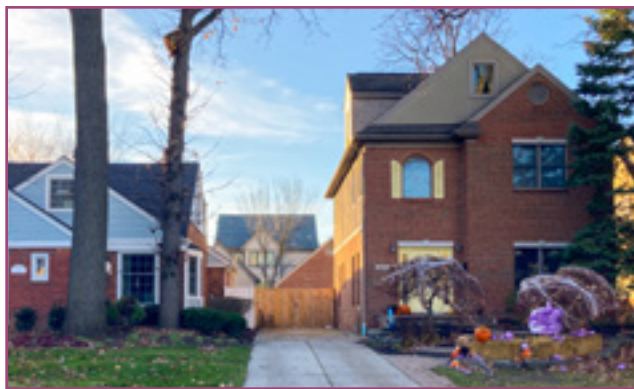
Construction of the new home at right would not be recommended in a historic district containing modestly scaled homes, as shown at left. The scale of the new construction overwhelms neighboring homes. City of Birmingham, photo by KDG, 2022.

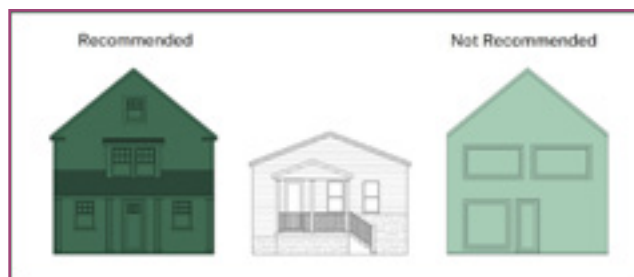
The facades of historic residential buildings, including the arrangement of doors and windows, lend character to residential historic districts. It is recommended that new construction complement the existing rhythmic pattern of the facades of existing houses. It is not recommended that the façade of new construction include overly large windows, windowless expanses, or an arrangement of exterior doors and windows that disrupts the existing streetscape.

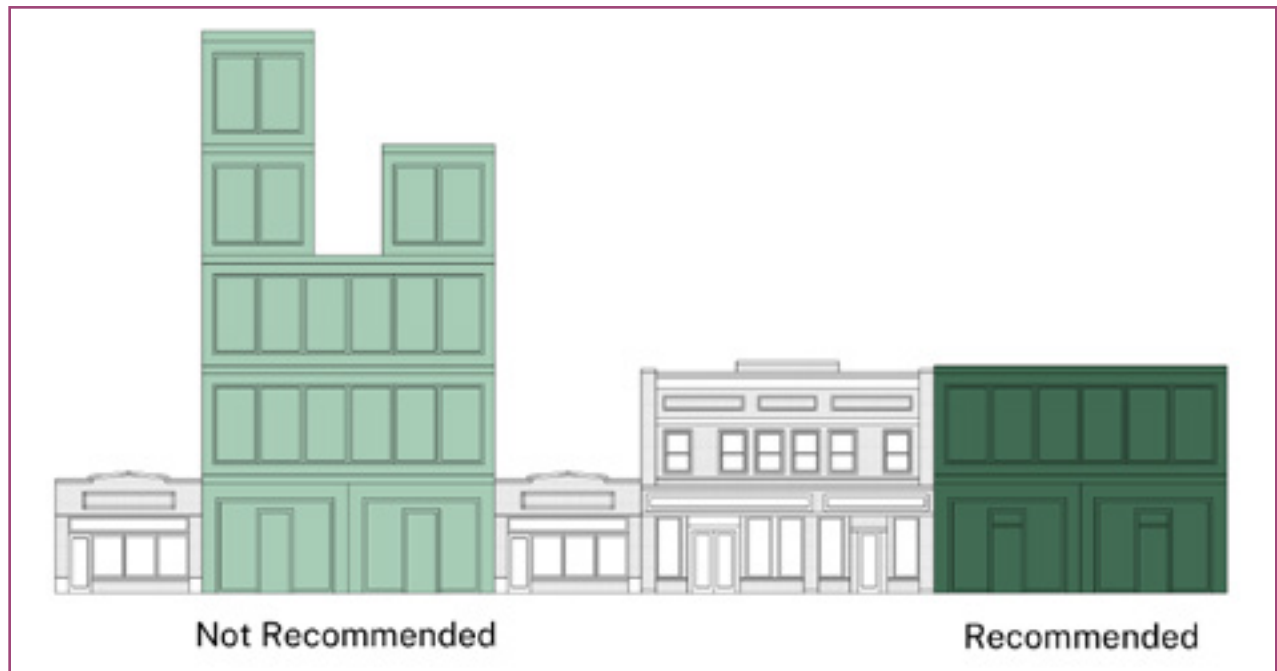
It is recommended that new construction in historic commercial districts take cues from existing historic buildings concerning massing, by ensuring that roof types and shapes of new construction are similar to existing buildings. It is not recommended that new construction employ shapes and roof types that do not complement neighboring buildings.

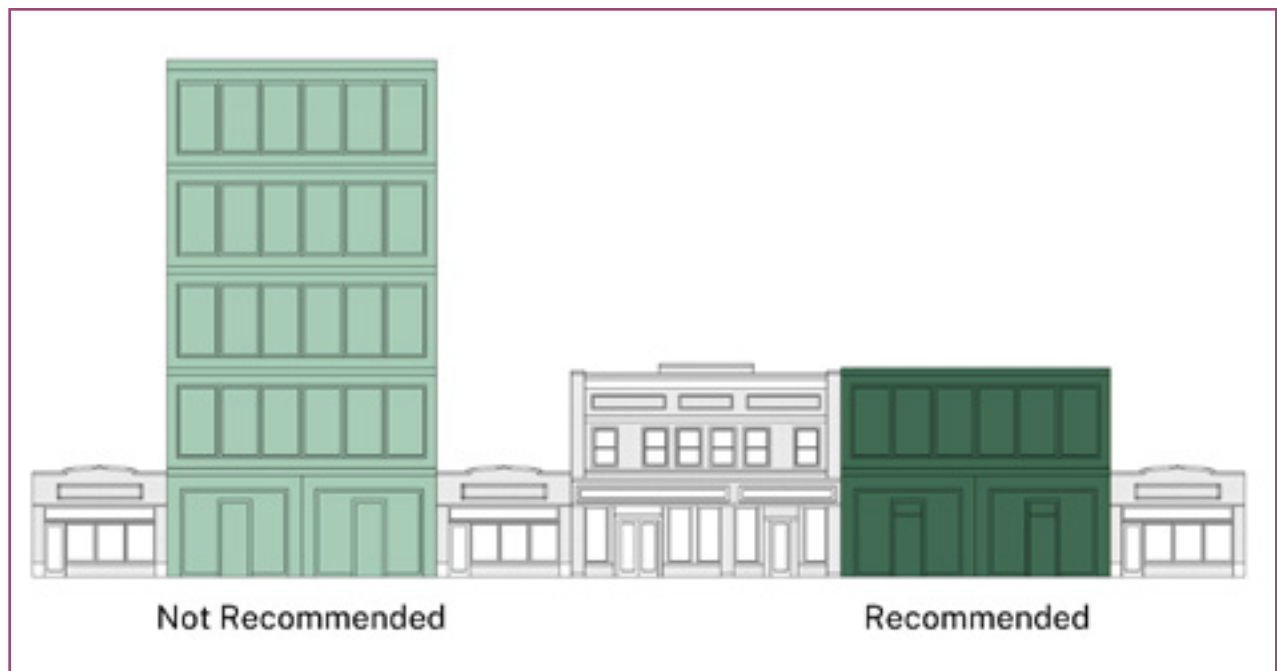
It is recommended that new construction in historic commercial districts respect the scale of existing buildings. Most of the historic commercial buildings in Birmingham's Central Business Historic District are 1 to 3 stories tall; therefore, new construction should stay within this height range. It is not recommended that new construction be at such a scale that neighboring buildings are overwhelmed.

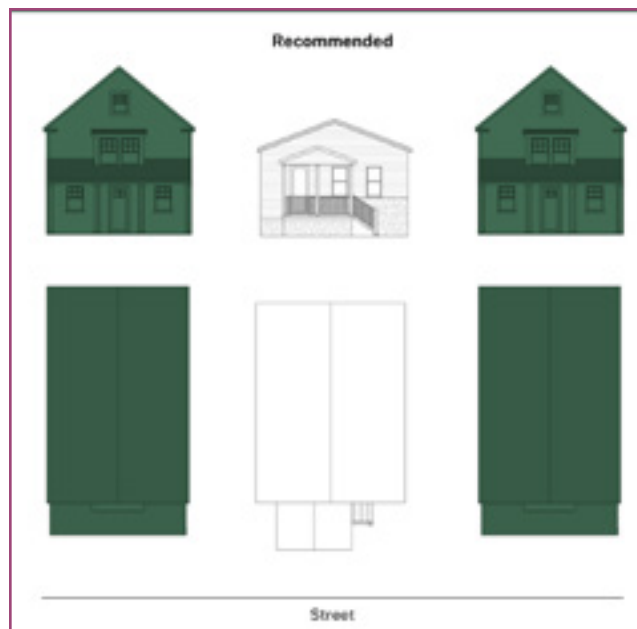
It is recommended that new construction in residential settings take cues from existing housing. In this example, the new construction shown in green is complementary in scale, shape, massing, and setback from the street compared to the existing house in the center.

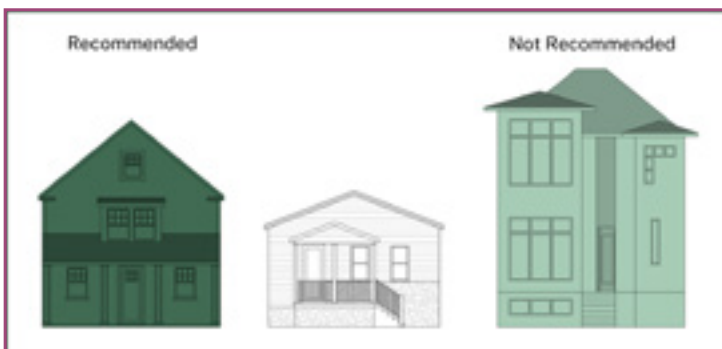
It is recommended that new construction in historic residential districts take cues from existing historic residences concerning scale and massing. It is recommended that roof types of new construction are similar to existing housing, and that the scale of new construction does not overwhelm neighboring houses. It is not recommended that new construction be of such a scale that it overwhelms existing houses or that its massing alters the historic streetscape.

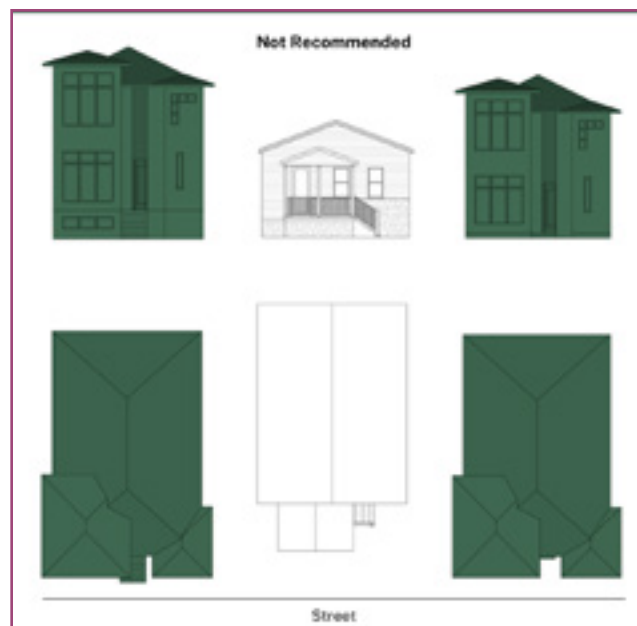
New residential construction, shown in green, is not recommended. The scale of the new construction overwhelms the existing housing and is not complementary in terms of massing, shape, or setback from the street. This type of new construction negatively impacts the character of historic neighborhoods.

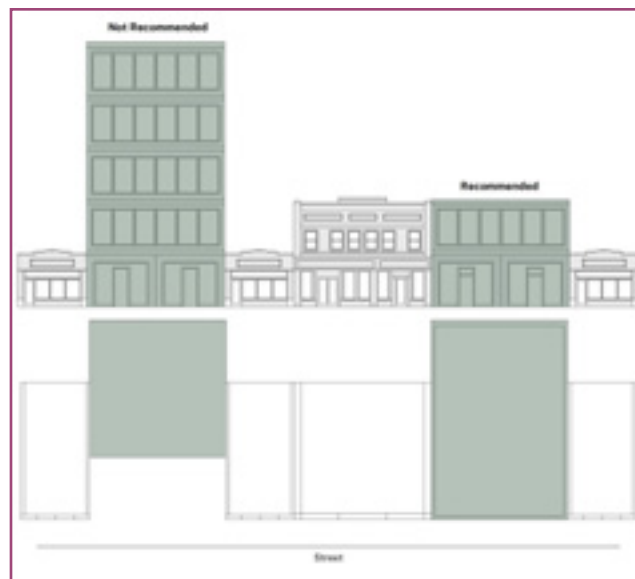
New construction in historic commercial districts should be complementary in size, scale, and façade composition to existing commercial buildings. Construction of buildings that are out of scale in terms of height to surrounding buildings is not recommended, whereas new construction that is comparable in terms of height is recommended.

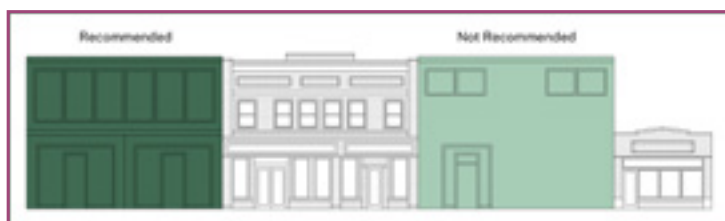
The facades of historic commercial buildings are usually characterized by their expanses of windows and presence of storefronts. It is recommended that new construction complement these historic norms with the inclusion of windows and storefronts that complement the rhythmic pattern of the existing buildings. It is not recommended that the façade of new construction include large, windowless expanses, exterior doors without a surrounding storefront, or a façade composition that disrupts the existing streetscape.

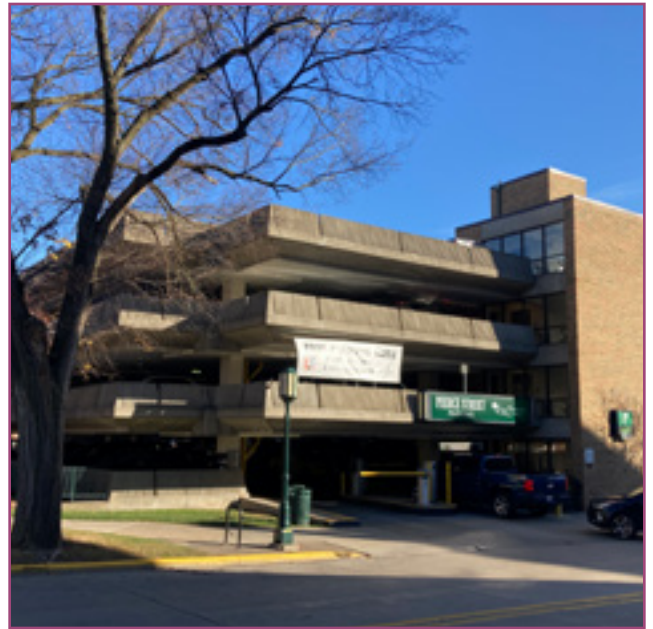
The Pierce Street Garage, a Brutalist style parking structure, would not be recommended in a historic district since it does not incorporate street level commercial space. City of Birmingham, photo by KDG, 2022.

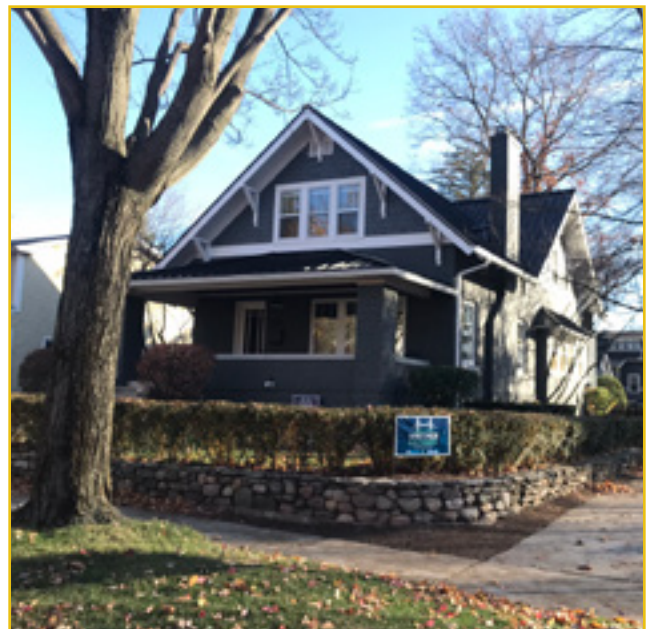
Maintaining and retaining site features like this stone wall contribute to the character of the neighborhood. City of Birmingham, photo by KDG, 2022.

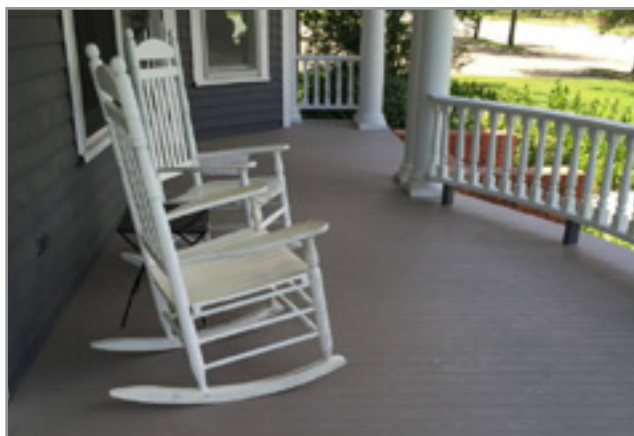
Selecting historically appropriate colors, dimensions, and textures can make the use of composite decking a viable alternative if repair or replacement of a historic wood porch or patio is not possible. Photo courtesy of Buck the Builder.

• **Composite Decking:** Composite decking is a popular alternative to exterior wood flooring and decking applications. Composite decking boards are the combination of two or more materials – typically wood fibers and a form of plastic. High density polyethylene (HDPE) or polyvinyl chloride (PVC) are mixed with wood fiber and chemical additives to create a strong and durable wood alternative. Composite decking is often resistant to fading and wear and tear of traditional wood decking although can be costly and has high rates of expansion and contraction to be considered during installation. Wood is preferred to composite decking but composite decking can be considered on applications that are on secondary or tertiary facades or minimally visible from the public right-of-way, for example a deck in the back yard.

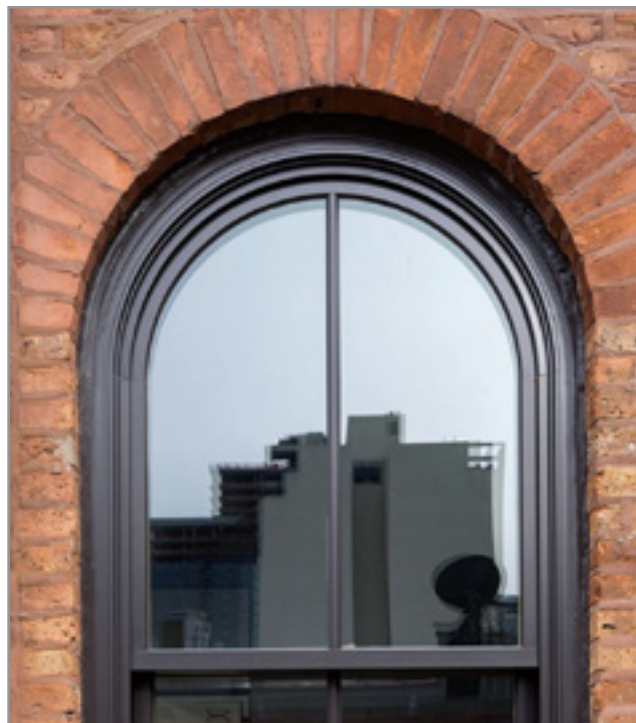
If repair or replacement of historic windows is not feasible, aluminum clad windows provide a potential solution that are capable of achieving the profile, depth, and colors of historic windows. Photo courtesy of AVI Windows and Doors.

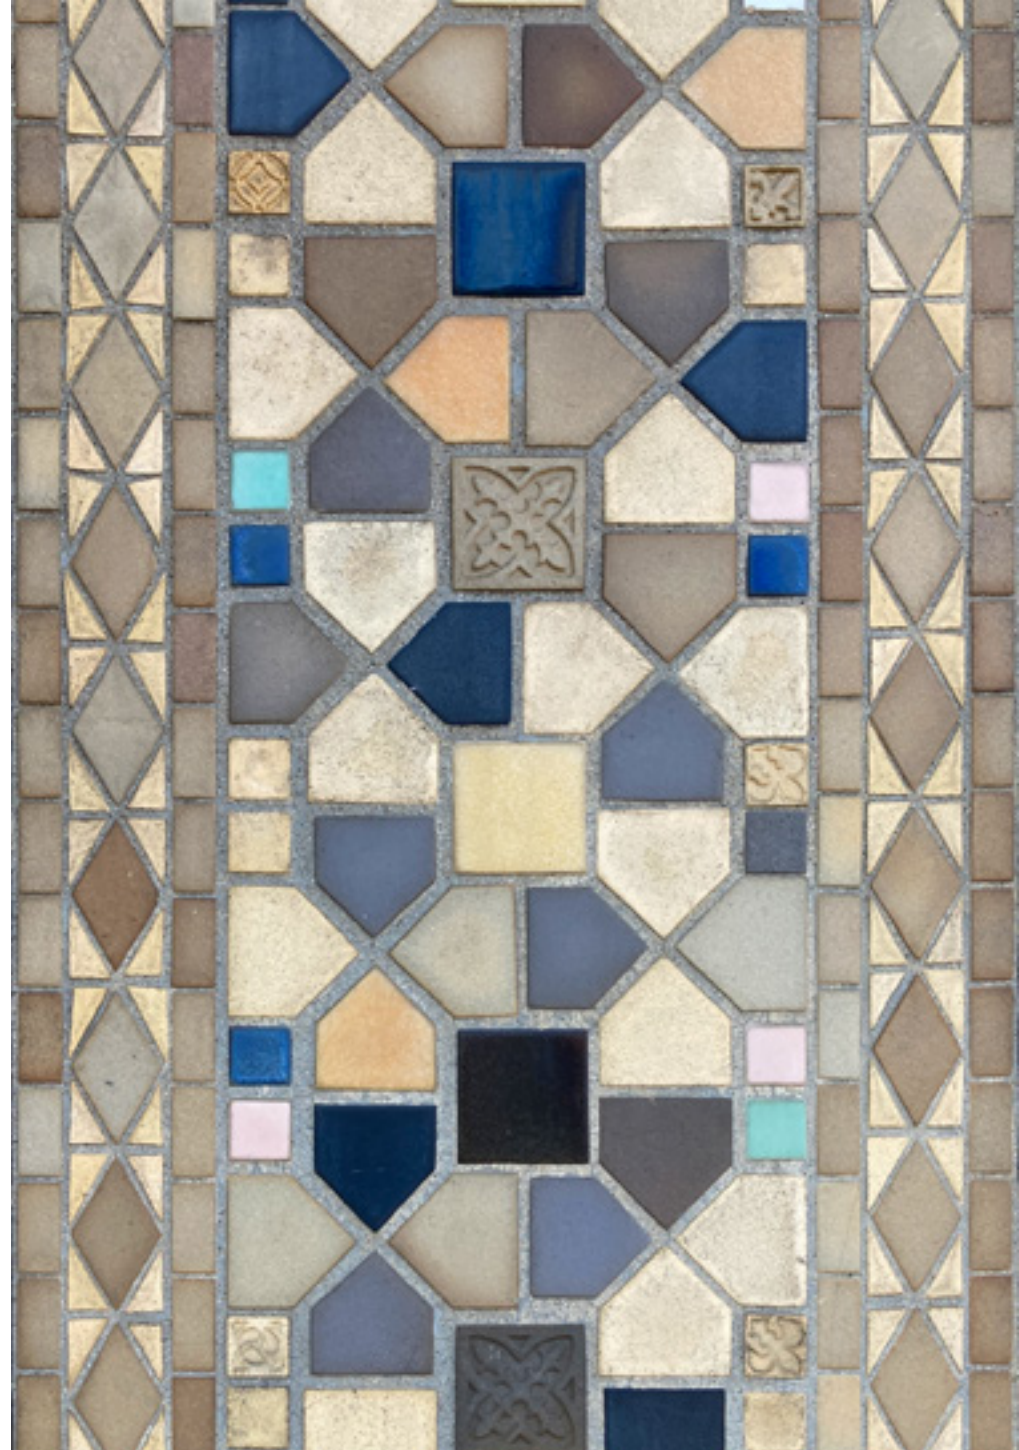
Historic Flint Faience tile on a building within Birmingham's Central Business Historic District, photo by KDG, 2022.

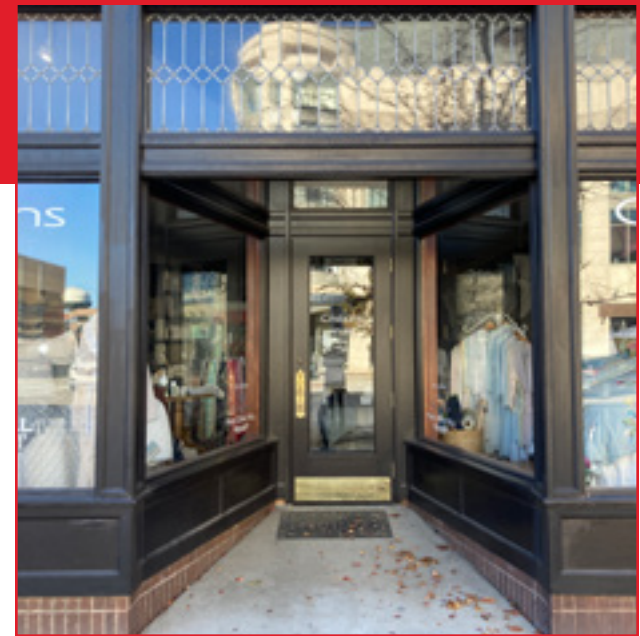
Preservation of historic storefront elements such as the recessed entry and leaded glass transoms is recommended. Central Business Historic District, City of Birmingham, photo by KDG, 2022.

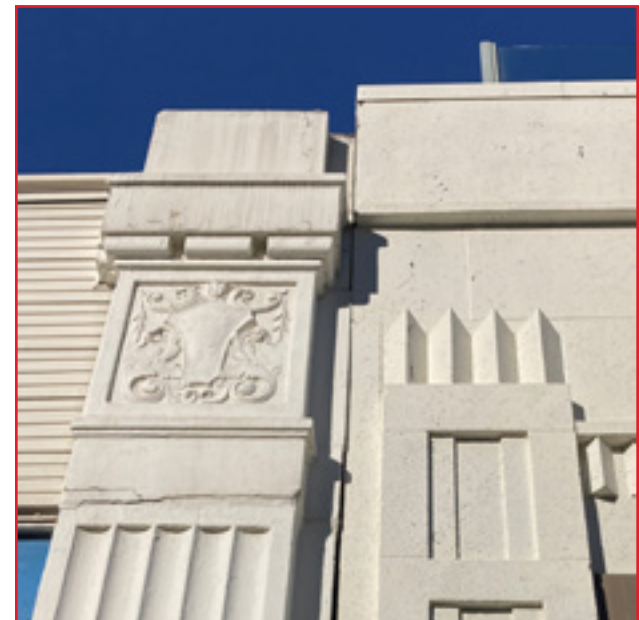
Historic exterior wall materials are often embellished with decoration and lends character to historic commercial areas. Central Business Historic District, City of Birmingham, photo by KDG, 2022.

Recommended: Identifying, maintaining and preserving historic wall materials. If wall material is deteriorated beyond repair, installing new material to match the historic material. Alternative or modern materials are only used as secondary materials, on new construction, or if historic materials are too deteriorated to repair or patch with in-kind materials.

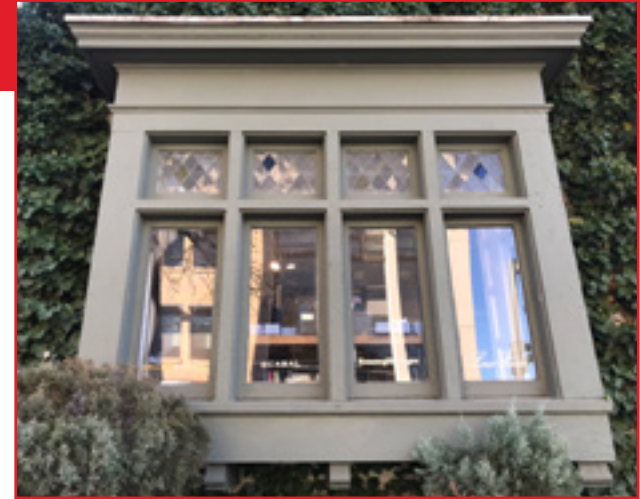
Regular maintenance such as painting exterior wood elements is a key component of historic building preservation. Central Business Historic District, City of Birmingham, photo by KDG, 2022.

Recommended: Developing and adhering to a maintenance schedule that involves the inspection of all historic materials and features for signs of damage or deterioration. A yearly assessment is ideal, as identifying issues early is critical in preserving historic materials and reducing the cost of repairs. Inspecting the building's envelope is key, such as assessing windows, the roof, gutters, and exterior cladding.

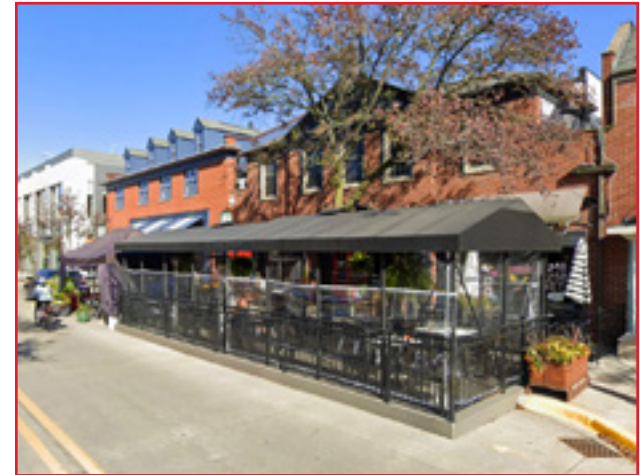
Sidewalk patio construction should be freestanding and not mounted or mechanically fastened to the façade, as shown here. Central Business Historic District, City of Birmingham, photo by KDG, 2022.

Recommended: Inclusion of a sidewalk café or patio in front of or behind a historic commercial building that does not damage any historic materials or obscure character defining features. The design of sidewalk features complements the style and design of the building. Sidewalk café and patio construction is freestanding and not mounted or mechanically fastened to façade.

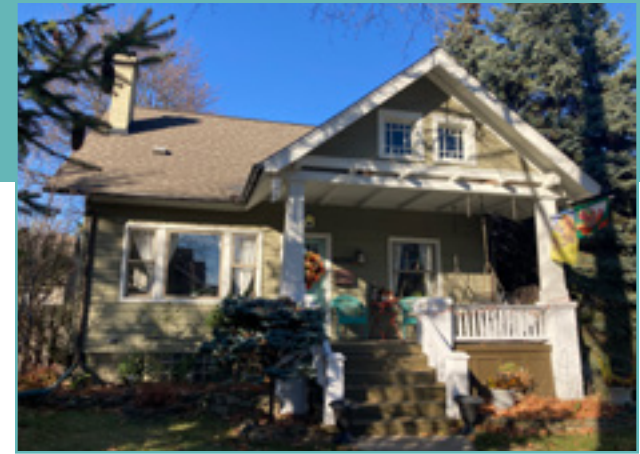
Preserving historic windows and maintaining historic exterior cladding preserves historic character in residential areas. City of Birmingham, photo by KDG, 2022.

Recommended: Identifying, maintaining, and preserving windows and their functional and decorative features. This includes features such as frames, sashes, glass, glazing patterns, trim, and pediments. Preserving the placement and size of windows on the façade and other elevations. Performing routine yearly maintenance and repairing historic windows by patching, splicing, consolidating, or otherwise reinforcing.

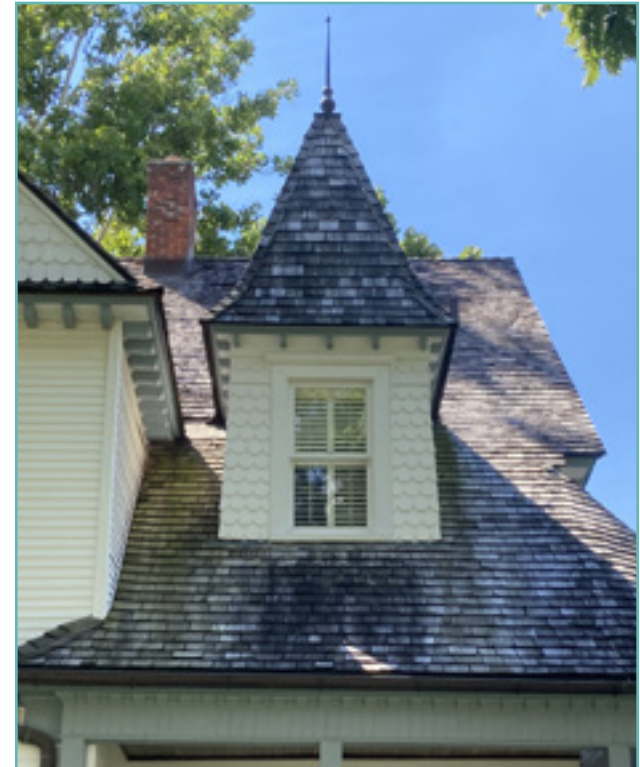
The prominent dormer and wood shingle roof are character defining features and should be preserved. Bates Street Historic District, City of Birmingham, photo by KDG, 2022.

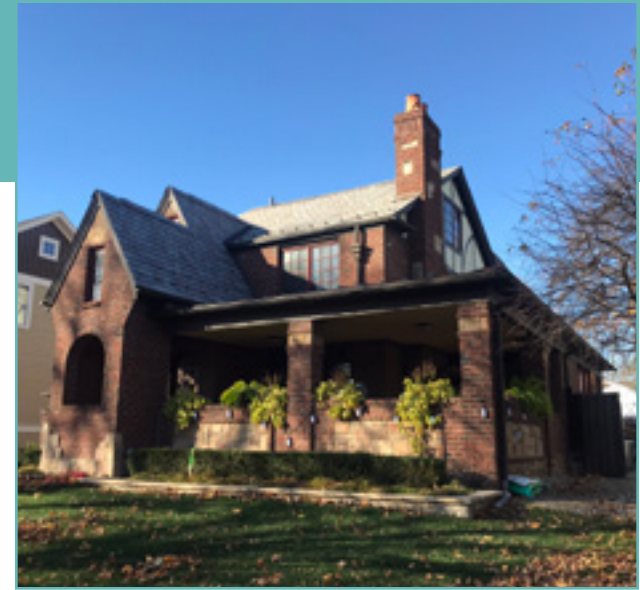
Porches were common components of historic residences and should be preserved. City of Birmingham, photo by KDG, 2022.

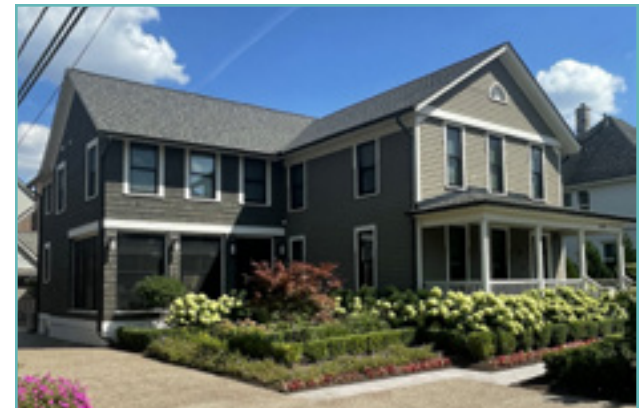
The placement of this addition to the left of the historic home is acceptable as it does not overwhelm this historic portion of the home and is placed near the rear. Bates Street Historic District, City of Birmingham, photo by KDG, 2022.

Acceptable: Constructing additions that minimally impact historic materials and design elements. Constructing an addition on a side elevation that reads as secondary to the historic house.

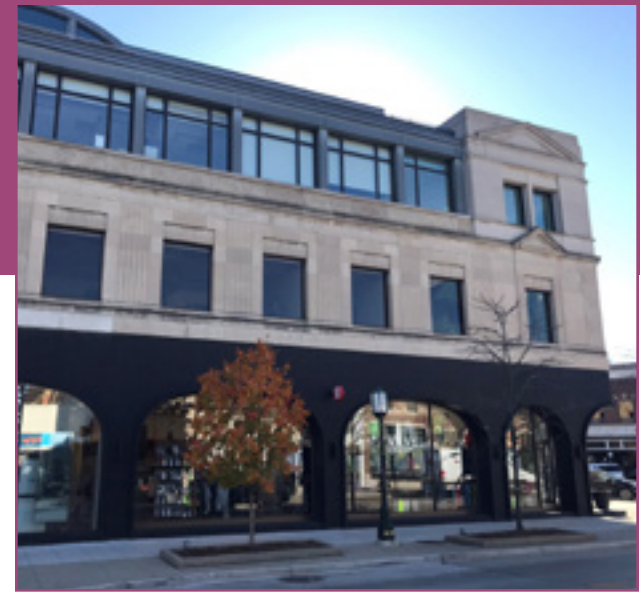
Large and prominent additions that are visible on the primary facades are not recommended, City of Birmingham, photo by KDG, 2022.

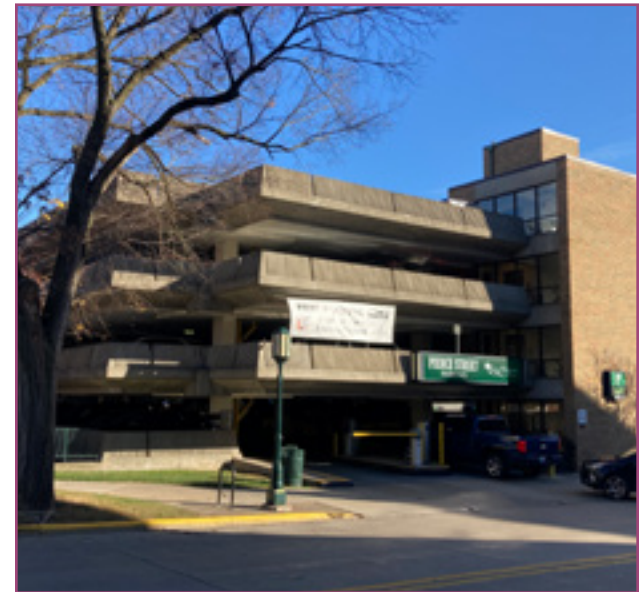
The Pierce Street Garage is a Brutalist style parking structure that, while not located in a historic district, is directly adjacent to the Shain Park Historic District. While the scale of the garage is compatible with the district, it does not incorporate street level commercial space which is a recommendation for newly built parking garages. City of Birmingham, photo by KDG, 2022.

Recommended: Designing and constructing new commercial structures or accessory structures that respect the existing scale, forms, setbacks, style, materials, and streetscape rhythm of existing historic resources. Utilizing exterior materials that are visually compatible with the surrounding buildings in terms of finish, color, texture, and design. Respecting the historic arrangement of site elements such as the location and spacing of the historic buildings, the sidewalk, and the street.
