AGENDA
BIRMINGHAM HISTORIC DISTRICT COMMISSION
WEDNESDAY – JUNE 7, 2023
BIRMINGHAM CITY HALL, 151 MARTIN ST., COMMISSION ROOM #205*
******* 7:00 PM*******

**Historic District Commission
Minutes Of May 17, 2023**

Historic District Design Guidelines

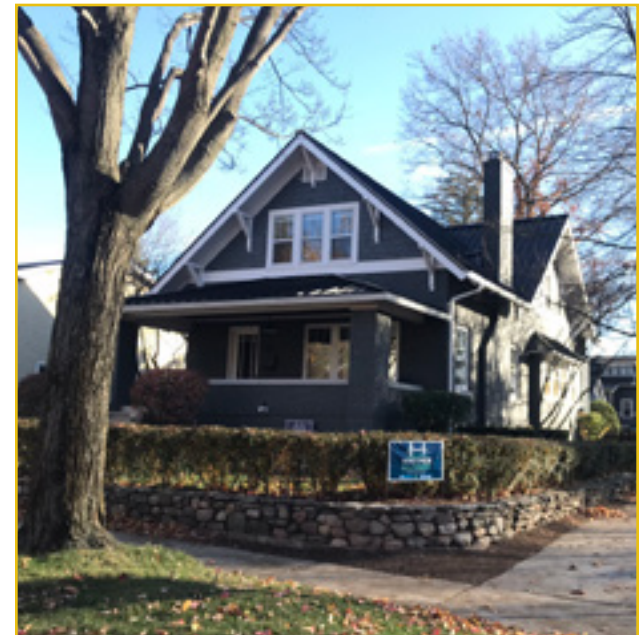
Maintaining and retaining site features like this stone wall contribute to the character of the neighborhood. City of Birmingham, photo by KDG, 2022.

Recommended: Identifying, maintaining, and preserving historic site features and landscapes such as fences, trees, hedges, stone walls, and open spaces. Repairing and maintaining historic fencing, walls, and other historic features. Locating new fences on the setback line and on the lot line. Retaining other historic site features such as stone curbs, decorative paving, designed grades and natural landforms, or hitching posts. Using hedges in place of fencing and placing vegetation along fencing.
