Basis of Design Report

ROCK ISLAND COVE SALT
MARSH RESTORATION

QUINCY, MA

PREPARED FOR:
THE CITY OF QUINCY DEPARTMENT OF
NATURAL RESOURCES

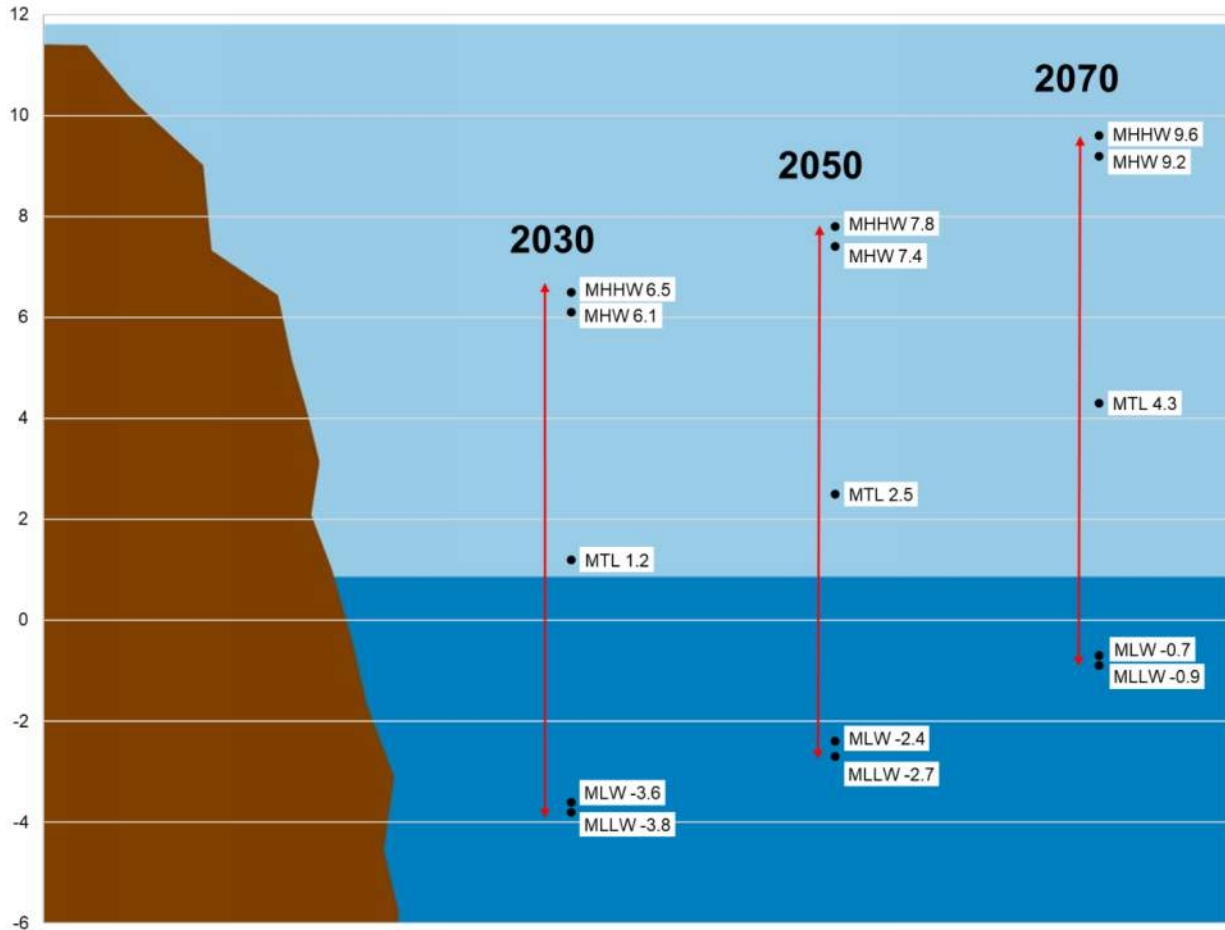
A tidal datum is a standard vertical elevation reference defined by certain phases of the tide. Tidal datums are often the reference for shoreline or coastal property boundaries where an elevation related to local sea level is needed. Projected tidal datums can be used to identify the elevation of tide levels along a shoreline in the future based on sea level rise. Figure 8 and Table 2 depict and describe the projected tidal datums for the assessment unit area for the 2030, 2050, and 2070 planning horizons.

Figure 8: Tidal Datums Visualization for the Assessment Unit Area

Tidal Datum	Elevation (ft-NAVD88)		
	2030	2050	2070
MHHW	6.5	7.8	9.6
MHW	6.1	7.4	9.2
MTL	1.2	2.5	4.3
MLW	-3.6	-2.4	-0.7
MLLW	-3.8	-2.7	-0.9

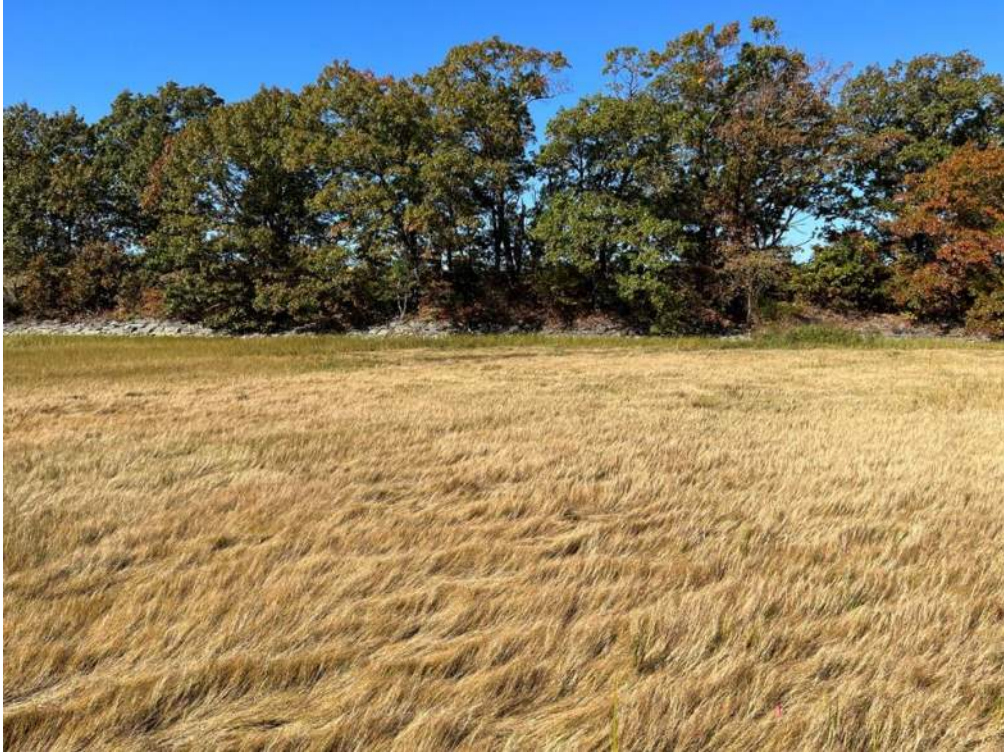
Photo 2: Man Made Wall Surrounding Portions of Marsh

It was determined that the north marsh has greater wetland disturbances present in comparison to the south marsh. The biggest disturbance causing metrics were observed to be an outcome of buffer encroachment, tidal restrictions (the main cause being the culvert and roadways placements), dense ditching crab burrow density (more present in north marsh), fill within the wetland (the adjacent dike surrounding the marsh (See Photo 2), the at grade access path adjacent to Lind Street (See Photo 3) and fill placed within south marsh), and edge erosion being more present in the north marsh system (specifically adjacent to the Rockland Street culvert).

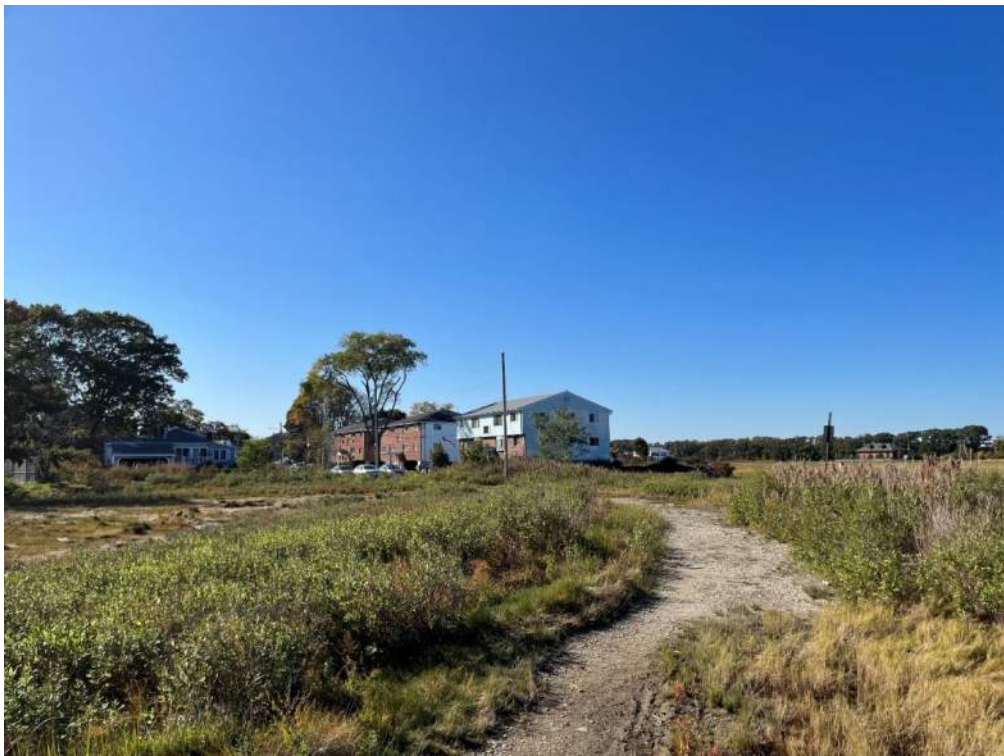
Photo 3: Man Made At-Grade Access Path Adjacent to Lind Street

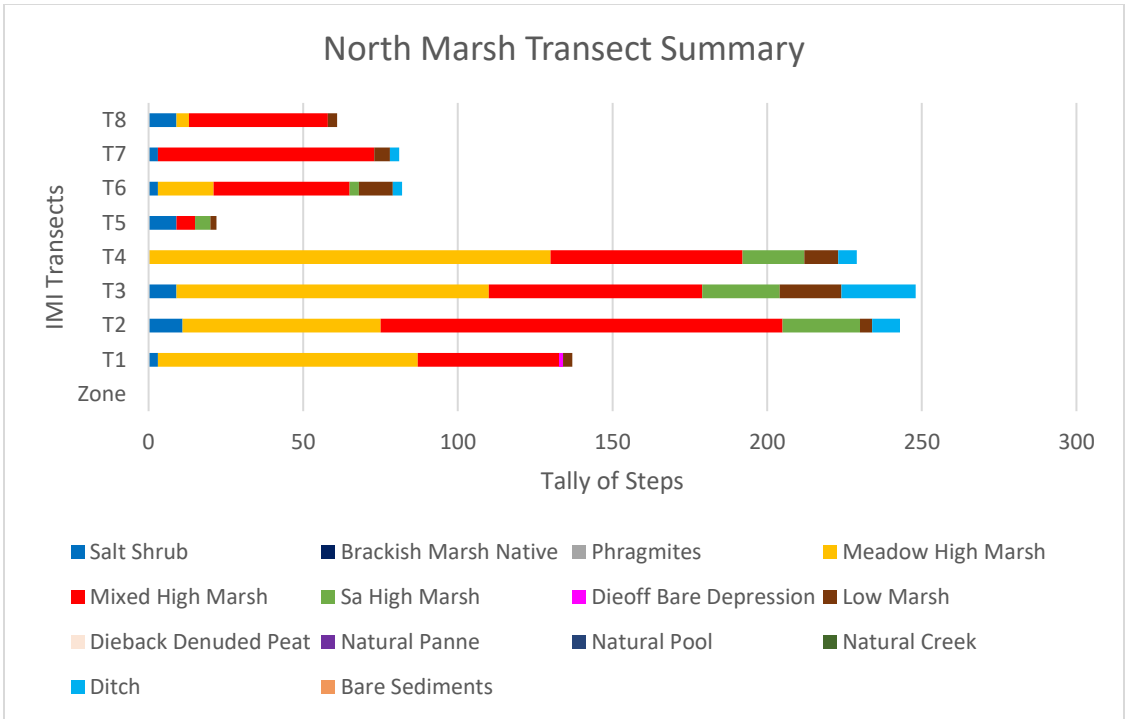
Figure 9: North Marsh Salt Marsh Cover Tally

Both sections of the salt marsh resulted in similar Index of Marsh Integrity Scores (IMI). The IMI scales the marsh on a scale of 1 (most degraded condition) to 9 (least degraded conditions being an undisturbed New England Marsh). The north marsh's IMI score came out to be 7.88 and the south marsh's IMI score came out to be 7.44 leading to an average of the combined marsh system to total 7.66. This index results provide insight that the Rock Island Cove Salt Marsh is in the higher percentile of salt marsh integrity meaning it is a lower degraded system.

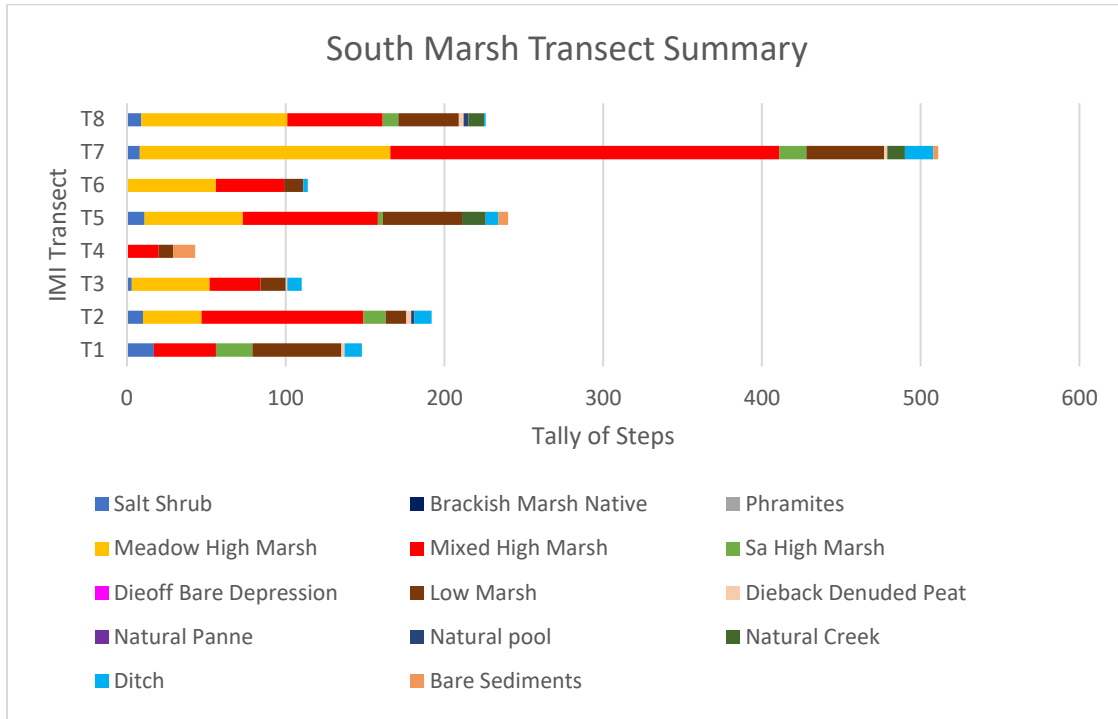
Figure 10: South Marsh Salt Marsh Cover Tally

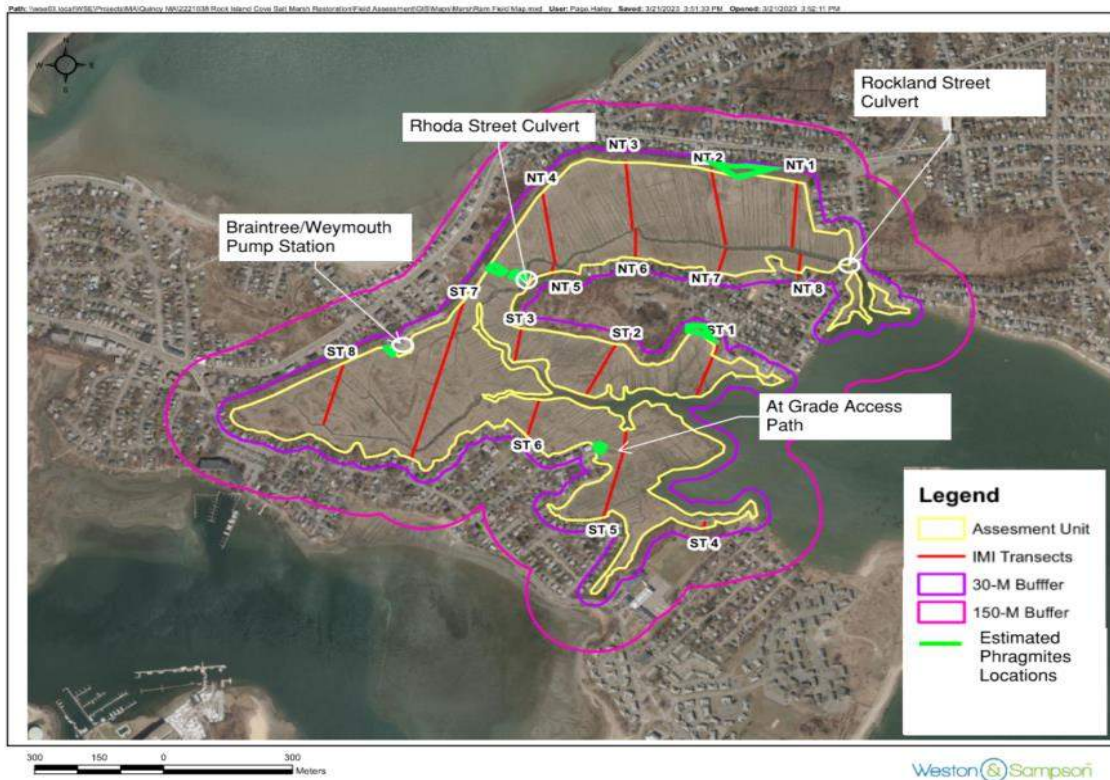
During the field investigation, the only invasive species observed on site was *Phragmites australis*. Areas located closer to residential back yards, next to the at grad path located at the end of Lind Street, adjacent areas to the Rhoda Street culvert and adjacent to Braintree/Weymouth pumping station were their presence of the invasive species (See Figure 11).

Figure 11: Approximate *Phragmites australis* locations

The invasive species are located in areas in the high marsh habitat and extend into adjacent uplands in areas where the species access to freshwater inputs. If the City looked to pursue to increase the movement of the freshwater in the high marsh habitat adjacent to the uplands this could lead to a reduction in the presence of invasives.

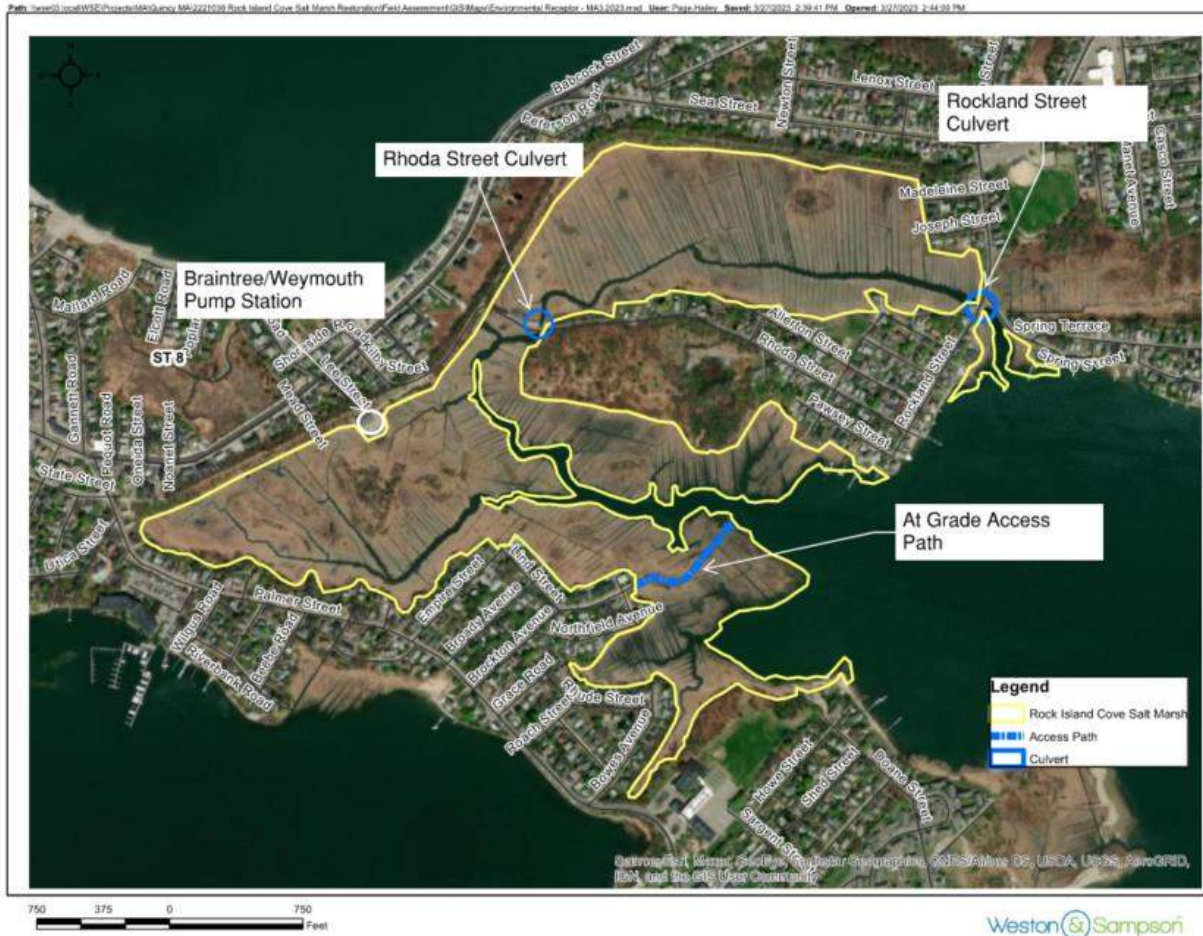
Possible tidal restriction areas are limited to the at-grade path located adjacent to Lind Street, the man-made wall/dike (located at landward edge of marsh system), and the Rhoda Street and Rockland Street Culverts. The main tidal restriction of this site is due to the placement of roads and culverts to allow flow underneath the roadways (Rhoda Street and Rockland Street Culvert). See Figure 12.

Figure 12: Possible Tidal Restrictions Map

The main tidal restriction in this system has been identified as the Rockland Street Culvert and at-grade path adjacent to Lind Street in which are scoped to be two of the main focuses of restoration efforts.

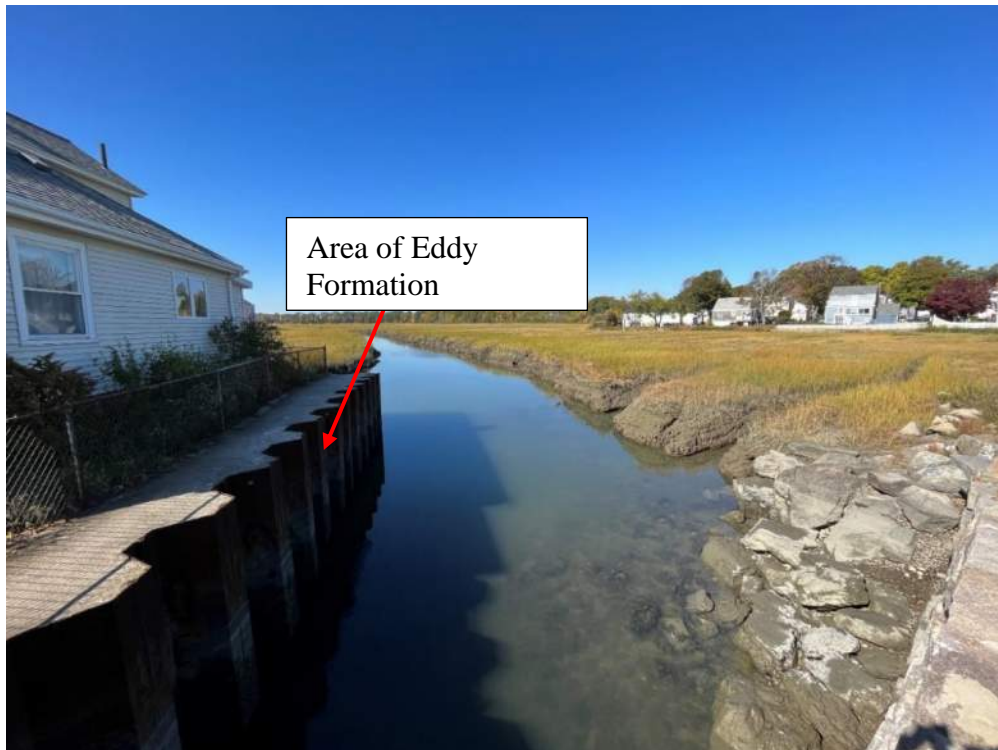
Additionally, through the assessment a bulkhead was noted upstream of the Rockland Street culvert, and it was observed that an eddy is being formed as the tidal creek flows through and gets caught in between the end of the bulkhead and marsh system (See Photo 4). This area can be considered a potential area for restoration activities to take place.

Photo 4: Upstream of Rockland Street Culvert

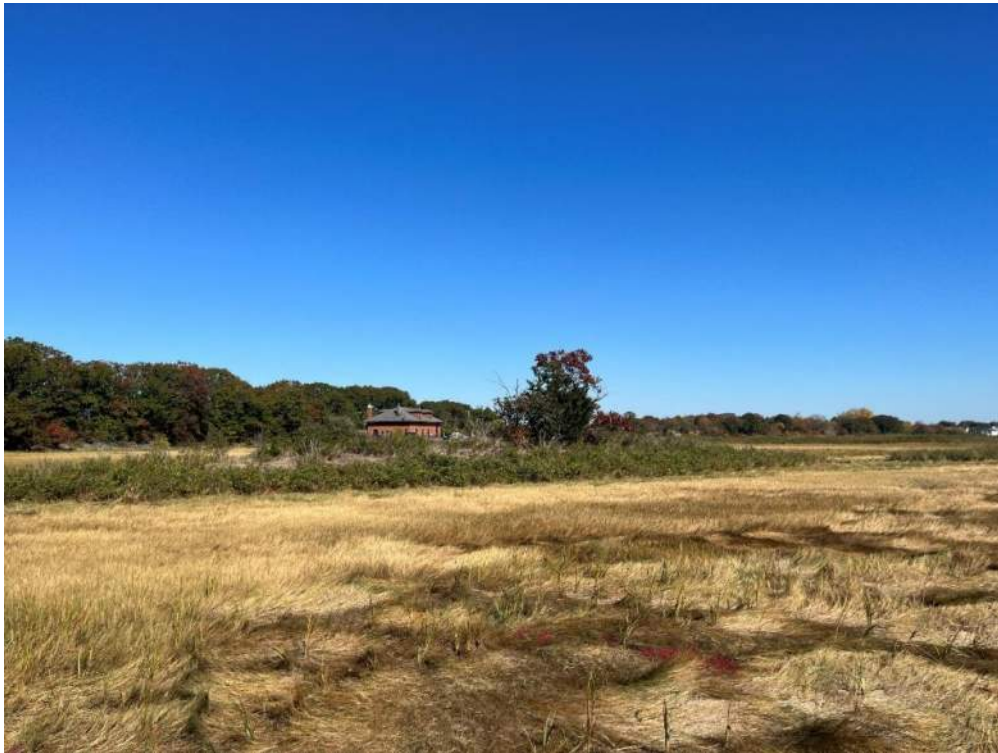
The south marsh contains fill within the marsh system that has potential to be removed. However, there is a dike surrounding the marsh system with a man-made wall which makes this a difficult candidate for fill removal. However, as shown in Figure 13, there is an area located in the middle of the south marsh system that could be considered for removal and allow approximately 2,100 SF of area for additional low marsh restoration. See photo 5 below.

Photo 5: Fill within Marsh System

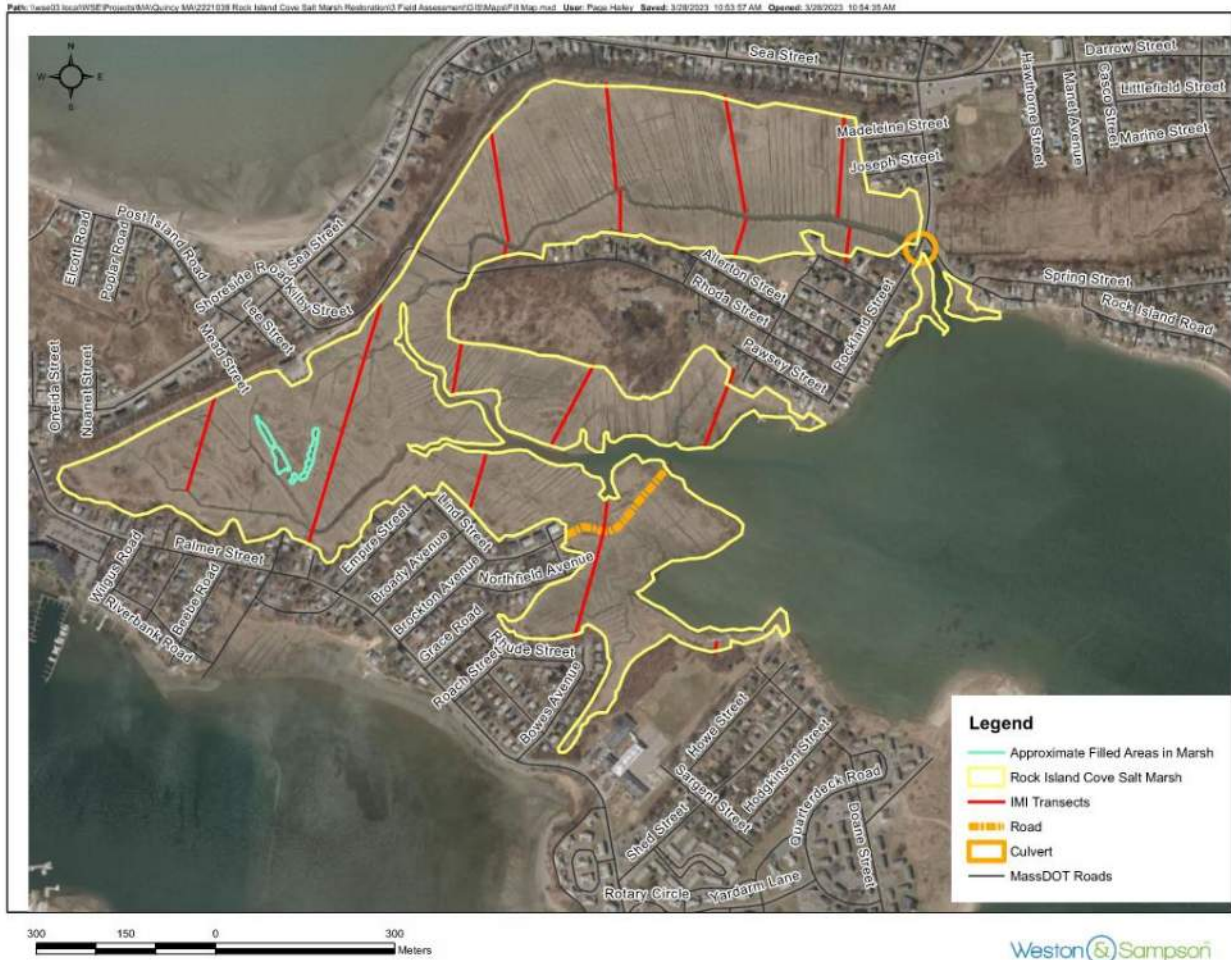
Figure 13: Fill Within Rock Island Cove Salt Marsh

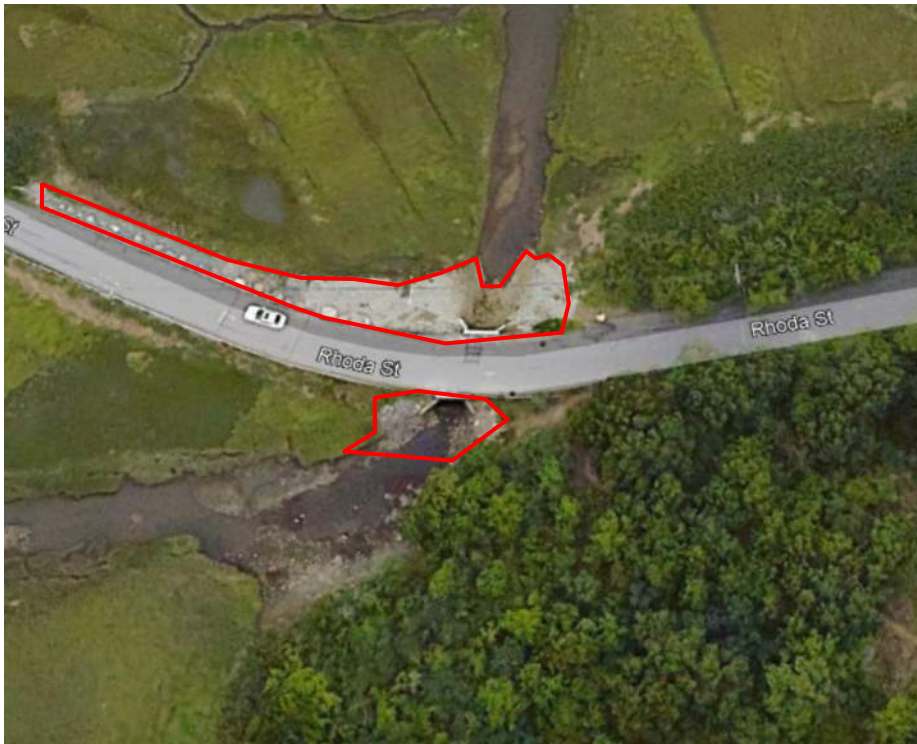
The area of the Rhoda Street Culvert currently exhibits the use of excessive riprap stone for stabilization on the marsh surface, roadway embankment, and inside the channel on both sides. The team has assessed that this stone is not necessary and is exacerbating the growth of *Phragmites australis*. It is proposed that this stone should be removed/reused thoughtfully, and existing surfaces restored to their proper habitat type using natural techniques and materials. See Figure 24 below for an image of existing conditions.

Figure 24: Rhoda Street Culvert Existing Conditions

The Rhoda Street culvert was observed during the assessment as having the presence of a large amount of riprap both upstream and downstream of the culvert. With the placement of this riprap, it was also observed during lower tide events the flow is being limited by the large rocks placed through the culvert. Additionally, over time it seems that phragmites have become more dominant adjacent to this culvert. See proposed restoration alternative description below.

- Removes the unnecessary stone along the roadway, down the bank, and on the marsh surface.
- Restoration would include the eradication of the existing stand of invasive *Phragmites australis* with replacement of native plant communities.
