1 Introduction

Dudek was retained by Merlone Geier to prepare a Historical Resources Technical Report for the proposed Buena Park Downtown project (Project). This section provides a description of the Project, including information about the location, setting, and proposed Project activities. This section also presents the regulatory setting for the Project, and a description of the Built Environment Study Area.

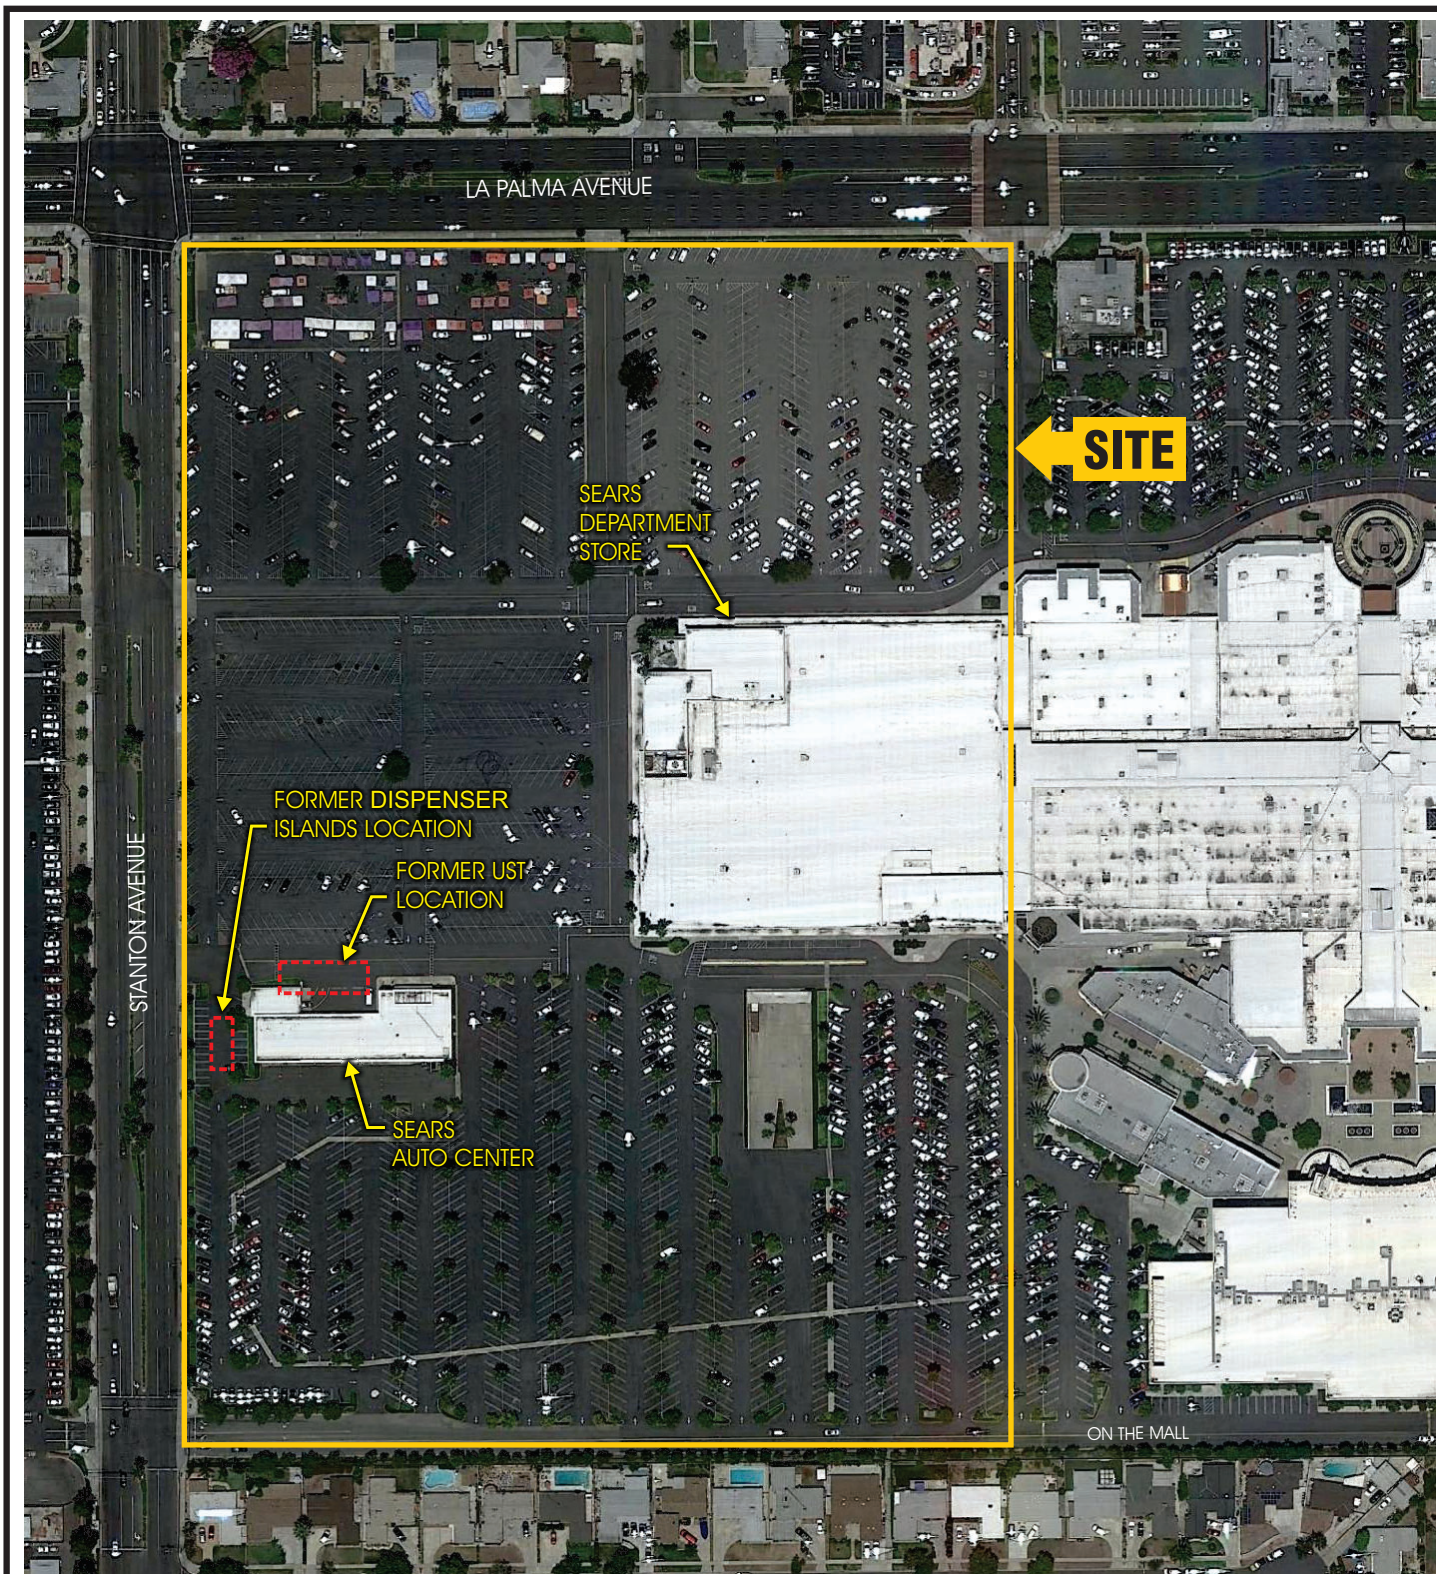
Title:			SITE PLAN
8150 LA PALMA AVENUE BUENA PARK, CALIFORNIA			
Prepared for:			MERLONE GEIER PARTNERS
ROUX	Compiled by: M.M.	Date: 10NOV21	FIGURE 2
	Prepared by: B.H.C.	Scale: AS SHOWN	
	Project Mgr: A.L.C.	Project: 2904.0015S000	
	File: 2904.0015S100.01.CDR

— PROPERTY BOUNDARY

Descriptions of the Property and surrounding areas are included in the following sections. Figure 1 presents the location of the Property in the general context of the city of Buena Park and Figure 2 shows the current Property configuration.

- In 1958, a building permit was issued for a service station.
- A 1965 Certificate of Occupancy was issued for automotive service on the Property.
- A figure with an unknown date indicates there was a fuel dispenser island with four pumps directly west of the Auto Center building at some point (Figure 2).
